Repair Welding Methodology for the Glasses of the Kaplan Turbine Runner at the Hydro Power Plant Djerdap 1

Abstract. Vertical Kaplan turbines, manufactured in Russia and with nominal power of 200 MW, have been installed in 6 hydroelectric generating units at hydro power plant Djerdap 1. Hydroelectric generating sets have been designed for the service life of 40 years due to structural solutions and limited possibilities of performing periodic inspections and state analyses.

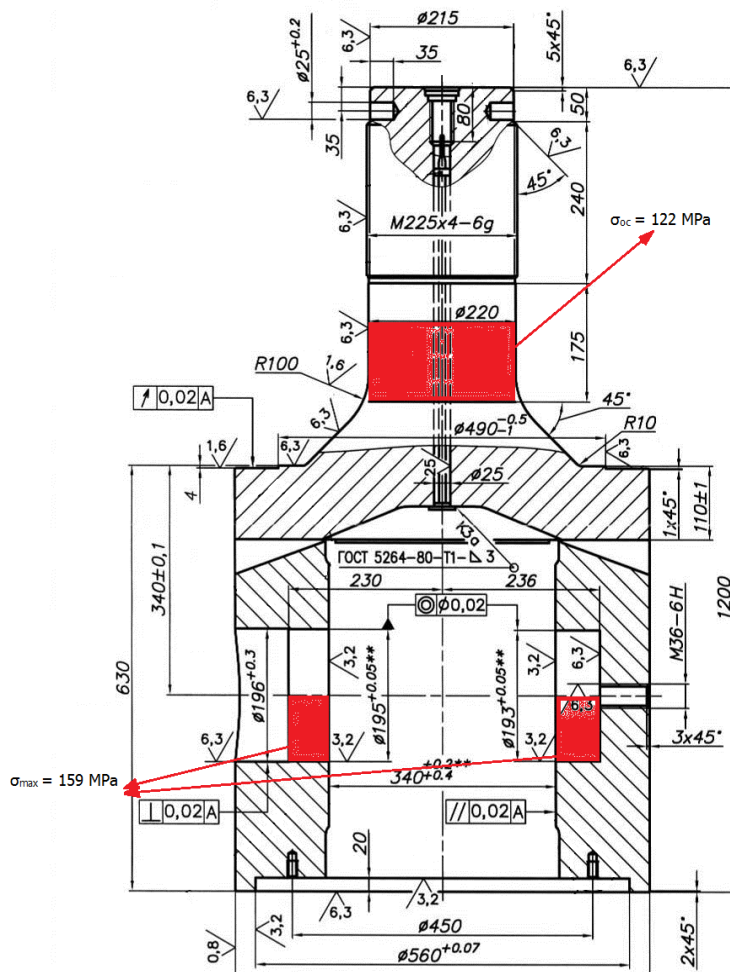
Every glass of the six is, during turbine operation under usual working conditions, subjected to the force $F_{oc} = 2.21$ MN, while maximum force by which the piston acts on the glasses is $F_{max} = 3.38$ MN. For given force values, responding stresses are $\sigma_{oc} = 122$ MPa and $\sigma_{max} = 159$ MPa, figure 2.

Figure 2. Appearance of a glass with basic dimensions and areas in which the stresses occur

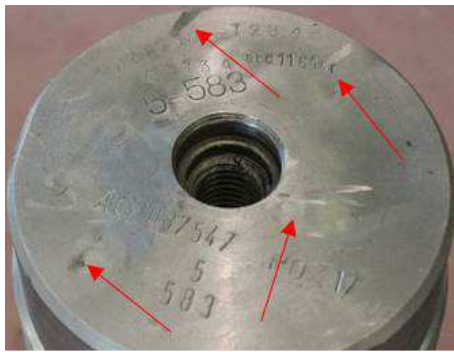
At figure 3 characteristic mechanical damages that occur at the front of the neck of runner glass (internal no.5) during the assembly and disassembly are presented. For the repair of defects that occur at the body of runner glasses due to corrosion, erosion and/or cavitation during the exploitation of the turbine of the hydroelectric generating set A1, which were detected by non-destructive tests, the preparation of surfaces for the repair welding / surface welding by fine grinding was carried out, figure 4.

Figure 3. Characteristic mechanical damages at the front of the neck of runner glass

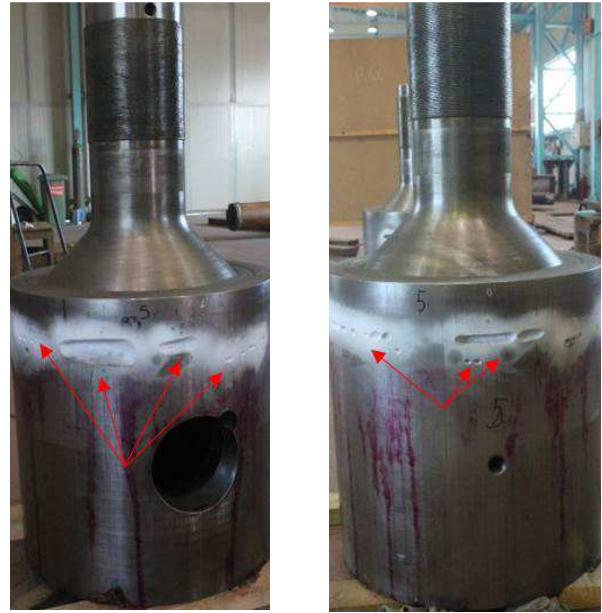
Figure 4. Preparation of surfaces for the repair (body of the glass nr. 5)

- Provision of means of protection at work;
- Marking of areas with defects;
- Grinding of areas with defects by angle grinders until total elimination of defects;

- Final examination of areas where grinding was carried out through the application of magnetic particle inspection;
- Rounding of sharp edges as a part of preparation for repair welding / surface welding, figure 5;
- Determination of location, width, length, depth, and volume of eliminated material for areas where grinding was performed;
- Degreasing, drying and cleaning of areas where grinding was performed.

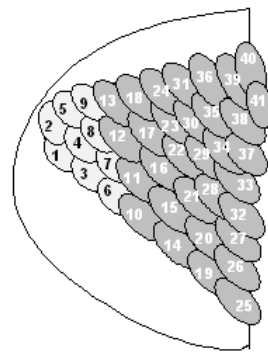
Figure 6. Appearance of a weld with the welding sequence

- Welding / surface welding was executed with the application of rutile based filler material, along with treatment of every deposited layer with the pneumatic hammer with the rounded top ($R = 4 - 5 \text{ mm}$);
- Number of deposited layers depends on the depth and shape of the grinded area, figure 6;
- Levelling of deposited filler material with parent material was executed by straight grinders;
- Machining of areas where grinding was performed was executed by serrated polishing discs, in order to obtain suitable quality of surface preparation for non-destructive tests;
- Repair welds / surface welds were examined by visual and magnetic particle inspection;
- Welding / surface welding process was repeated whenever it was necessary;
- Layers 1-9 were deposited by $\varnothing 3, 2 \text{ mm}$ electrode, the rest by $\varnothing 4 \text{ mm}$ electrode.
