BOŠNJAK S, ARSIĆ M, SAVIĆEVIĆ S, MILOJEVIĆ G, ARSIĆ D. Fracture analysis of the pulley of a bucket wheel boom hoist system. *Eksploatacja i Niezawodność – Maintenance and Reliability* 2016; 18 (2): 155–163, <http://dx.doi.org/10.17531/ein.2016.2.1>.

FRACTURE ANALYSIS OF THE PULLEY OF A BUCKET WHEEL BOOM HOIST SYSTEM

This paper presents the results of the pulley fracture analysis. Experimental investigations confirmed that the chemical composition and basic mechanical properties of the pulley material, except the impact energy at a temperature of -20°C , meet the requirements of the corresponding standard. The impact energy value at the temperature of -20°C is for $\approx 45\%$ lower than the prescribed value which has considerable influence on the appearance of the brittle fracture, especially having in mind the fact that the bucket wheel excavators operate at low temperatures. Metallographic examinations as well as magnetic particle inspections indicated that initial cracks in the welded joints occurred during the manufacture of the pulleys. Characteristic levels of the rope load cycle are obtained by using in-house software which includes the dynamic effects of the resistance-

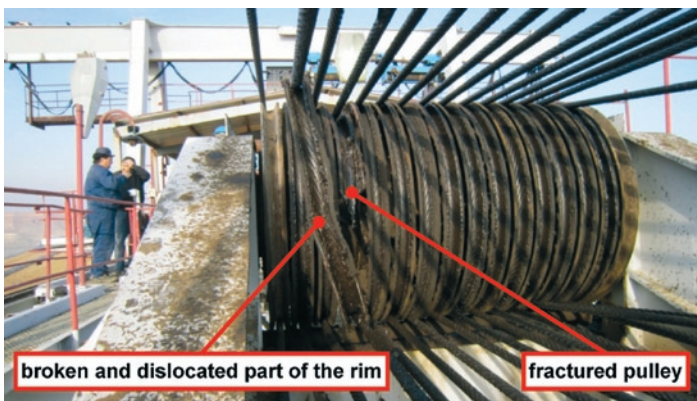
Fig. 2. Fracture of the pulley of the fixed pulley bloc

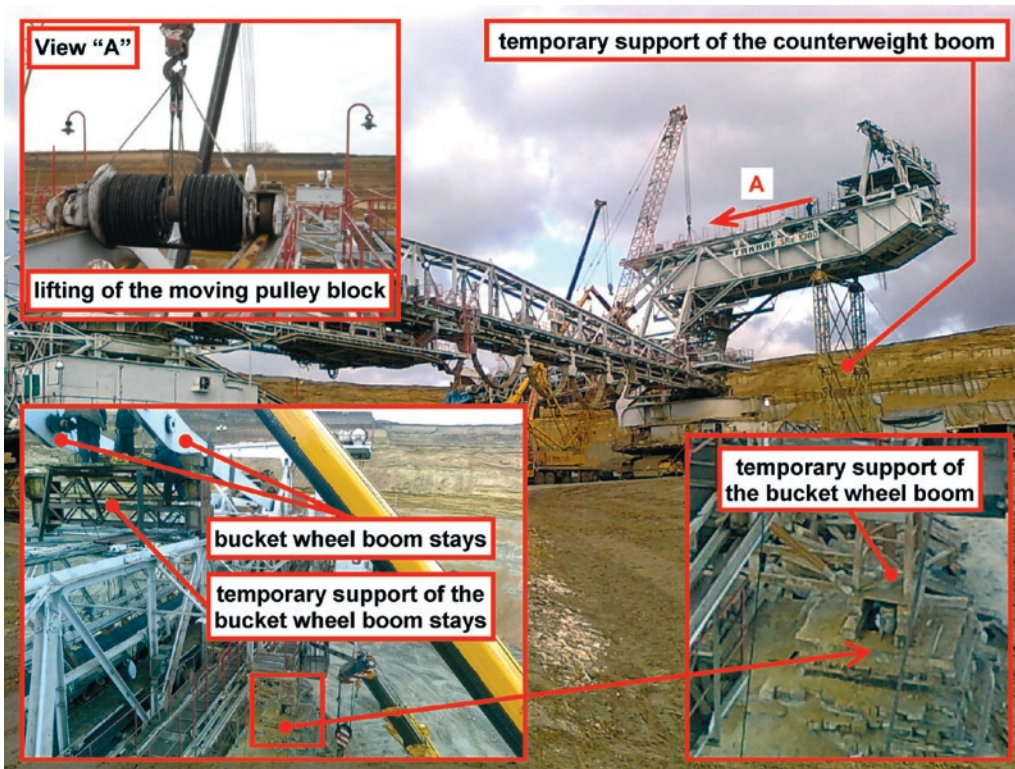
Fig. 3. Details of the BWE temporary supports and the dismantling of the BWB hoist system

supporting of the machine, dismantling of the BWE hoist system, testing and repair of the failed pulleys, testing of the rope and reassembling the BWE hoist system (Fig. 3, Table 1).
