## THE EFFECT OF EXPLOITATION CONDITIONS ON THE DAMAGE OF A ROLLER REDUCER TOOTHED SHAFT AND ITS REPAIR

**Abstract:** *This paper describes repair method of the toothed shaft of roller reducer located in Steelworks Smederevo facility, as well as the effects of exploitation conditions that have led to damage i.e. shaft fracture. After more than 15 years of in-service exploitation the shaft fracture has occurred at the bearing position. The fracture occurred due to blocking on the roller driven by this shaft. In order to restore the working capabilities of the shaft, the repair welding procedure has been established. Additional difficulties during establishing repair procedure were caused by the fact that the base material of the shaft was unknown, so certain assumptions were made (e.g. assumption of base material). Application of repair welding has resulted in significant direct and indirect savings in comparison to the purchasing of a new shaft.*

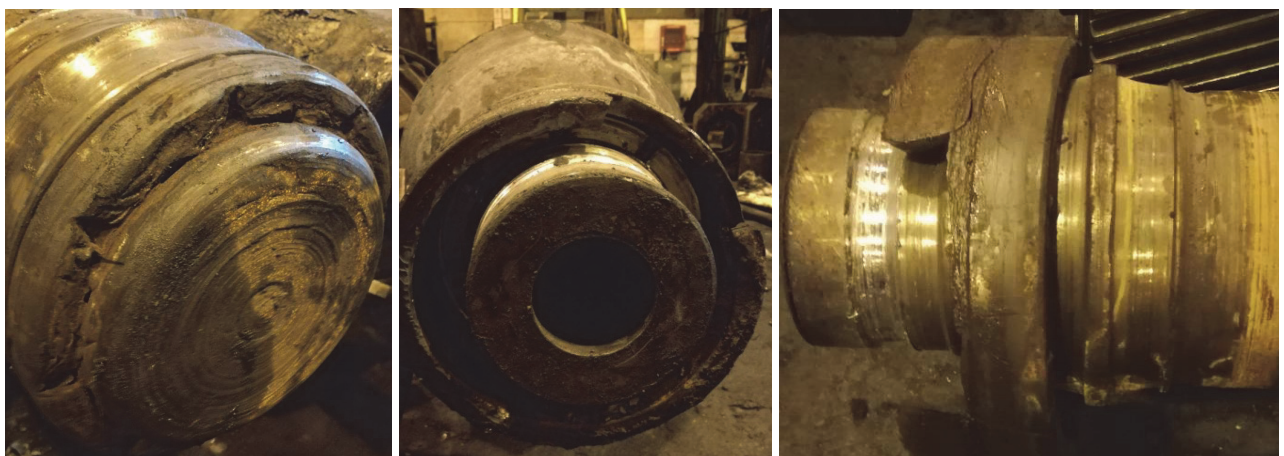
*Fig.1. Some of the damages of roller bearings which can (and did) cause the failure of the toothed shaft*

Presented in this paper is the case of damaging and repairing of a toothed shaft in the Železara Smederevo. The shaft is a part of the roller used for flattening of a hot-rolled strip. The flattening roller used for straightening of the hot-rolled strip, prior to its cutting, is driven by a reducer consisting of 11 gear shafts. After 16 years of exploitation, fracture of one of the toothed shafts occurred, directly in front of the bearing with a diameter of  $\varnothing 120$  mm. It was determined that the shaft failure occurred due to the blockage of the roll which drives this particular toothed shaft. Some of the damage of the roll and bearing failure can be seen in figure 1. Such damages can affect the failure of other reducer elements, as was the case here.

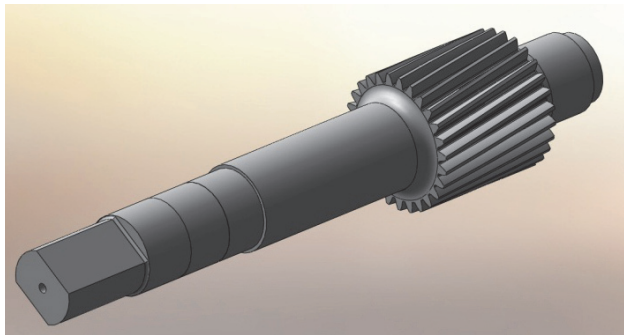
One 3D model of the toothed shaft used in this facility, wherein the fracture occurred, is shown in figure 2, with a clearly marked fracture location. The shaft was then repaired, since the manufacturing of a new part would result in downtime considerably longer than expected.

Fig.2. 3D model of a toothed shaft where fracture occurred

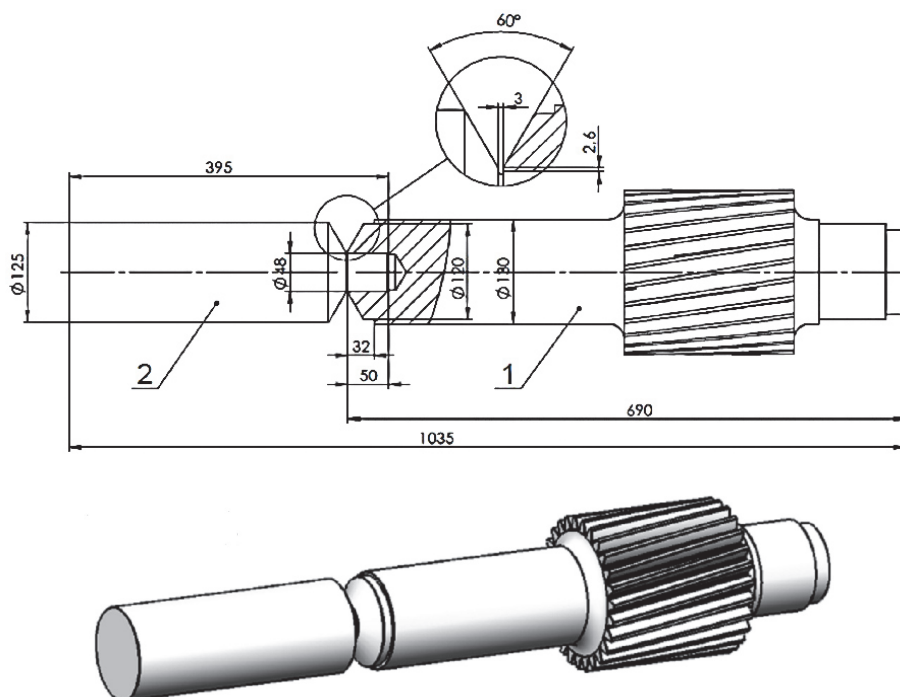
Fig.3. The “V” groove: 1) denotes the base part of the shaft 2) denotes the “attachment” that needs to be welded

It was suggested that the fracture location on the gear side should be realigned and prepared for the welding, with “V” groove and  $60^\circ$  groove angle. In addition, an “attachment” (aforementioned replacement for broken part), which should be welded to the main part, which would then be machined to its designed dimensions (the ones taken from the broken part) needed to be made, using a material similar to the parent one. As it has been said, a “V” groove was prepared, with an M48 thread, whose length was 50 mm. The “attachment” material that was supposed to be welded with the thread due to the shape of the part was steel 30CrMoV9 (Č4734 according to old JUS designations), which was not heat treated.

The appearance of the “V” groove, i.e. the grooving of the base part and the attachment, is shown in figure 3. Also shown in the figure is the thread M48. The diameter of the attachment that was necessary to weld was  $\varnothing 125$  mm. After welding, welded replacement will be reduced to its designed dimensions. The base part of the toothed shaft in figure 3 is denoted by number 1, whereas the part that needs to be welded (the replacement) is denoted by 2. Figure 4 shows the machined parts of broken shaft.

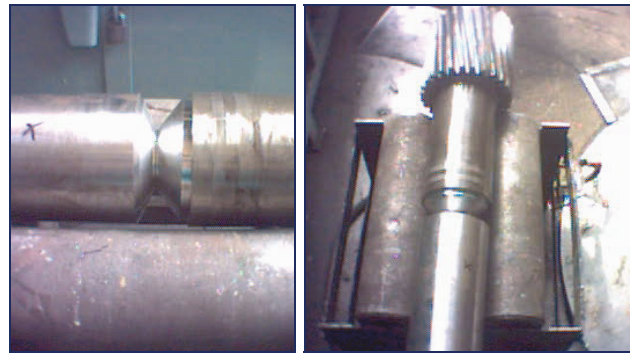
Fig.4. Appearance of machined parts of broken shaft

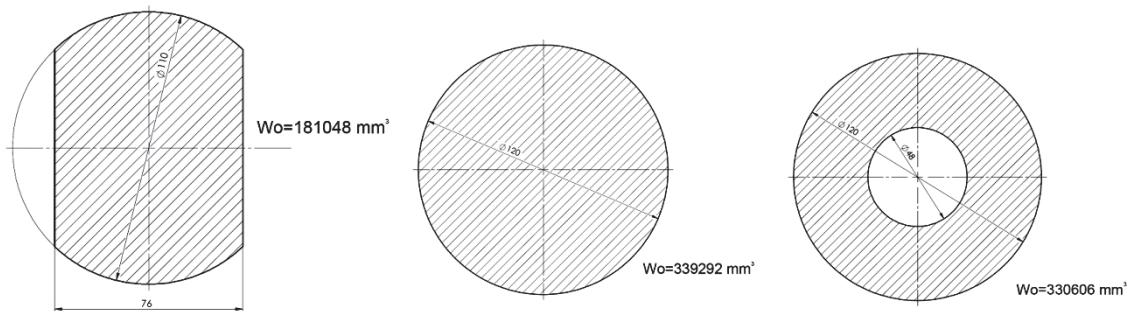
Fig.5. Elastic section modulus of the shaft (smallest cross-section, full cross-section- fracture location, weld cross-section)

It can be seen that the elastic section modulus of the welded cross-section is equal to 97.4% of the full shaft cross-section, thus the stress is 2.6% higher, which is negligible.

Fracture was located immediately in front of the bearing, which represented an advantage, since the weld could be formed in the zone beneath the bearing. At this location (where the bearing was), the shaft was subject only to torsion, and no bending. By calculating the elastic section modulus at the smallest branch (figure 5), it was

determined that there was no need to weld the full  $\varnothing 120$  cross-section and that a “ring” can be formed instead, in order to make an overhang in the attachment and a hole in the gear, for the purpose of “centering”.

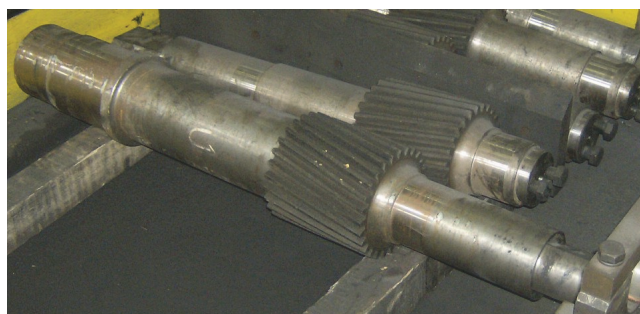
Fig.6. Toothed shaft after the repair welding of the broken part

After 4 hours, its temperature was around 70°C, and it was roughly machined on a lathe. Hardness of the weld and the adjacent area was around 210 HB, which is acceptable when compared to the measured parent material hardness of 180 HB, since there is no significant difference. After the welding activities have been completed, visual, penetrant and ultrasound controls were fully performed. No defects were detected. Figure 6 shows the shafts after the repair welding.

Manual arc welding (MAW) was selected as the welding technique. Weld root was performed using electrode PIVA 29/9 R with a diameter of  $\varnothing 3.25$  mm, whereas electrode PIVA 350 B ( $\varnothing 4.0$  mm) was used for weld filling. Root pass was done in 2 layers. The chemical composition and mechanical properties of clean welds made with both electrodes are shown in table 5.

After the groove was prepared, and immediately before welding of these two parts, the toothed base part was locally preheated using a burner, whereas the replacement

for broken part was preheated in a chamber furnace. Welding was performed by two welders in order to speed up the process as much as possible and to prevent rapid

cooling during the welding. The temperature during the process did not drop below 220°C (it was controlled every 15 minutes using a non-contact thermometer). After the welding, the gear shaft was placed in a metal container and covered with sand.

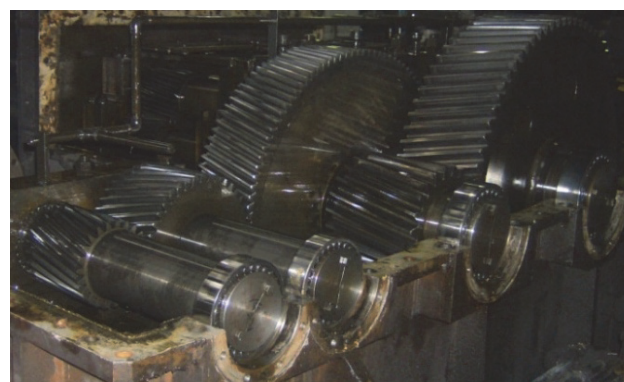
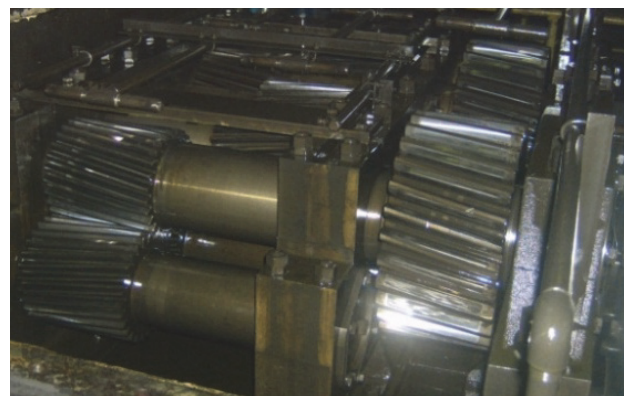
It is well known that repair welding can restore the work functionality of a machine part. Such was the case here, as well. Repairing of the toothed shaft, by means of welding an attachment to the location of the broken part, and machining of this attachment to adequate dimensions restored the functionality of the shaft. The complete repair process was performed within 24 hours. After the welding activities, control and machining of the toothed shaft were completed, it was re-installed into the hot-rolled sheet roller reducer. After few years of exploitation, this reducer was inspected, and the inspection is shown in the figure 7. Repaired shaft is still in exploitation.

Fig.7. Roller reducers used for flattening of hot-rolled strips during the inspection in 2017

teeth takes at least 30 days. Machine part repairs can achieve financial savings, both directly, by comparing the costs of a new and a repaired part, and indirectly, by reducing the downtime which could otherwise negatively affect the number of manufactured hot-rolled sheets, further sales, etc. The price of a new shaft is 2700 Euros, whereas the total cost of the repair procedure is negligible compared to it. The shaft is still in exploitation and shows no signs of defects, as determined by regular inspections. In order to reduce the possibility of failure of shafts in this reducer, it is suggested to lubricate the bearings in a more adequate way in order to reduce their jamming. Bearing failures can affect fracture of both the shaft and other parts of the installation (indirectly). Lubrication should be in accordance with manufacturer recommendations involving specific types of bearings, as well as the exploitation conditions to which the shaft and bearings are subjected. Additionally, it is recommended to regularly examine the reducer assembly, i.e. to perform inspections and controls more frequently.
