## STRENGTH PROBLEMS OF THE TRAVELLING MECHANISMS OF THE OPEN PIT MACHINES

**Summary:** The extremely heavy duty conditions of the Surface Mining Machines (SMM) provide fertile ground for the occurrence of the various types of failures in their travelling mechanisms and belonging substructures. Although failures of the SMM travelling mechanisms occur infrequently, they may lead to very serious or even disastrous consequences. Even in cases when consequences are not catastrophic they cause direct costs, as well as indirect costs due to the downtime that substantially diminishes the effects of SMM exploitation. Furthermore, replacement of damaged parts is executed on site, often in hard working conditions that essentially prolong the downtime of the complete surface mining system. This paper discusses the causes of the failures in the vital parts of the crawler travel gear of the bucket wheel excavators and spreaders: chain links, track wheels, two-wheel bogies and undercarriage. Based on the results of the analytical-numerical-experimental analyses, it was concluded that: (a) chain links' failures are caused by 'manufacturing-in' defects; (b) track wheels' failures are caused by 'd

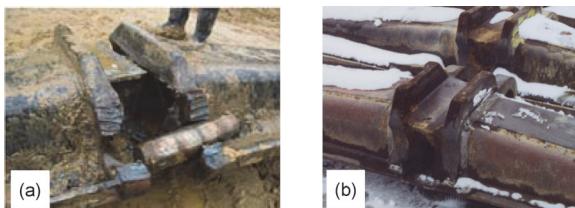
Stacker ARs 2000 presents the final link in the system for continuous overburden removal in the open pit mine "Kostolac" – Serbia. During the stacker's travel from the erection site to the open pit mine, three crawler chain links fractured, presenting an indication of the problems that were to occur during exploitation. In fact, after only 1000 working hours (about three months), 30 chain links sustained fractures, Fig. 1(a) [1]. The similar fractures occurred during perennial exploitation of the bucket wheel excavator (BWE) SchRs 1760 (operating in open pit mine "Kolubara" – Serbia), Fig. 1(b).

Fig. 1 Typical chain link fracture: (a) ARs 2000 [1]; (b) SchRs 1760 [2]

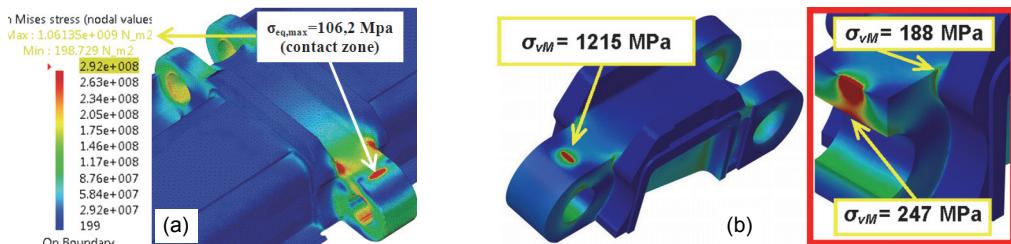
After calculation of the chain link stress state by applying the linear finite element method (FEM), it was concluded that the maximum level of stresses in the critical zones for both, ARs 2000 and SchRs 1760 chain links, does not compromise the integrity of the considered structures, Fig. 2.

Fig. 2 Distribution of von Misses stresses in critical zone:  
(a) ARs 2000 [1]; (b) SchRs 1760

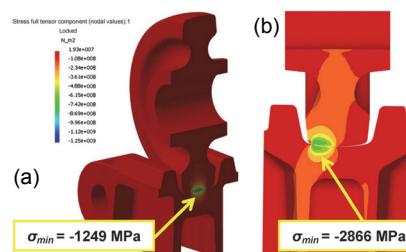
Serious track wheels threads damages, Fig. 4, occurred immediately after the beginning of the overburden system exploitation approximately at the same time as fractures of stacker ARs 2000 crawler chain links. Both analytical and numerical analysis pointed out that contact stress values are inadmissibly high. Inclination of chain link towards the track wheel causes changes in the geometry of contact and the contact surface load as well, which leads to considerable changes of the stress field and multiple increase of contact stresses, Fig 5. The results of the numerical and experimental analyses as well as the fact that damage to the track wheels threads occurred during the first 1000 working hours (fatigue crack propagation had not been able to develop yet), point out that static overstressing (i.e. design fault) joined with lower material properties than required (i.e. manufacture faults) is the main cause of wheel damages [3].

Fig. 5 FEA results: (a) normal components of stress tensors in vertical direction; (b) components of stress tensors in the direction of contact surface perpendicular [3]

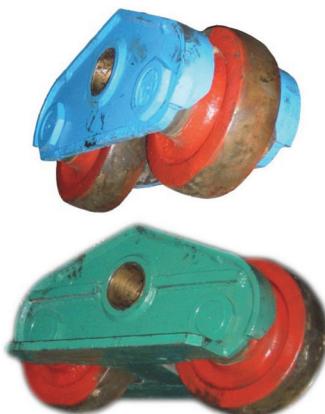
Two variants of the TWB structure were analyzed: the originally designed and the redesigned, Fig 7. Three calculation models for stress state identification were used for each of the variants [5]. The first does not include the influence of the track wheel axle on the lateral loads distribution. The second model includes the mentioned influence while the third considers the track wheel axle as a structural part of the TWB. Models M1, M3 and M5 describe the original, while models M2, M4 and M6 describe redesigned structure behavior. In all of the studied cases, the stress state in the redesigned TWB structure is considerably lower than that in the original TWB structure, Fig 8. Experimental results obtained on a test board especially designed for this purpose [4], confirmed the validity of the TWB reconstruction design. Based on the fact that the results of the FE analyses indicate a considerable influence of track wheel axles on the TWB structure stress state [5], Fig. 9. Nevertheless, the conservative approach to calculating the TWB structure, using models which do not include track wheel axles, provides sufficient TWB carrying capacity even in the case of unforeseen loads.

Fig. 7 Original and redesigned TWB structure

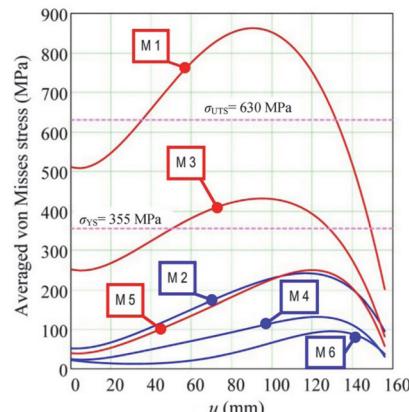
Fig. 8 Comparative distribution of averaged von Misses stresses in the critical zones [5]

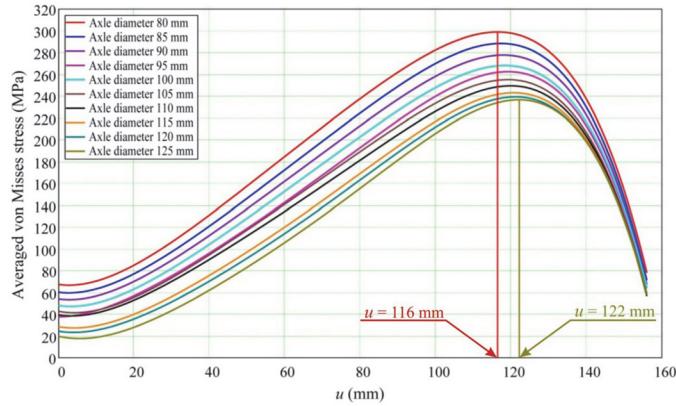
Fig. 9 Dependence of von Misses stresses on the track wheel axle diameter (M 5) [5]

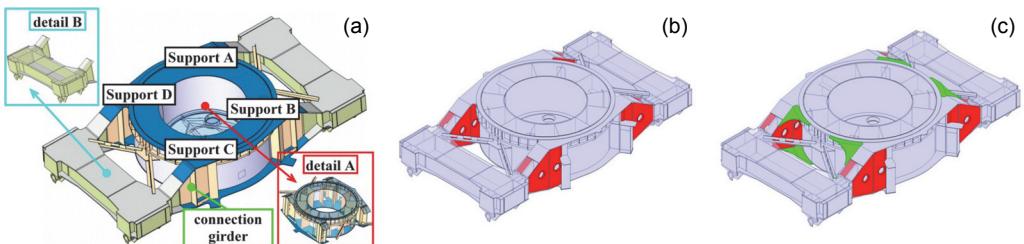
Rigid connections between the undercarriage and crawler beams, Fig. 10 (a), offers a very high factor of safety against tipping but at the same time make unfavorable conditions for adapting to the form of the ground surface. In order to stop the cracks from appearing, the undercarriage structure was intuitively reinforced by building in vertical plates thus strengthen the connection girders, Fig 10 (b). In a very short period of time after the reconstruction, new cracks occurred on elements of the original undercarriage structure and even on added structural elements [6]. The analysis of the undercarriage stress-strain state is performed for three variants, Fig. 10, for 3-point and 4-point leaning and for five load cases described in [6], Fig. 11. Reasons for cracks appearance within both the original and the intuitive redesigned undercarriage structure are design faults.

Fig. 10 3D models of undercarriages: (a) The original undercarriage design (Variant I); (b) Intuitive redesigned undercarriage (built in structural parts are shown in red), (Variant II); (c) Undercarriage redesigned according to [7]

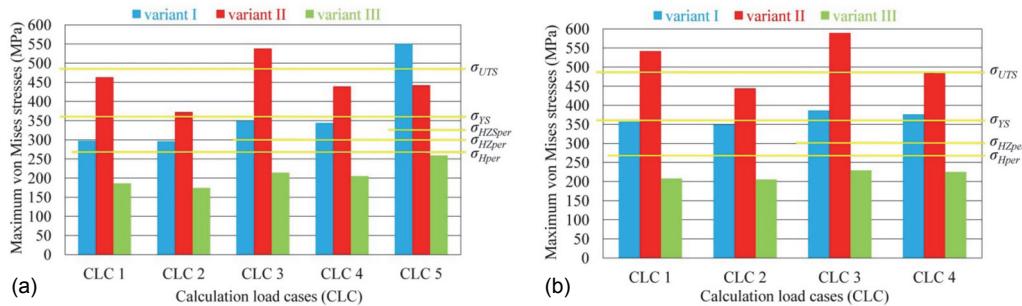
Fig. 11 Stress states: (a) in cases of 4-points leaning; (b) in cases of 3-points leaning
