Assessment of integrity and service life of the upper ring of turbine runner guide vane apparatus at hydro power plant 'Đerdap 1'

During the rehabilitation of the hydroelectric generating set A6 at hydro power plant 'Derdap 1', state analysis and integrity assessment were carried out for all vital components and structures. After the completion of non-destructive and destructive tests carried out on parent material and welded joints of the structure of the upper ring of guide vane apparatus as part of vertical Kaplan turbine runner, it was decided that it should be replaced with a new one, because parent material and welded joints were degraded beyond repair. Existing upper ring of guide vane apparatus was made of steel St 3, in accordance with GOST standard. New upper ring of guide vane apparatus was manufactured through the use of steel S 235, in accordance with DIN standard. During ultrasonic testing 6 mm high lack of root penetration was detected at the load carrying welded joint along the entire circumference of the guide vane apparatus. It should be noted that there is no possibility of restoring the welded joint, because the occurrence of deformations at the structure has t

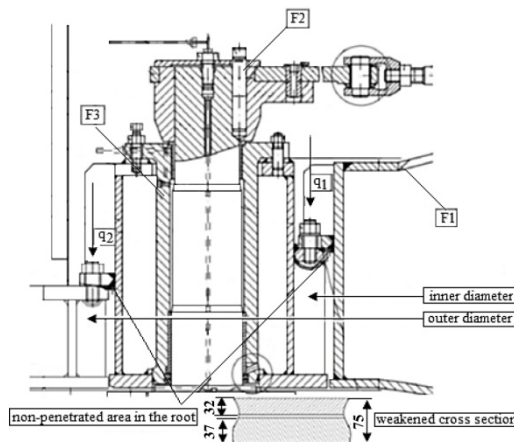
During ultrasonic testing of the upper ring of guide vane apparatus 6 mm high lack of root penetration was detected at the load carrying welded joint, along the entire circumference of the guide vane apparatus. It should be noted that there is no possibility of restoring the welded joint, because the occurrence of deformations at the structure has to be avoided.

Permanent and transferable loads that occur at the inner and outer diameter of the upper ring of guide vane apparatus ($D_i = 9.870$ mm, $D_o = 12.240$ mm), figure 3, have the following values:

For welded joint with 6 mm high lack of root penetration (figures 3 and 4), values of moment of inertia (I_y) and values of section modulus (W_{ys} , W_{yu}) were calculated for predetermined loads. Performed analyses and calculations showed that the integrity of

Figure 3. Appearance of loads that occur during service and non-penetrated welded joints

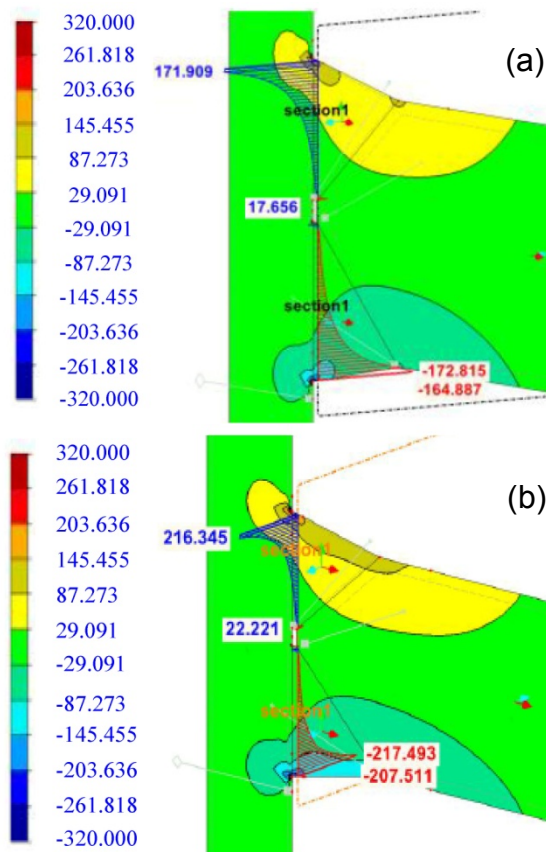
Through the use of finite element method the numerical calculation of stresses that occur at the welded joint with lack of root penetration for new upper ring of guide vane apparatus in normal and disturbed mode of turbine operation was carried out. Calculation results are presented in figure 4.

the upper ring of guide vane apparatus is not threatened, because values of shearing stress for the overall length of the welded joint with the existing lack of root penetration does not exceed 12% of equivalent stresses for various loading modes.

Figure 4. Appearance of distribution of von Mises stresses [MPa] at the welded joint with lack of root penetration for new upper ring of guide vane apparatus in (a) normal and (b) disturbed mode of turbine operation

where: $K_{Ic} = 30 \text{ [MPa}\cdot\text{m}^{1/2}]$ – minimum allowed value of stress intensity factor for temperatures below 0°C , steel S235 [9], $Y = 1.12$ – parameter that depends on structural element geometry and crack shape [10], $\sigma_{max} = 22.2 \text{ MPa}$ – maximum stress in disturbed mode of turbine operation (figure 4b), a_c – critical length of edge crack.

which is higher than 6 mm, obtained as the lack of root penetration.
