# Filler Material Choice for Stop Valve Repair Welding

**FILLER MATERIAL CHOICE FOR STOP VALVE REPAIR WELDING**

Filler material choice for repair welding of stop valve spindle of thermal power plant by-pass pipeline was presented in this paper. Repair welding of the stop valve spindle was necessary because of plant operating problems due to very frequent localized damage appearance in the form of erosive wear on it. For this purpose it was necessary to choice appropriate filler material with high wear resistance characteristic. Experimental investigation and testing (hardness measurement, chemical composition analysis and microstructural investigation) of prepared specimens after welding simulation with different kind of filler material was performed. On the basis of obtained results it was recommended procedure for application of the filler material with generally preferable characteristic.

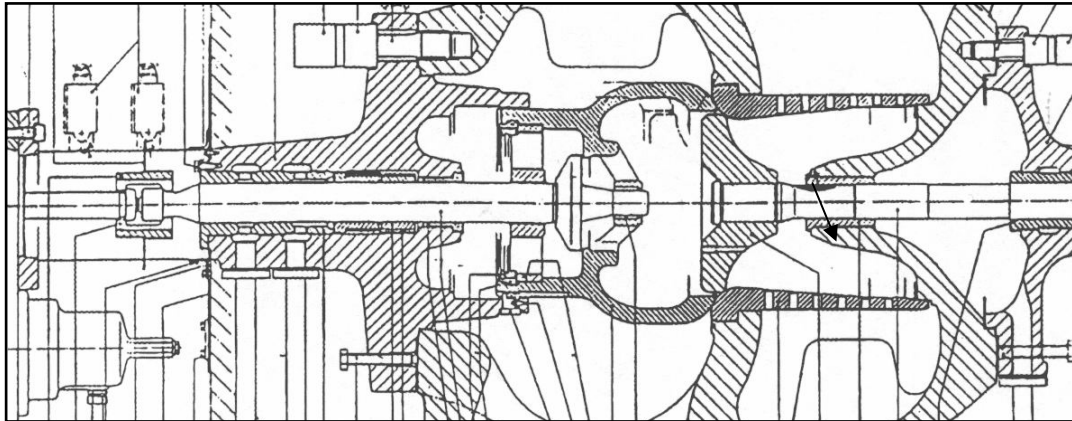
During operation of the low pressure stop valve, significant erosion damaging on the valve spindle in the vicinity of the valve plate is taking place, Figs. 1 and 2. Since this kind of damage started to appear very often, it became necessary not only to protect this valve area but also to increase the erosion resistance of spindle surface layer.

The damaged area appeared in the case - spindle contact zone with dimension: 11-13 mm in depth and ~ 110 mm in length. The spindle made from austenitic stainless steel X8CrNiMoVNB 1613 has a diameter in damage area app.  $\varnothing 89$  mm.

**Figure 1 – View of low pressure stop valve part  
Damaged area is denoted by arrow**

Taking into account all emphasized beneficial of Stellite, including procedure in complexity in comparison with two other applied repair welding techniques, it was clear that the Stellite overlay application directly on parent metal was optimal choice. The confirmation of correctness of Stellite choice was also significantly prolonged period of reliable and safety operation of repaired stop valve spindle.

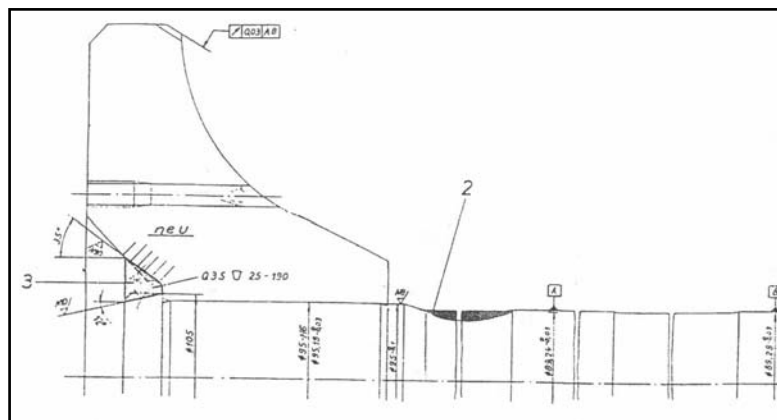
**Figure 2 – Schematic view of damaged area location**

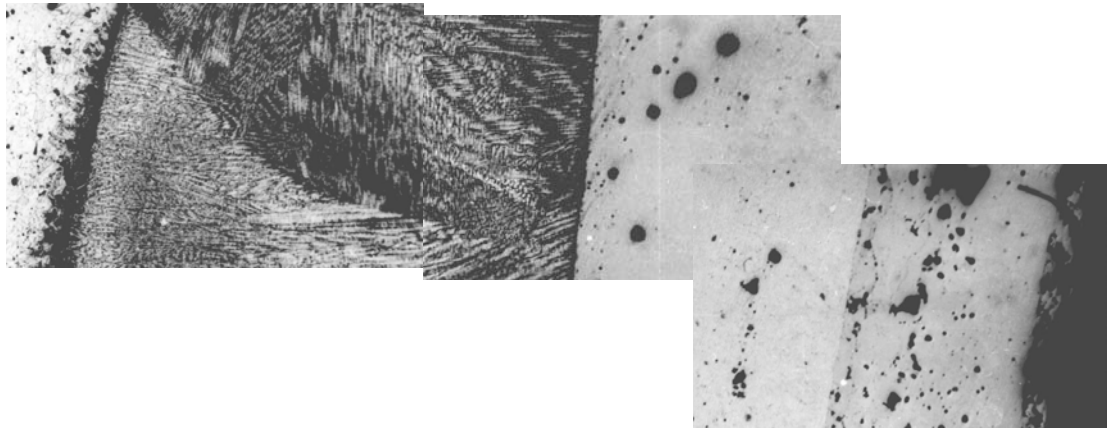
Metallization was applied in three layers, two underlayers with final layer. All three layers, and especially the final layer, have very poor quality and they are inhomogeneous and porous, Figs. 4-6a. The underlayers interface is also poorly realized with incomplete fusion with narrow diffusion zone. Relatively long cracks between layers can be observed, Fig 6b.

Figure 4 – Sample 1A. Transversal cross section. Metallization layers – weld metal – parent metal (40x)

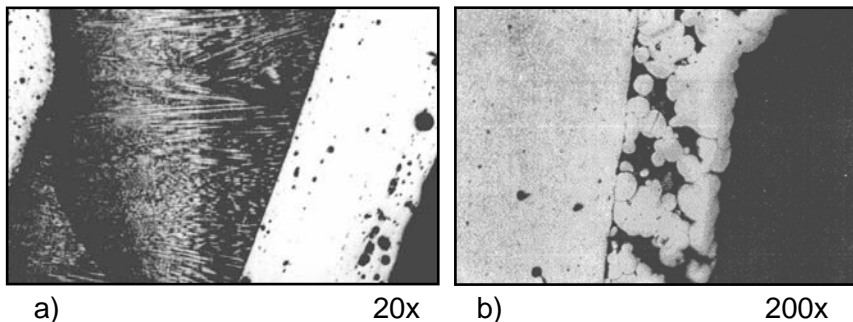
Figure 5 – Sample 1A. Transversal cross section. a) Metallization layers - weld metal - parent metal; b) Detail from Fig.5a - Final porous layer

In the area of final layer individual powder particles can be observed, Fig. 5b, and their presence implies that there was no fusion between particles. Also, long cracks, starting from final layer and propagating through entire metallization zone, can be observed, Fig 7.

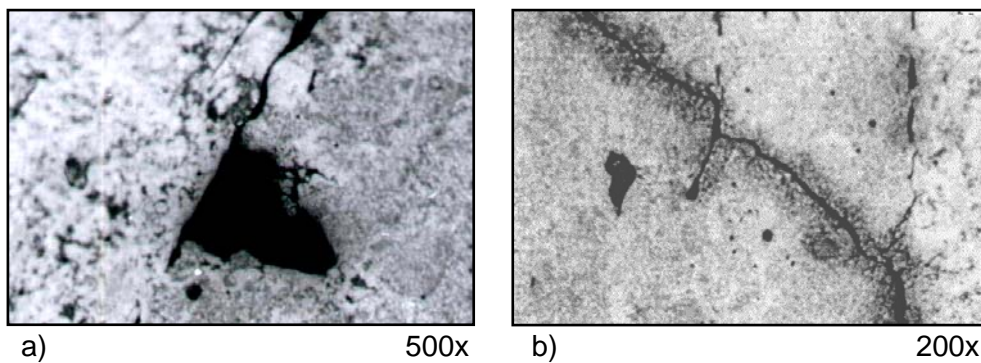
**Figure 6 - Sample 1B. Longitudinal cross section. Flaws in metallized layers; a) Shrinkage; b) Cracks**

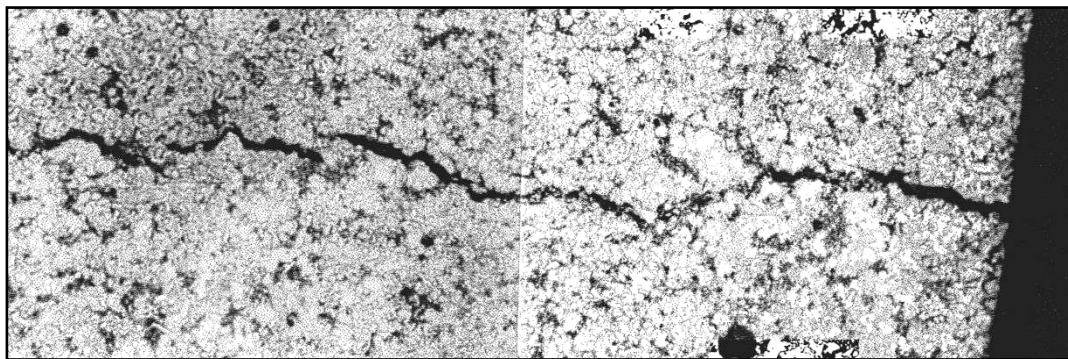
It can be assumed, on the basis of the obtained hardness results in metallized layers, that the cracks revealed during the microscopic investigation were initiated and propagated through the metallized layer not only because of poor quality of performed metallization but also because of great difference in hardness in the narrow zone. Therefore, the first criterion for elimination of particular approach of repair welding was the hardness level and its variation, because the very high hardness level [6] does not mean at the same time the highest erosion resistance.

**Figure 7 - Sample 1D. Crack through metallization layer (200x)**

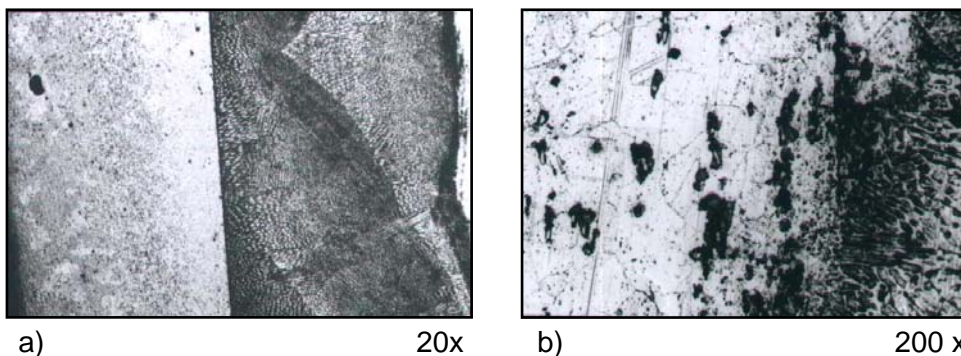
The microstructure of repair weld layer is austenite as cast, achieved through several passes. Microstructure per pass is unequal, with different grain size (hardness distribution is variable) and probably with different distribution of alloying elements, which implies that welding parameters and the amount of heat input are not the same for individual pass, Figs. 4, 8, 9. The presence of diffusion zone is observed between base and weld metal, while on the metallization layer side, distinct interface boundary containing cavities can be seen.

The microstructure of the parent metal is austenitic with polygonal small grains and twins, Fig. 8b.

**Figure 8 - Sample 1B. Longitudinal cross section. a) Parent metal - weld metal; b) Detail of parent metal - weld metal interface**

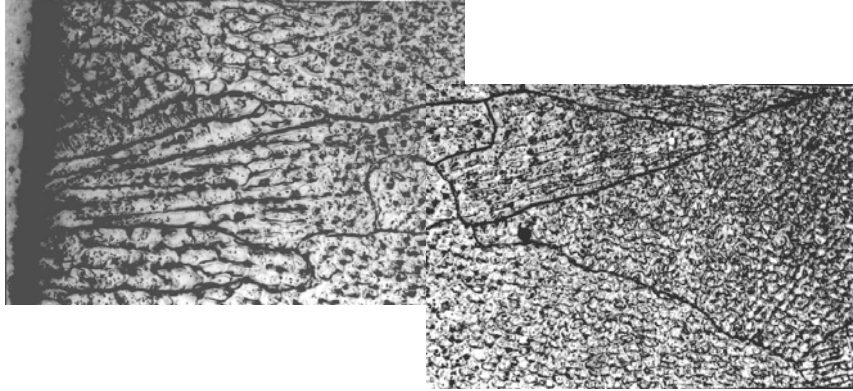
**Figure 9 - Sample 1B. Longitudinal cross section. Weld metal (200x)**

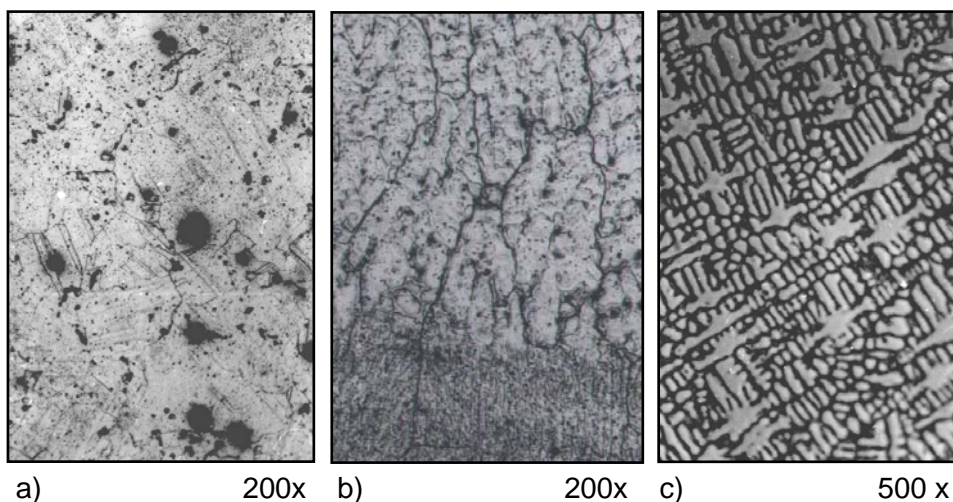
The microstructure of final layer consists of dendrites with lamellar eutectic carbides, Fig 10c. The hardness results are in agreement with observed Stellite microstructure.

The microstructure of repair weld layer is as cast austenitic, achieved through several passes, and in all microstructural features is very similar as at sample 1, Fig. 10b.

The microstructure of the parent metal is austenitic with polygonal small grains and twins, Fig 10a.

**Figure 10 - Sample 2. Transversal cross section a) Parent metal in the vicinity of fusion zone; b) UTP 68HH filler material; c) Final layer - Stellite**

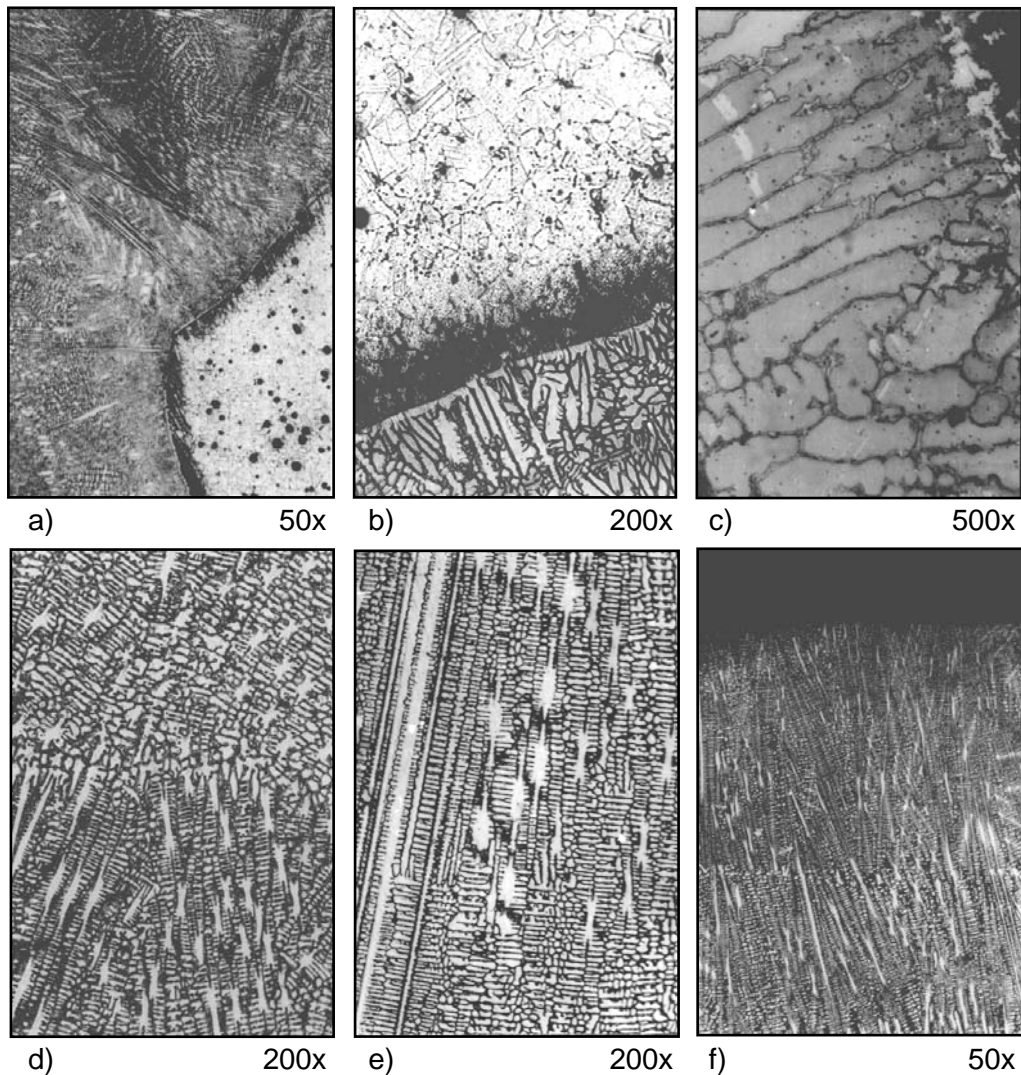
The microstructure of sample 3 in transversal cross section is shown in Fig. 11. Repair welding was carried out in several passes. The microstructure of weld metal consists of dendrites of different sizes and spreading directions with lamellar eutectic carbides, Figs 11(d-f). The hardness results are in agreement with observed Stellite microstructure. Diffusion zone between parent material and welded layer is relatively narrow and with variable thickness, Fig. 11b.

**Figure 11 - Sample 3. Transversal cross section. a) Parent metal - Stellite; b) Parent metal – Stellite; c) Stellite – fusion zone; d) Two layers of Stellite; e) Stellite in the vicinity of the surface; f) Surface zone of final Stellite layer**

The first phase to form during Stellite 6 cooling from the liquid state consists of cobalt-rich dendrites with a face-centered cubic (FCC) crystal structure [8] with carbide phases dispersed in inter-dendritic regions in the cobalt-rich matrix (Figure 11c). The remaining liquid eventually solidifies by a eutectic reaction into an interdendritic, intimate lamellar mixture of the FCC phase and  $M_7C_3$ - eutectic carbides. Most of the W remains in solid solution and therefore it provide additional solid solution strength. The excellent wear resistance of these alloys is attributed to the high volume carbides and the unusual deformation characteristics imparted by Co-rich matrix. This strain hardening of the matrix by alloy addition is explained through the change in the stacking fault energy (SFE) [8].

On the bases of the obtained hardness and microstructural results, the III approach of damaged spindle repair welding only with Stellite as filler metal was recommended. The reason for this decision was obvious because of:
