Damage Analysis on Tooth Gear Ring of a Bucket-Wheel Excavator

Abstract. This paper deals with damage analysis of gear ring after manufacturing process, just before *in-service* period. Tooth gear ring segments were made of 40MnCrSi3V low-alloyed cast steel, which chemical composition and mechanical properties were given in table 1 and 2, respectively.

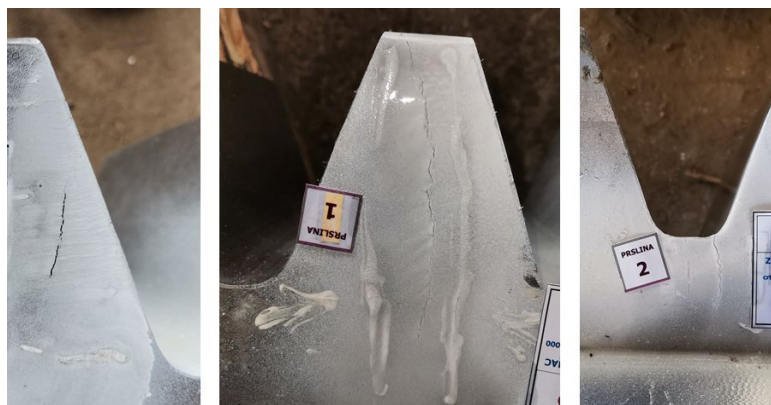
Concerning parent material characteristics, in this case low-alloyed cast steel 40 MnCrSi3V, inspection and control of gear segments were necessary to be performed after manufacturing. Non-destructive testing method with magnet particles (MT) of fluorescent suspension of particle size 3 μm was performed for potential defects detection. Surface indications were observed on 8 out of 12 gear segments on these new parts, where the lengths of the cracks goes up to 110 mm. Some of the observed defects were shown in Fig. 1. Defects were located in segments main body the gear teeth, its main body etc. Taking into account aforementioned, observed defects on new gear ring segments were caused in manufacturing process i.e. by casting process and inadequate cooling rate.

Figure 1. Examples of observed defects on gear ring of a bucket-wheel excavator.
