## UTICAJ OTKAZA ZUBACA NA BEZBEDNOST MAŠINA – ISPITIVANJE I ANALIZA THE EFFECT OF TEETH FAILURES ON MACHINE SAFETY – TESTING AND ANALYSIS

Stručni članak / Professional paper

*According to clauses of Machinery Directive 98/37/EC the basic requirements are defined which have to be met by gear power transmissions in regard to health and safety. Different types of gear teeth damage, fracture and affecting conditions of environment, service and maintenance are analysed in the paper. A detailed description of damage forms of teeth flank surfaces under high loads and insufficient lubrication which can cause failure of heavy machinery and also imposes danger for people and environment. Testing and analysis procedures for some types and levels of teeth damage are shown. Tests of gear teeth of an excavator front arm are presented.*

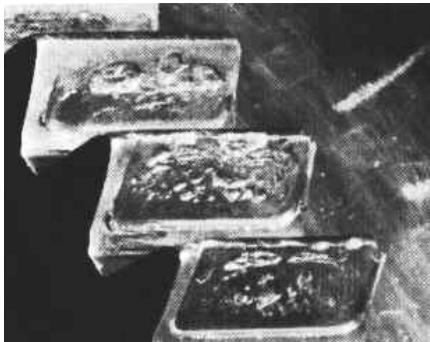
Slika 1. Adheziono habanje  
Figure 1. Adhesive wear.

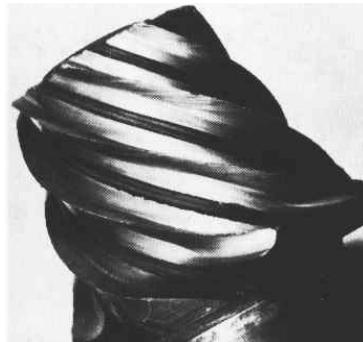
Slika 2. Prekomerno habanje  
Figure 2. Excessive wear.

At the beginning of gear pair operation, so called running-in wear occurs, with positive effect on load distribution on two coupled teeth, because of smoothing of the surface of the machined tooth flank. It can occur in forms of moderate wear and polishing. Moderate wear reveals that metal has been removed from both addendum and dedendum teeth surfaces, and polishing is a very slow wearing-in process in which the roughness of contacting surfaces is gradually worn until mirror-like surfaces. After a certain working period, wear attains a critical level, defined as excessive wear, Fig. 2.

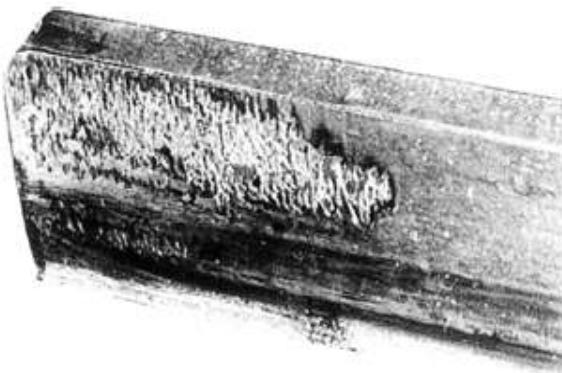
Scuffing is the type of tooth flank damage due to high surface pressure and sliding velocity, occurring as form of specific wear with fissures and incisions in the sliding direction. *Cold scuffing* occurs at circumferential velocity below 4 m/s, on gears produced of quenched and tempered steel of lower machining quality, occurring rarely, and *hot scuffing* occurs at high sliding speeds and surface pressures, on heat treated cylindrical gears. An example of expressed scuffing as a result of pronounced misalignment of coupled gears axes is presented in Fig. 3.

Slika 3. Izraženo zaribavanje  
Figure 3. Excessive scuffing.

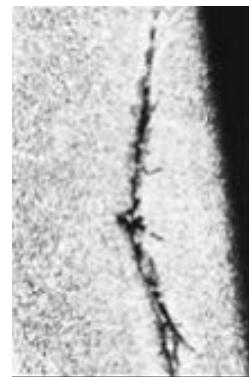
Slika 4. Prvac prsline ispod površine boka zupca  
Figure 4. Tooth flank sub-surface crack direction.

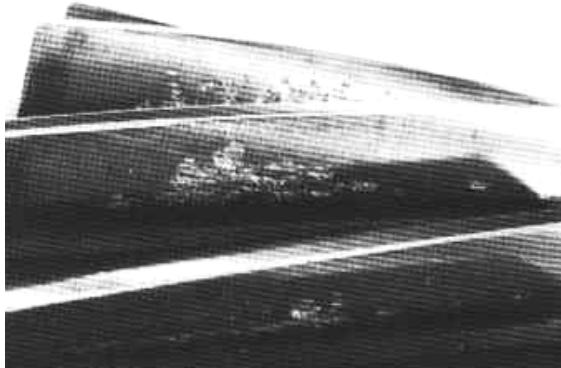
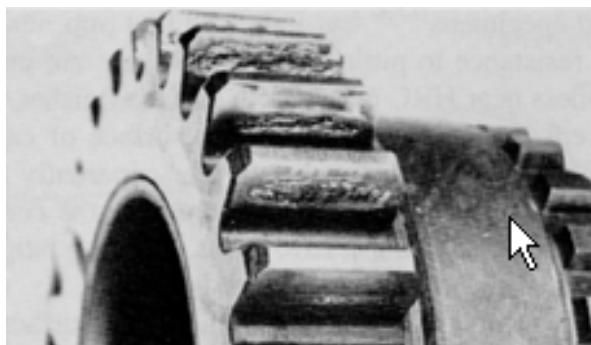
Slika 5. Piting boka zupca – početni (gore) i progresivni (dole)  
Figure 5. Tooth flank pitting – initial (up) and progressive (down)

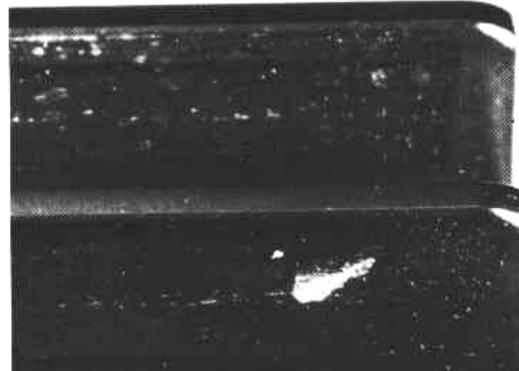
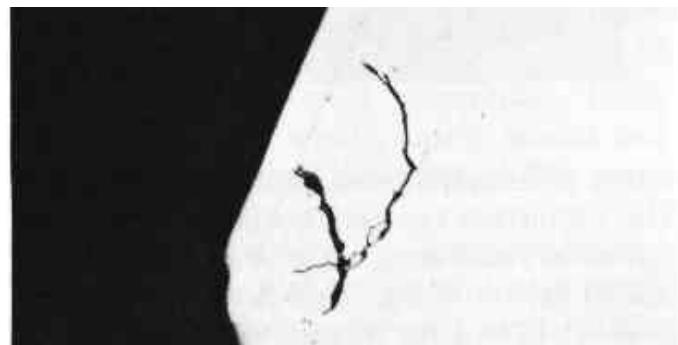
*Spalling* is damage similar to flake pitting in which the detached material fragments tend to be thicker than the hardened layer and are of irregular shape. It usually occurs on flank hardened surfaces of cylindrical gears with straight teeth. This damage on the gear with straight teeth is shown in Fig. 6, and with micrograph (100×) revealing the development of sub-surface cracks.

Slika 6. Ljuštenje cepanjem  
Figure 6. Spalling.

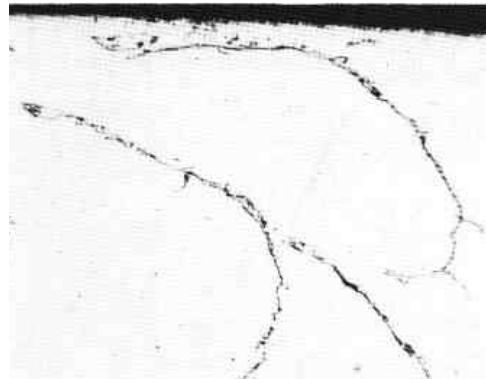
*Fatigue cracks* are results of repeated alternating or cyclic loads with magnitudes usually considerably below the tensile strength of the material (Fig. 7).

Slika 7. Izgled zamorne prsline (60x)

Figure 7. View of fatigue crack (60x).

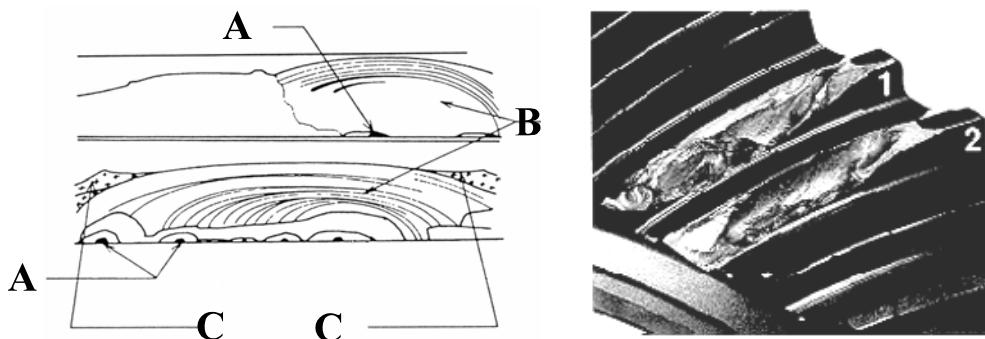
Slika 8. Zamorni lom zbog savijanja (A–inicijacija prsline; B–rast prsline, C–lom)

Figure 8. Bending fatigue fracture (A–crack initiation; B–crack growth; C–fracture).

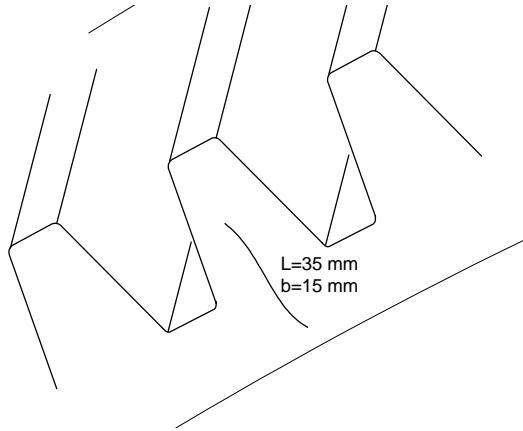
Slika 9. Oblik i dimenzije prslina na čelima zubaca (L—dužina prsline, b—dubina prsline).  
Figure 9. Shape and dimension of cracks on tooth faces (L—crack length, b—crack depth).

- cracks on tooth faces (Fig. 9),
- cracks on flanks of previously repaired regions on the wheel of the right and left gear pairs.

Gonjeni zupčanici imaju oštećenja čiji tip i intenzitet ukazuju na potrebu njihove zamene.
