Failure analysis of a special vehicle engine connecting rod

**Failure analysis of a special vehicle engine connecting rod**

This paper presents failure analysis of the connecting rod used in a 12-cylinder diesel engine set on a special vehicle. The fracture of the connecting rod occurred during the engine test in laboratory conditions. Chemical and metallographic analysis as well as mechanical testing have confirmed that the material properties of the connecting rod met the requirements of standard specification and technical documentation. Linear finite element (FE) analysis was performed to evaluate stress state of the connecting rod under maximum load. The results of FE analysis showed that the position of the fracture is consistent with the zone of highest stress. Fractographic analysis has not been able to reveal the main cause of mechanism of fracture due to substantially damaged fracture surface.

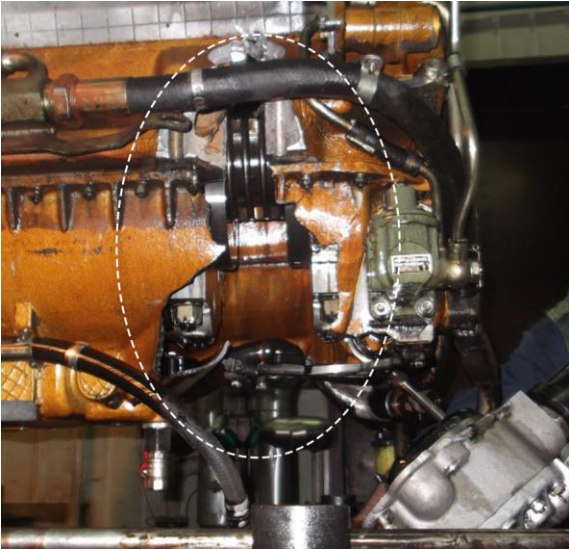
Figure 1

During the laboratory tests conducted on the 12-cylinder diesel engine, there was an engine breakdown due to the fracture of the connecting rod of the first left cylinder of the engine, Fig. 1. The projected life span of the subject-matter engine is 500 hours of operation, whereas the engine had 130 hours of operation until the breakdown and 5 hours of operation on the engine test bench in the testing laboratory. The last regular periodic check of the engine was carried out 10 hours before the breakdown and a conclusion was drawn that all the parts of the engine and its systems were functioning properly.

In a short period after the connecting rod had been fractured, the uncontrolled movement of its part, which remained contact with the crankpin journal of the engine crankshaft, caused the greatest damage to the engine. Firstly, this part of the connecting rod penetrated through the lower part of the crankcase engine and dislocated the oil pump from its position in the oil pan. Secondly, it broke the upper part of the crankcase of the engine in the area of the front left support of the engine. Then, it smashed the free end of the cylinder liner and, finally, plunged into the ridge of cylinder block. This ridge was found deformed with a visible crack.

Fig. 1. The damage of the cylinder block and the crankcase of the engine.

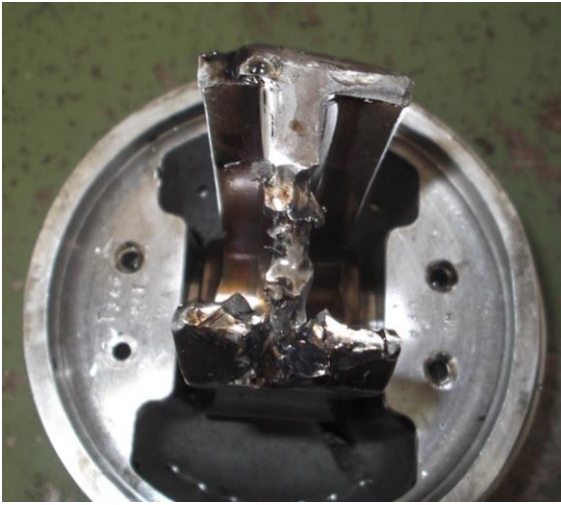
Figure 2

The additional damage was caused by the uncontrolled movement of the auxiliary connecting rod and the piston of the first cylinder on the right. The surface of the fracture on the part of the connecting rod which is connected to the piston with the small end - Fig. 2- is significantly deformed due to the multiple collisions with the other part of the connecting rod, until the time when the engine was stopped.

Fig. 2. The part of the broken connecting rod with the piston.

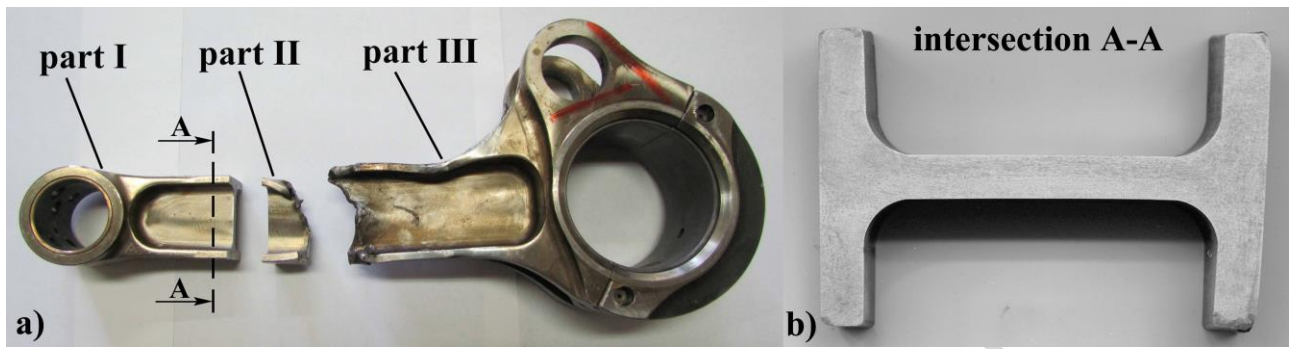
Figure 3

It was noticed that the fracture of the connecting rod occurred at a distance of approximately 15 cm from the center of the big end connecting rod, Fig. 3a.

The analysis of the fracture surface was carried out on the part of the connecting rod marked with “part II” in Fig. 3a. Neither position where the crack was initiated nor presence of the traces, pointing to the

The macrostructure of the sample is shown in Fig. 3b. The visible presence of the non-metallic inclusions, as well as the impermissible metallurgical defects, such as porosity, voids, cracks, bubbles etc. were not observed. No defects of the forging was detected.

Fig 3. (a) The broken connecting rod (b) The metallographic specimen for macro-structural testing (intersection A-A).

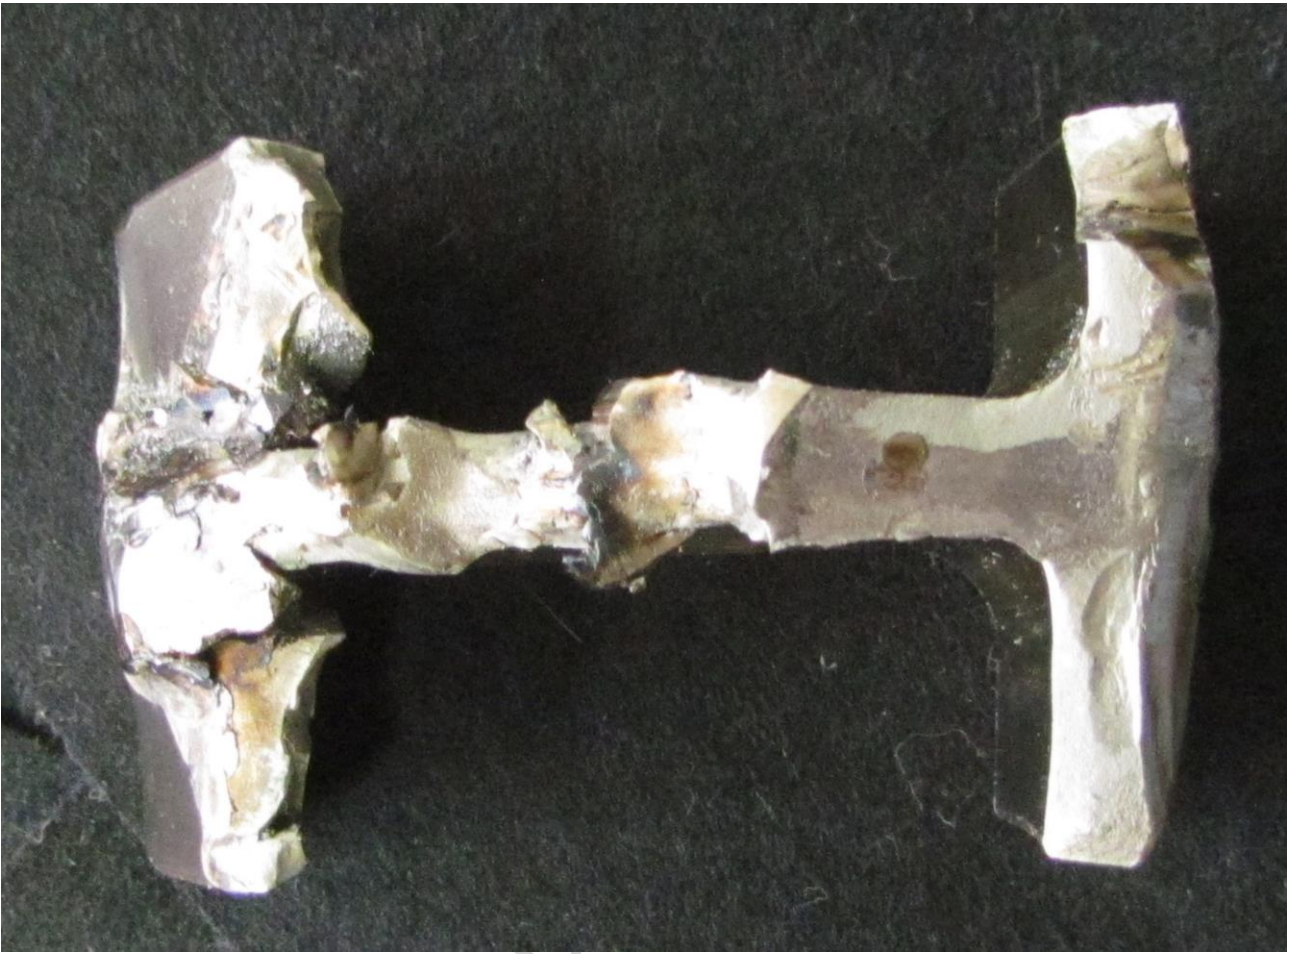
Figure 4

The visual and the examination under the stereomicroscope showed the presence of significant macroscopic damage of fracture surfaces on the original fractured surface of the connecting rod, caused by the uncontrolled movement of the connecting rod after the catastrophic failure until the engine stopped running (Fig. 4).

possibility that the fracture was caused by the connecting rod fatigue, was seen. Significant damage to the fracture surfaces largely prevented a better analysis of the fracture surfaces.

Fig. 4. Mechanical damage of the fracture surface of the connecting rod.

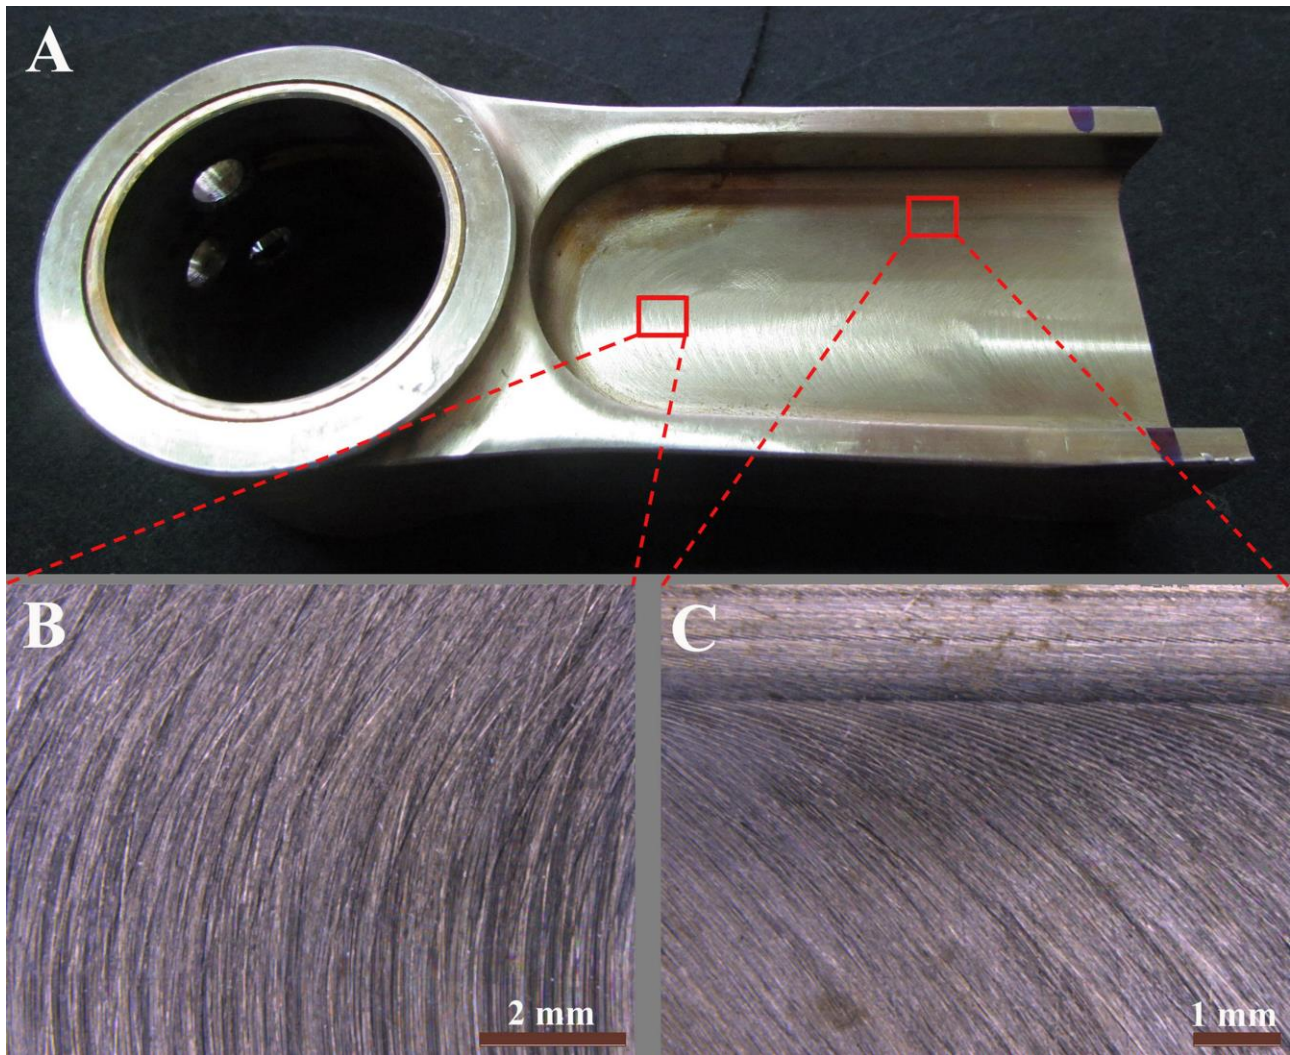
Figure 5

The traces of machining on the external surface of the connecting rod were detected (Fig. 5). Also, in the radial transition between the flat surfaces, the presence of undercuts was observed. In those areas, the machining knife penetrated the radius and made a recess.

On the sample surface, the traces of machining were observed. The undercuts and the sharp lines during the changeover from the flat side towards the lateral sides, in which the machining knife entered the radius, were also noticed. In the conditions of high cyclical variable loads, the perceived processing deficiencies represent the potential points where a crack can be initiated. In this regard, the observed presence of the discrete recess that extends along the entire length of the radial changeover from the flat side towards the lateral sides on the connecting rod is especially unfavorable.

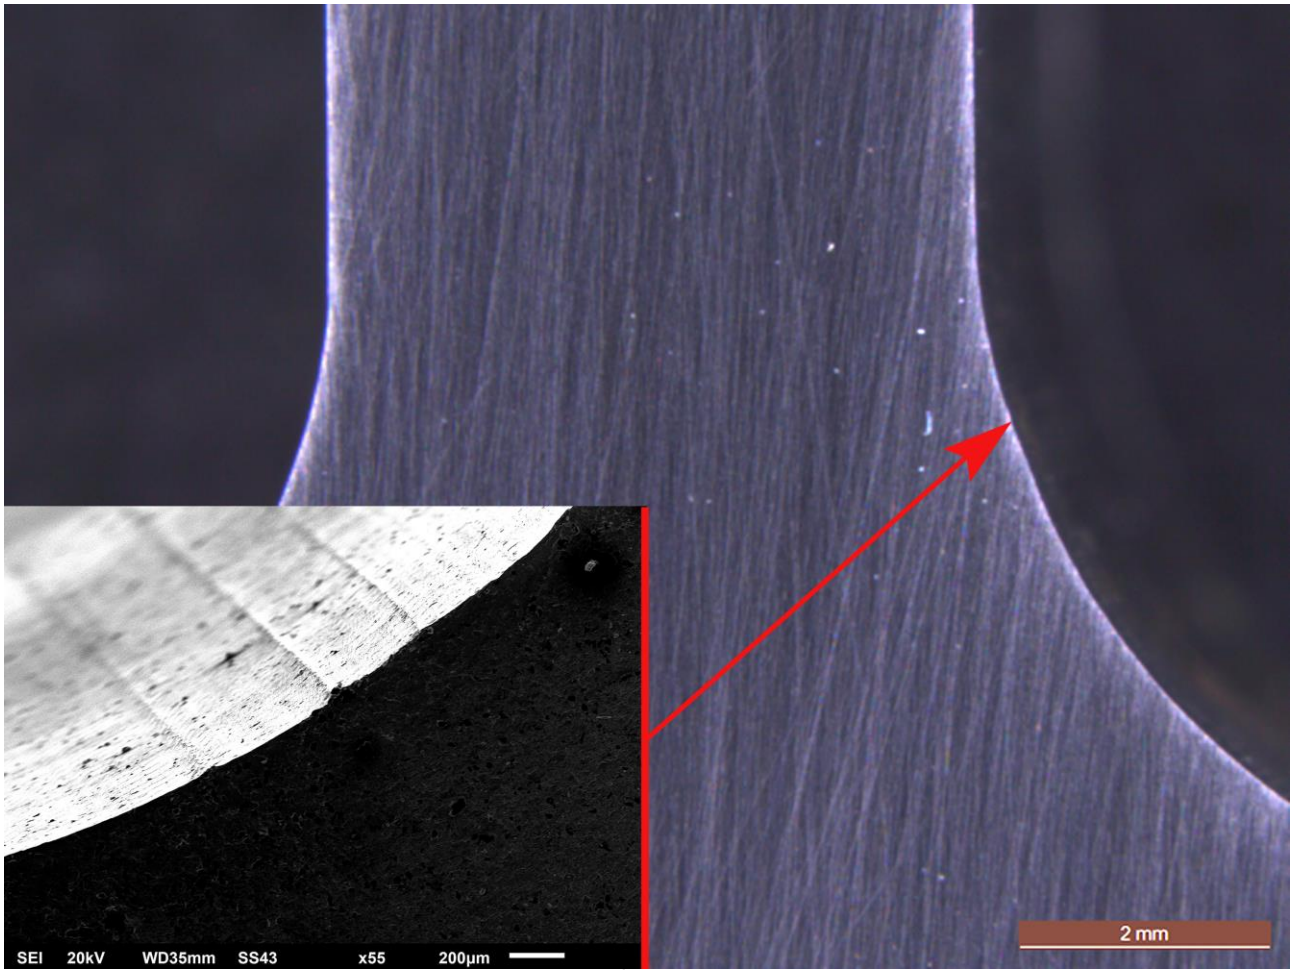
Figure 6

No undercuts were noticed at the cross section of the connecting rod body. The traces of machining on the connecting rod surface were confirmed by using the SEM microscope (Fig. 6).

This is supported by the observed inadequate level of the polishing of the surface of the connecting rod body. Namely, the microscopic record led to the observation of the fact that the outer rounding of the cross section of the connecting rod body designed as the "I" profile was not polished, as it is suggested in the technical documentation.

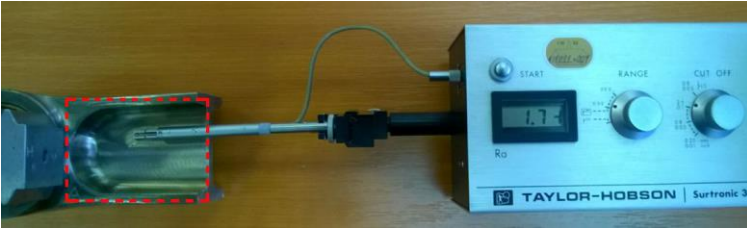
Figure 7

The surface roughness was measured on the marked area of connecting rod shown on Fig. 7. The average value of surface roughness (Ra) is 1,6  $\mu\text{m}$ . This value, according to standard SRPS M.A1.026 [8], corresponds to the N7 class of surface roughness. According to the technical documentation, class roughness should be N1, which corresponds to the values Ra of 0.006 to 0.025  $\mu\text{m}$ .

In addition to the visible traces of machining, it is also observed that the level of the surface roughness is significantly higher than the level required in the technical documentation.

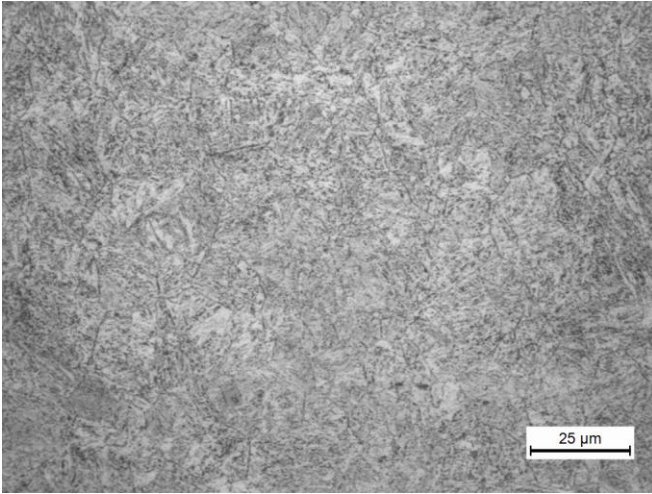
Figure 8

The microstructure of the material is homogeneous, fine-grained and corresponds to the structure of the tempered martensite without the presence of the segregation (Fig. 8).

Fig. 8. Material microstructure

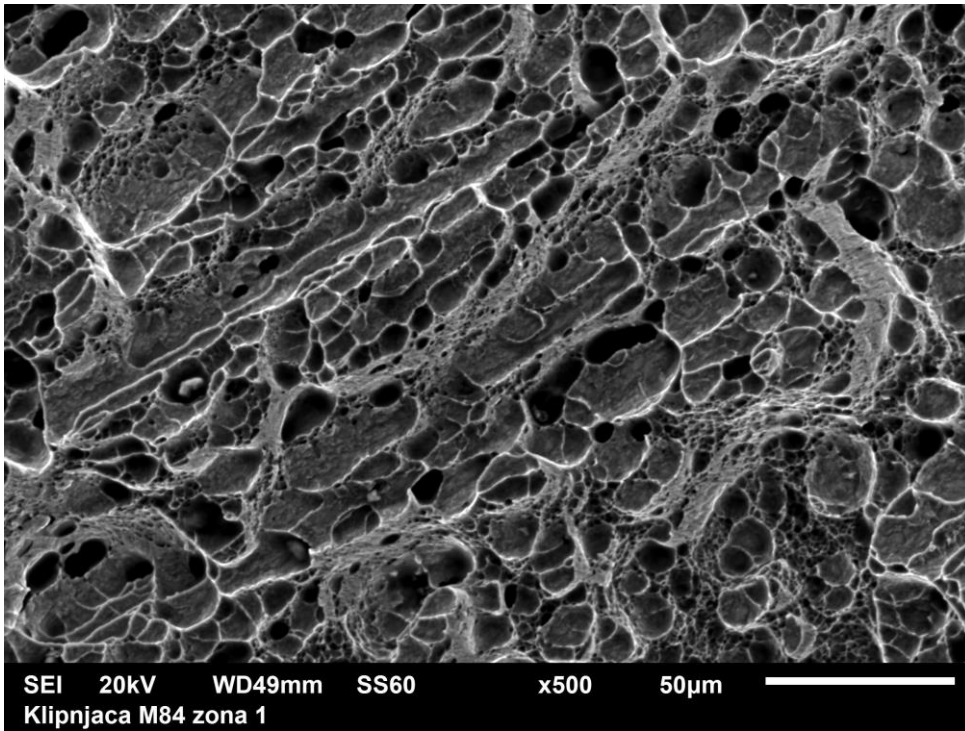
Figure 9

In order to obtain detailed information about mechanism that led to the failure, the fracture surfaces were observed by SEM. The observed fracture surfaces were significantly damaged, as a consequence of the uncontrolled movement of the parts of the broken connecting rod. These parts after had collided with the certain other parts of the engine until the moving parts of the engine stopped moving. Because of that, the failure mechanism cannot be determined with certainty. Further, on the small, undamaged parts of the fractured surface, the indicators (the lines of fatigue) pointing to the fatigue of the mechanism of the fracture were not detected. It should be highlighted that it is very hard to detect the lines of fatigue in martensitic and bainitic structures present here. No radial ridges that would indicate unstable crack propagation or the brittle character of the fracture were observed, either. On the other side, the results of the fracture surface analysis disclosed ductile character of the fracture.

Fig. 9. The SEM photograph of the fracture surface showing spherical “dimples” correspond to microvoids that initiate crack formation.

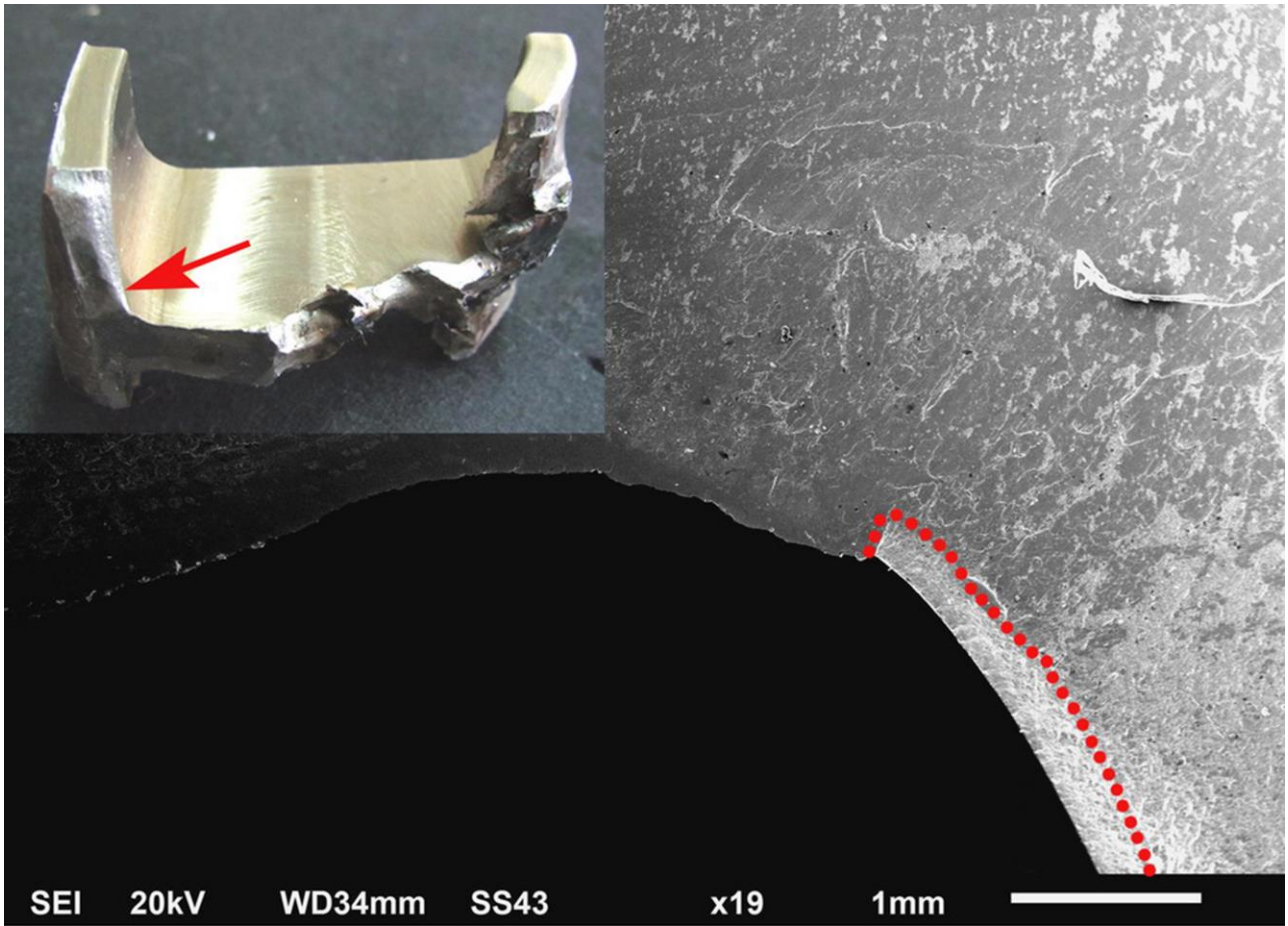
Figure 10

In the zone of the radius of the connecting rod, in a very narrow band of the intact fracture surface, right next to the outer edge, the “stretch marks” were identified (Fig. 10). The presence and origin of the “stretch marks” cannot be explained with certainty, i.e. whether they occurred as the result of the fracture or possibly presented the traces of the fatigue of the material. The part of the sample of the connecting rod outside the area indicated by the red line was further compacted after the initiation of

the fracturing of connecting rod and no additional indicators that could point to the cause of the fracture can be seen.

The fractographic analysis could not confirm that the fatigue had been the main cause of the fracture of the connecting rod. Based on the observed “stretch marks” on the part of the radius of the fracture surface these cannot be said with certainty to be indicative of the fatigue since they did not have the shape characteristic for fatigue. It is not possible, either, to confirm with certainty whether they occurred as a result of the breakage or possibly represent the traces of the fatigue of the material.

Fig. 10. SEM photograph of a part of fracture surface of connecting rod (red arrowhead on the macrograph in the top left corner) showing the stretch marks (area indicated by the red dotted line in SEM image).

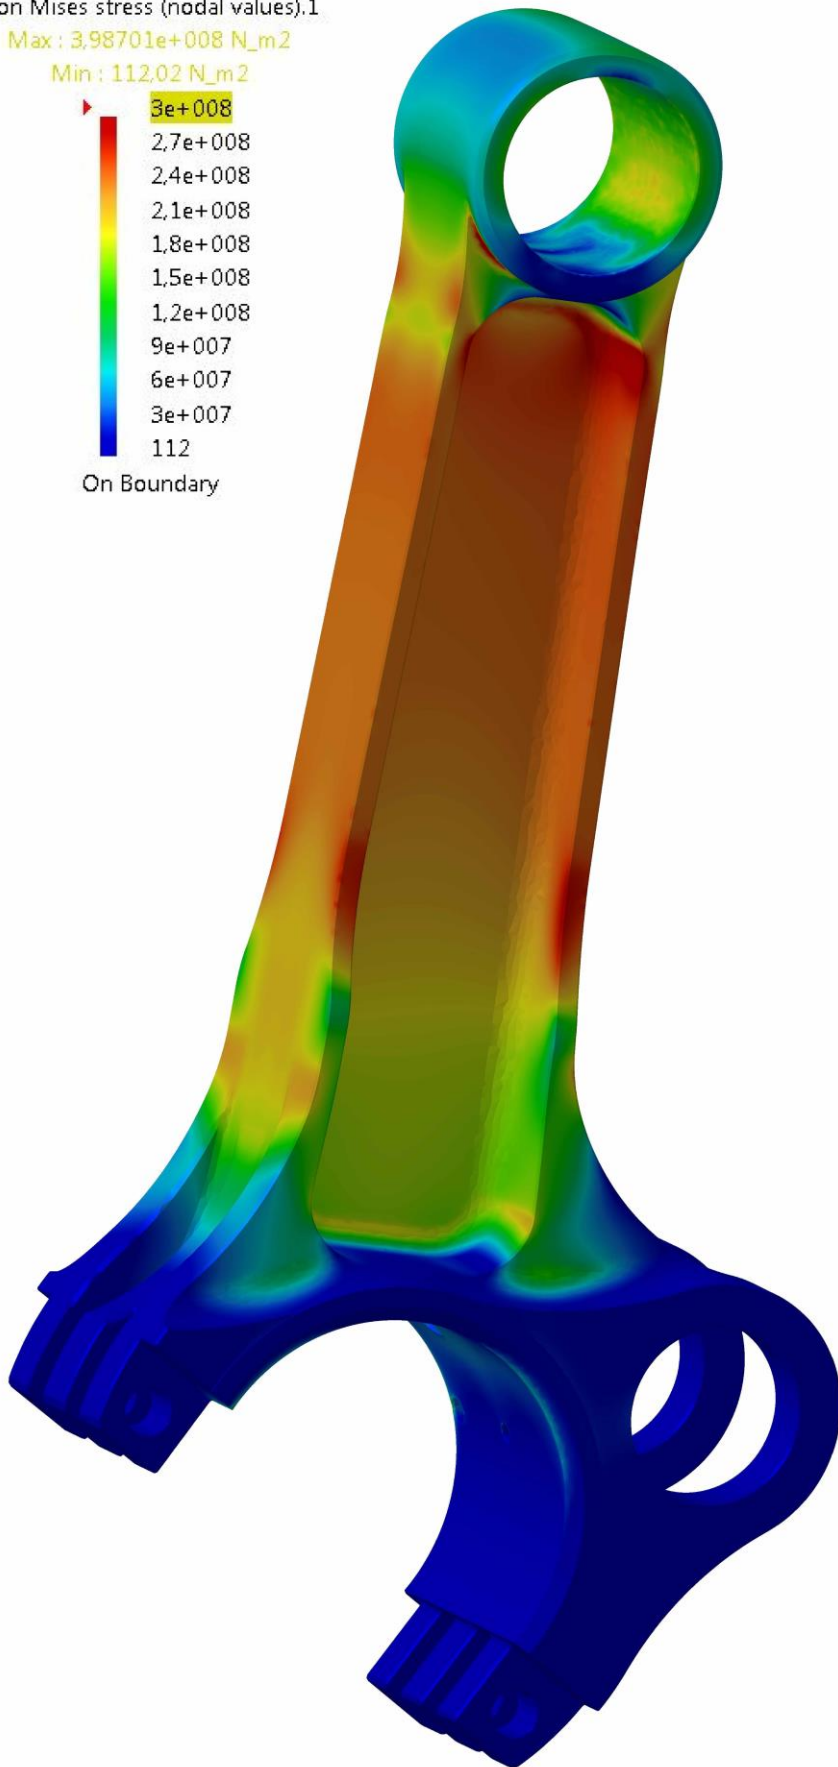
Figure 16

The analysis of the stress state of the connecting rod showed that the maximum value of stress of the connecting rod was 398,7 MPa, in the part of the connecting rod where the initiation of the fracture of the connecting rod was assumed to have been made.

The initial point of fracture had probably occurred on one of the eight points of the convex rounding of the cross section of the body of the connecting rod, which is the position of the connecting rod with the maximum value of stress (398,7 MPa), according to the analysis of the stress state.

Fig. 16. Stress field in the connecting rod.

Von Mises stress (nodal values).1

Max : 3,98701e+008 N\_m2
