Failure Analysis of the Tower Crane Counterjib

Nenad Đ. Zrnić^{a,*}, Srđan M. Bošnjak^a, Vlada M. Gašić^a,
Miodrag A. Arsić^b, Zoran D. Petković^a

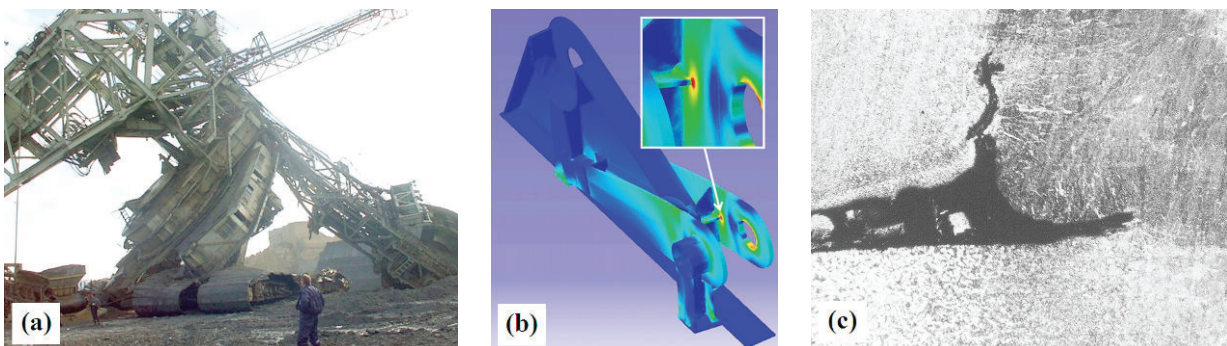
Fig. 1. Collapse of the BWE Sch Rs 1760 caused by the fracture of the end eye connection of the support of the portal tie-rod: (a) BWE after collapse; (b) very pronounced stress concentration in the structure of the portal tie-rod as a result of poor design – the ‘designing-in’ defect; (c) cracks in the root of the weld joint of end eye and lengthwise plate – the ‘manufacturing-in’ defect

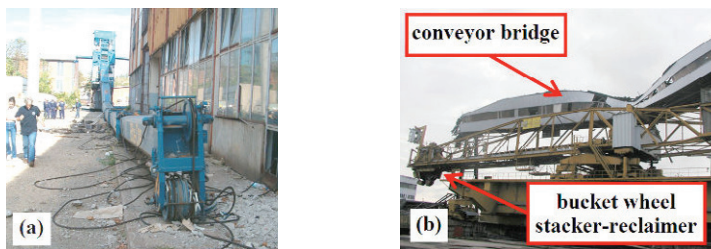
Fig. 2. (a) Overturning of the mobile crane caused by operator mistake i.e. the ‘operating-in’ defect; (b) conveyor bridge fall caused by hurricane i.e. the ‘environment-in’ defect

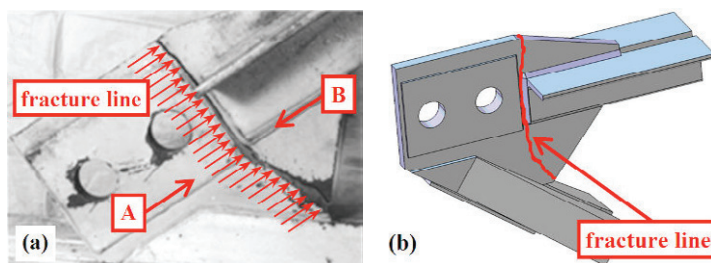
This paper will discuss failure analysis of the tower crane that was used during the construction of a hydroelectric power plant. Due to the breakaway of the gusset plate of the counterjib truss structure, Figs. 3 and 4, plastification occurred and the counterjib ballast fell from the crane. This caused the crane’s loss of static stability whereupon the jib leaned (at a distance of approximately 29 m from the axis of rotation) onto the structure of the adjacent portal crane. Because of this there was no total overturning of the crane. On the day of the accident the weather was cloudy with moderate wind speed (from 4.3 m/s to 6.2 m/s), while the temperature varied in the range from -4°C to -2°C .

Fig. 3. Fractured gusset plate: (a) after the damage (the parts were assembled in the laboratory of FME); (b) 3D model of the joint fracture

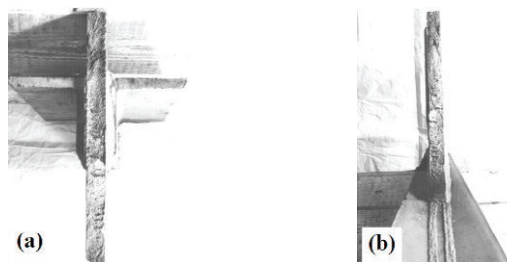
Fig. 4. Gusset plate crack surface (see also Fig. 3(a)): (a) view A; (b) view B

- Influence of the parent metal hardening in the fracture zone (transition from a ferrite/pearlite to a bainite microstructure), followed by a jump in hardness (198 HB) and a significant decline in toughness especially in low temperature conditions, as confirmed by the appearance of fracture surfaces (coarse-grain structure, the absence of plastic deformation – brittle fracture), Fig. 4,
- Influence of the weld seam perpendicular to the direction of the force action;
- Influence of the excessive proximity (inadequate clear distance) of the gusset plate welded joint – between profiles of the truss chord and plates to reinforce the opening (designed distance between profiles endings and

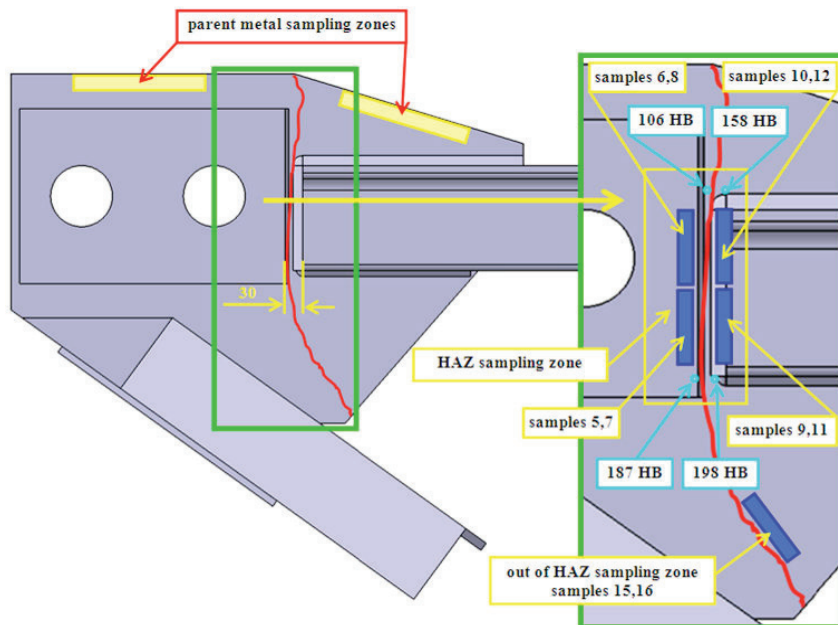
The sampling scheme and position of the measuring points is shown in Fig. 7. Based on the results of the chemical composition and mechanical properties investigation, Tables 1 and 2, it is conclusive that the parent metal matches the quality class of the steel S235 according to the code EN 10025. However, it is noticeable that the impact toughness values are lower than the prescribed ones. The values of impact toughness in the fracture zone, in HAZ and beyond, are also very low, Table 3.

Fig. 7. Sampling locations and position of hardness measuring point

plates for reinforcement is 30 mm, Fig. 7) – which is significantly less than a clear distance of five times the plate thickness between welds (in our case the truss chord profile thickness is 15 mm) considered as adequate by Soderberg [16]. Also, the clear distance is even considerably less than three times the plate thickness, recommended in [16] as the minimum value in certain cases.

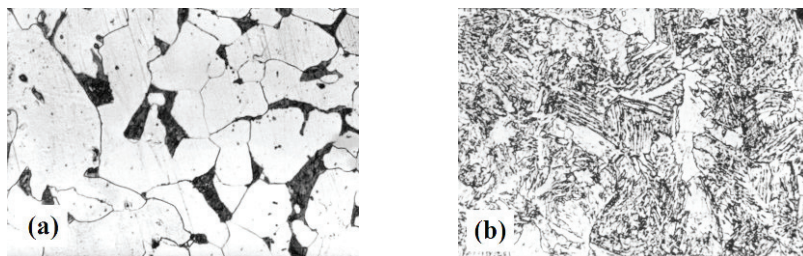
Out of the fracture zone the parent metal has a ferrite/pearlite microstructure, Fig. 8(a). In the fracture zone, Fig. 8(b), parent metal has a bainite microstructure.

Fig. 8. Microstructure of the parent material: (a) ferrite/pearlite - out of the fracture zone; (b) bainite – at a distance of ≈ 8 mm from the fracture line
