Radomir Jovičić¹, Aleksandar Sedmak¹, Stojan Sedmak², Ljubica Milović², Katarina Jovičić²

LEAKAGE OF AN AUSTENITIC STEEL CO₂ STORAGE TANK CURENJE POSUDE ZA SKLADIŠTENJE CO₂ OD AUSTENITNOG ČELIKA

Originalni naučni rad / Original scientific paper
UDK /UDC: 621.642.34:669.15-194.56
Rad primljen / Paper received: 21.01.2012

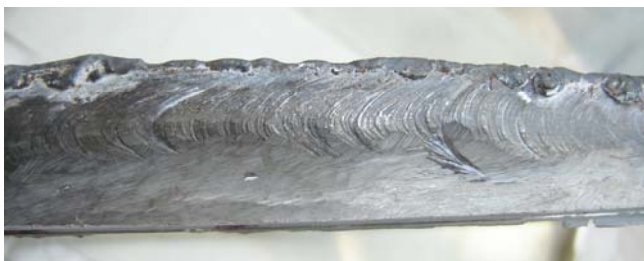
The cylindrical part of the flange and the welded joint between the flange and mantle of a manhole are presented in Fig. 5. This part is cut out from a manhole in the repairing procedure. The flange is separated, first together with the welded joint, by applying gas flame cutting, and then the segment with cracks is separated by machining. The lower edge in Fig. 5 is uneven as a residue of machining by lathe.

Figure 5. Cylindrical part of the flange and welded joint between the flange and mantle of the manhole.

It is concluded that the detected cracks affect the safety operation of the tank, and hence **retrofitting** is required /5–9/. The only economical way for retrofitting is complete elimination of the damaged zone. The same flange with the removed dissolved carbides is now re-welded with the manhole mantle, and the applied welding procedure has prevented the precipitation of brittle phases.
