FAILURE PREVENTION OF ROTATING EQUIPMENT BY VIBRODIAGNOSTICS PREDUPREĐIVANJE OTKAZA OBRTHNIH MAŠINA POMOĆU VIBRODIJAGNOSTIKE

Originalni naučni rad / Original scientific paper

The design and capacity of a recently developed portable device MICROMON for vibrodiagnostics at the University of Belgrade, Faculty of Mechanical Engineering, and its in-service application are presented in this paper.

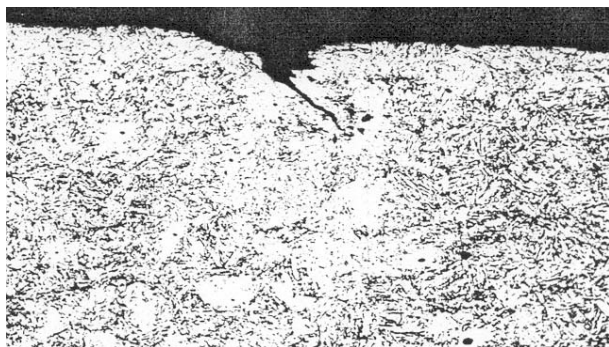
Corrosion attack due the improper water preparation took place in the blades, where fatigue cracking initiated (Fig. 3), and this contributed to introduce initial damages, followed by the fatigue process, /2/.

Figure 3. Corrosion attack as initial fatigue crack.
