Darko Daničić¹, Stojan Sedmak², Ivo Blačić³, Snežana Kirin⁴

SCENARIO OF FRACTURE DEVELOPMENT IN BUCKET WHEEL EXCAVATOR SCENARIO RAZVOJA LOMA U ROTORSKOM BAGERU

Originalni naučni rad / Original scientific paper
UDK /UDC: 620.17:621.879.48
Rad primljen / Paper received: 09.12.2013.

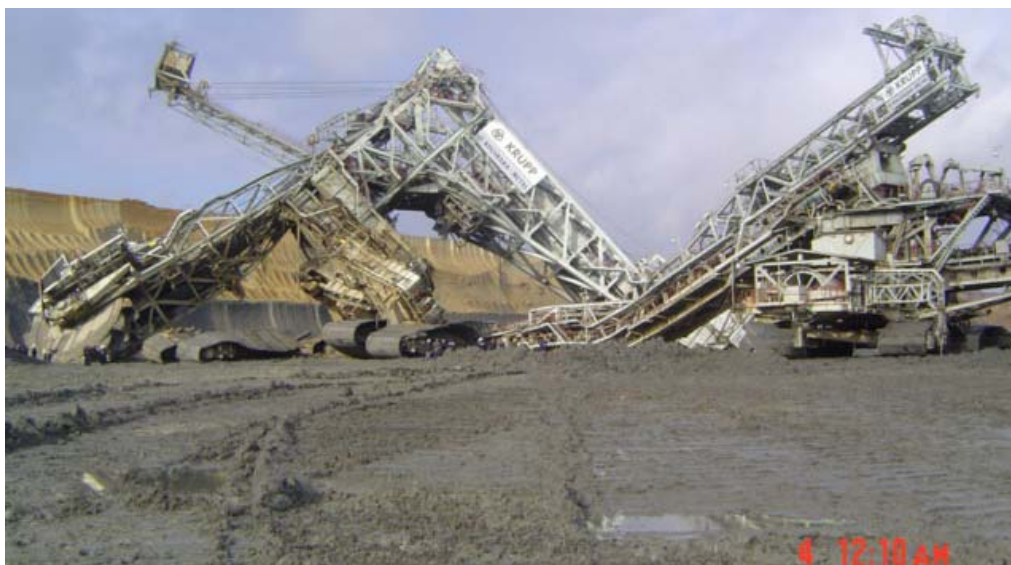
BWE SchRs 1760, unexpectedly and with no warning catastrophically failed in 2004, after 17 years of regular service on an open surface mine in Serbia (Fig. 1). The cause had been fatigue fracture initiated in the welded joint and developed in lugs of the counterweight holder (Figs. 2-3), followed by final fast fracture. Cracks initiated at the sites of stress concentration and inhomogeneous microstructure of welded joints, primarily in the HAZ, under the effect of external loads and residual stresses, /13/.

Figure 1. Collapse of bucket wheel excavator SRs 1760.

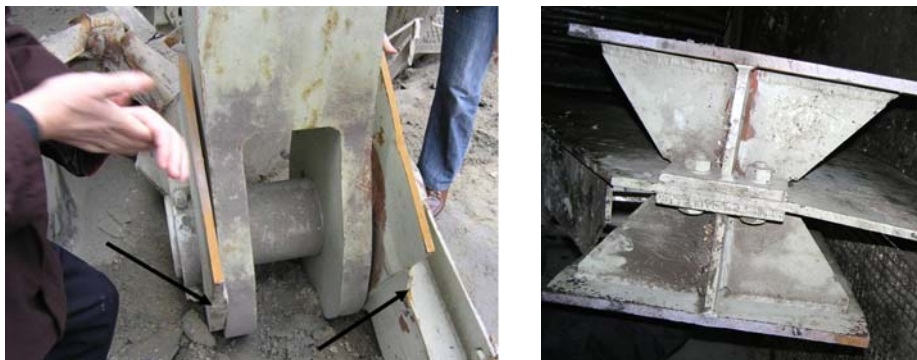
Analysing the lugs in Fig. 2 and the design scheme (Fig. 5a) a symmetrical distribution of load and stress in the two lugs could be assumed as reasonable. This is not the case as it is possible to conclude analysing the fracture surfaces on lugs 62 and 68 (Fig. 3).

Figure 2. Fracture of two lugs on the counterweight holder.
Slika 2. Lom dveju uški na držaču protivtega

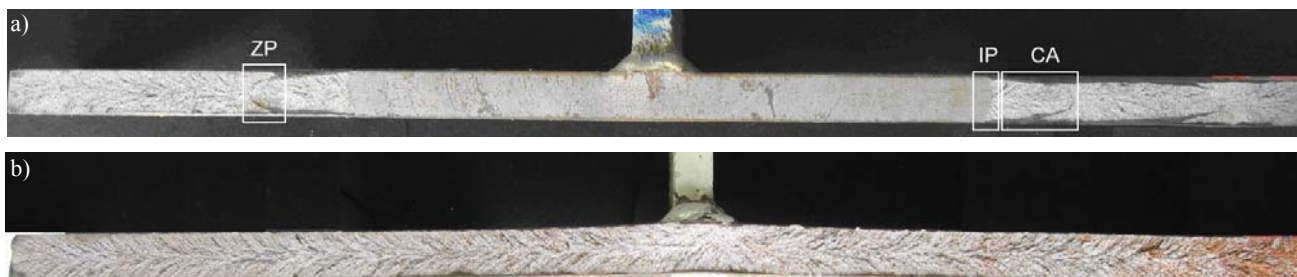
The fracture surfaces of the left lug, pos. 68 (Fig. 3a) and the right lug, pos. 62 (Fig. 3b) are substantially different. The right lug had fractured in a brittle manner, due to an overloading. Brutal fracture in the left lug took place when the loaded cross section area was significantly reduced after extended fatigue cracks on both sides of the welded rib (Fig. 3). Flat fatigue crack growth at pos. 68 had been interrupted by stable crack growth, with visible shear lips.

Figure 3. (a) Lug (pos. 68) fracture (fatigue, stable crack growth and brittle fracture), (b) Brittle fracture of lug (pos. 62).
Slika 3. (a) Lom uške (poz. 68) (zamor, stabilni rast prsline i kruti lom), (b) Kruti lom uške (poz. 62)

A continuous fatigue crack, over 300 mm long (Fig. 3a), developed through the homogenous microstructure uniformly, for every sequence of variable loading. In this segment of fracture the Paris' law can be applied for determining the time spent for fatigue crack growth.

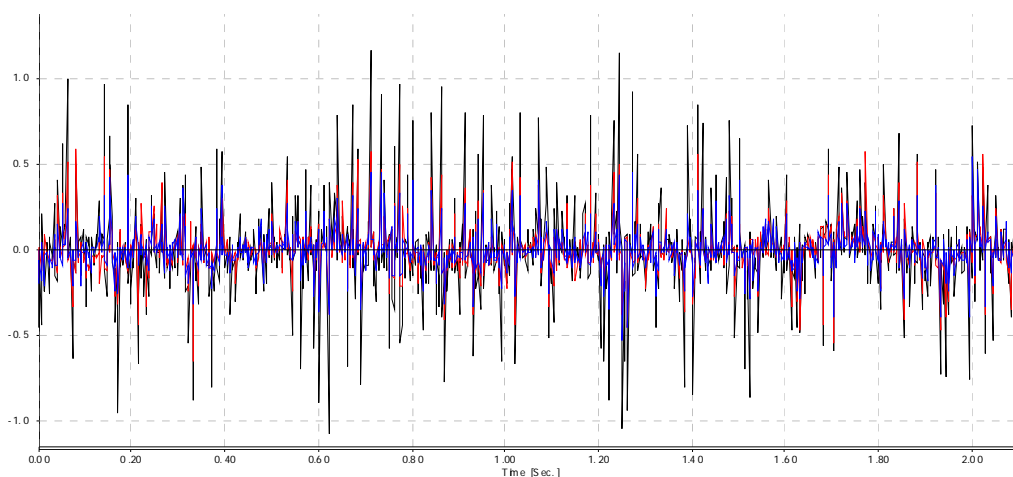
Figure 4. Strains recorded at typical locations of the BWE welded structure in operation.
Slika 4. Deformacije registrovane na tipičnim lokacijama pri radu zavarene konstrukcija rotornog bagera

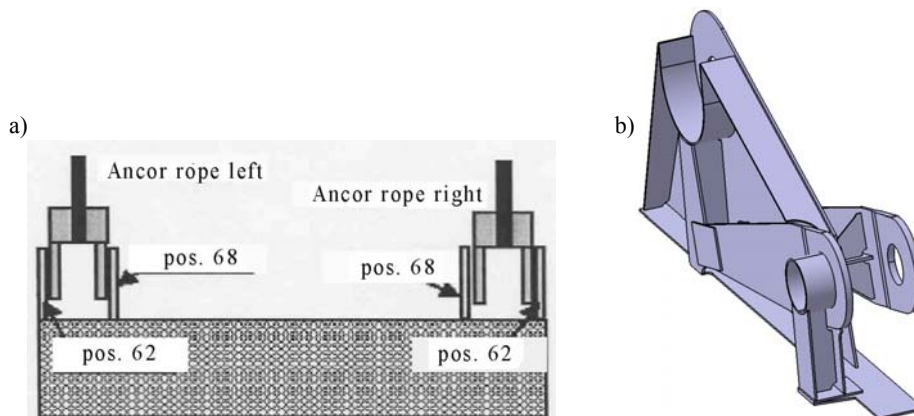
In the case of BWE SchRs 1760, the originally applied design of the connection of the main rope to counterweight structure had more than one unfavourable solution. Double lug design is used (Fig. 5) and the load distribution in the structure is non-symmetric regarding the direction of the load. From Fig. 5b it is clear that the tension force is transferred to positions 62 and 68 through the ribs, pos. 60. In this way the distribution of load to the lugs is unbalanced. The ribs, although transferring the load, are treated as auxiliary elements and strict requirement for welding inspection was not prescribed.

Figure 5. (a) Design scheme of anchor ropes, (b) connection of the main rope and counterweight.
Slika 5. (a) Shema of užadi ankera, (b) veza glavnog užeta i protivtega

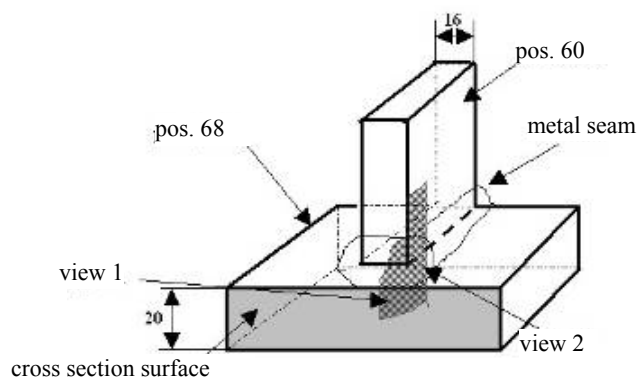
The design details of the welded joint between rib (pos. 60) and the lug (pos. 68) are shown in Fig. 6. The same design is used for other lug, pos. 62.

Figure 6. Design scheme of welded joint between the lug (pos. 68) and rib (pos. 60).
Slika 6. Shema zavarenog spoja između uške (poz. 68) i rebra (poz. 60)

The design details (Fig. 6) indicate that fillet welds applied between rib (pos. 60) and the lug (pos. 68) had been performed without penetration, since the joint had been considered as an auxiliary one. These welded joints had not been manufactured according to the welding procedure specification (WPS) and were not inspected properly. Heterogeneous microstructure (Fig. 8), and the presence of defects and imperfections, (Fig. 9), discovered by investigation after the collapse, are typical.

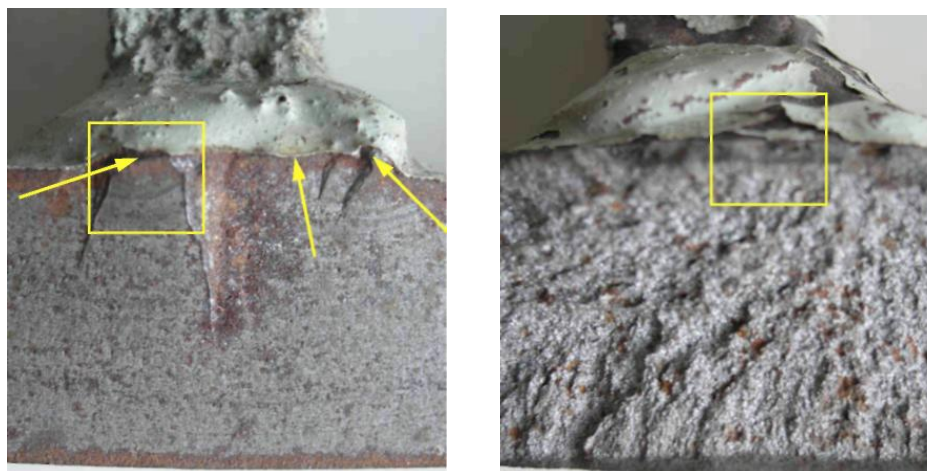
Two facts need to be noticed. At first, the fatigue crack started from the welded joint between positions 68 and 60 (Fig. 7 left), at defect location 1, and is produced by welding. Variable loading has transferred as fatigue loading completely to position 68 (Fig. 3a). On the other side, at position 62, although similar defects were detected (Fig. 7, right), the fatigue crack did not develop (Fig. 3b). The explanation can be found in the design of lugs: position 62 is fixed to the main structure (Fig. 5b) while position 68 is free to swing.

Figure 7. Welded joints between rib and lugs (pos. 68 left, pos. 62 right).
Slika 7. Zavareni spojevi rebra i uški (poz. 68 levo, poz. 62 desno)

Figures 7 to 9 allow to conclude that for both lugs, the welding quality is poor, causing eventually a high level of stress concentration, similar in joints of both lugs, pos. 68 and 62 – to the ribs.

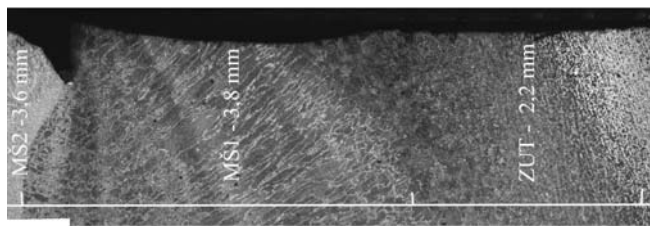
The time period for crack initiation and propagation through weld metals in two runs (about 3.6 and 3.8 mm, Fig. 8) up to the HAZ in the lug (2.2 mm) is difficult to evaluate, since this process is complex.

Figure 8. Welded joint section, normal to fracture of lug, pos. 68.
Slika 8. Presek zavarenog spoja, normalno na lom uške, poz. 68

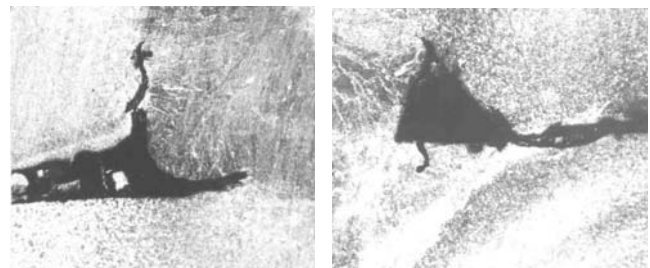
Figure 9. Crack in fillet weld root (left); incomplete root penetration (right).
Slika 9. Prslina u korenu ugaonog šava (levo); nepotpuna penetracija (desno)

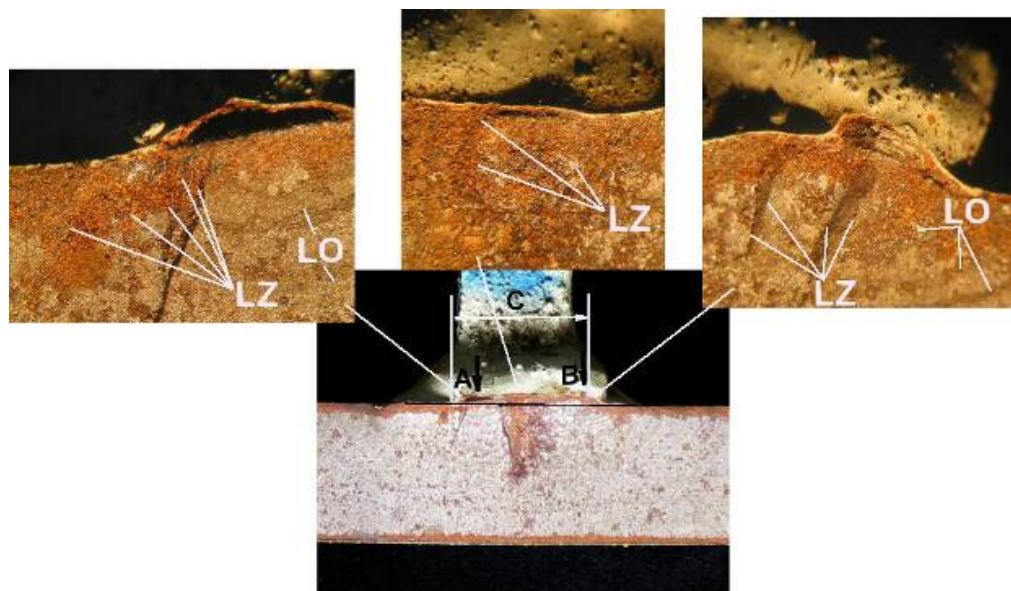
For the scenario of fracture in Fig. 3a, more interesting is the development of fatigue fracture in the lug, pos. 68. More details on fatigue crack transition to the lug, pos. 68, are visible in Fig. 10. They might be used for explaining the fatigue crack initiation in this lug. Variable loading exerted its effect only to pos. 68, and not to pos. 62, what is attributed to the fixation of the latter to the main structure.

Figure 10. Initiation of dominant fatigue cracks in lug, pos. 68: details A and B; LZ-ratchet marks; LO-beach marks, critical region C.
Slika 10. Inicijacija dominantnih zamornih prslina u uški, poz. 68: detalji A i B; LZ-linije zaustav.; LO-linije odmar., kritična oblast C

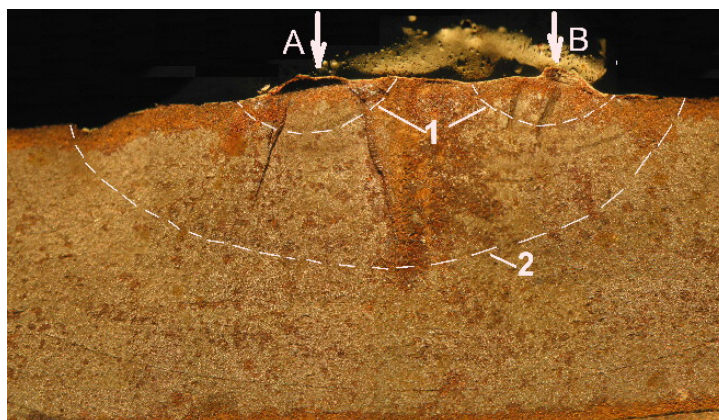
Ratchet marks, beach marks and striations, typical for fatigue, can be recognised on the fractured surface (Figs. 7 and 10), which entered into the lug as two separated fatigue cracks (1) in an early step and merged in a dominant fatigue crack (2) (see Fig. 11). It is interesting to note that cracks (1) started in the HAZ of low fracture toughness in the lug material, and crack (2) developed through the material of a more homogeneous microstructure of the parent metal.

Figure 11. Merged early fatigue cracks (1), points A and B, in a dominant crack (2).
Slika 11. Spajanje prvobitnih zamornih prslina (1), tačke A i B, u dominantnu prslinu (2)

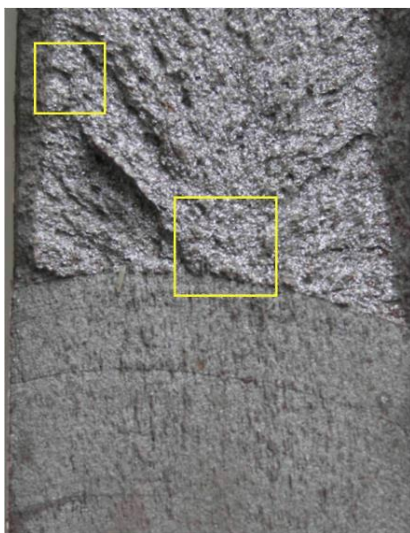
Figure 12. Transition from flat fatigue fracture surface, with visible beach marks and less visible striation, to stable tearing, region IP in Fig. 3.

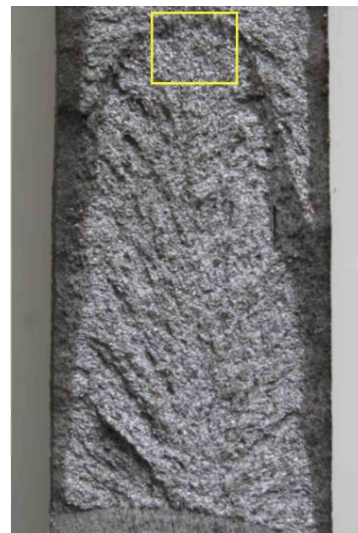
the region IP (Fig. 12) the low cycle fatigue had preceded the tearing segment CA, which was arrested by FSZ (Fig. 13). After this new FSZ, the crack continued to grow, again by tearing fracture, up to the formation of FSZ before final fast fracture.

Figure 13. Final stretch zone after developed shear lips, prior to stable growth of ductile crack, corresponding to region CA in Fig. 3.

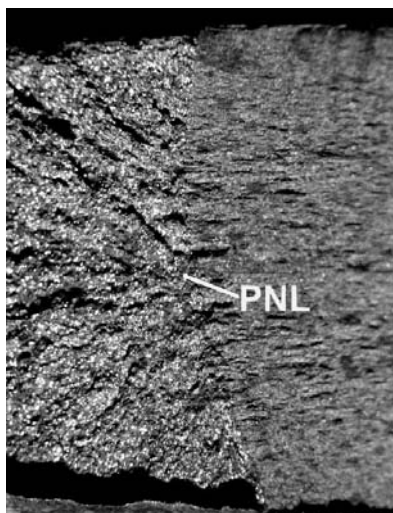
The region of transition from fatigue- to static fracture is presented in Fig. 14. In addition to the beach marks, the static splitting fracture was detected in the fatigue process, in the crack tip blunting region, where structures with low cohesive strength are present, along the plate thickness. The presence of static fractures on the fatigue fracture surface indicates a faster rate of propagation of the fatigue crack.

PNL- final stretch zone (*zona konačnog loma*)

Figure 14. Transition from fatigue to static fracture.

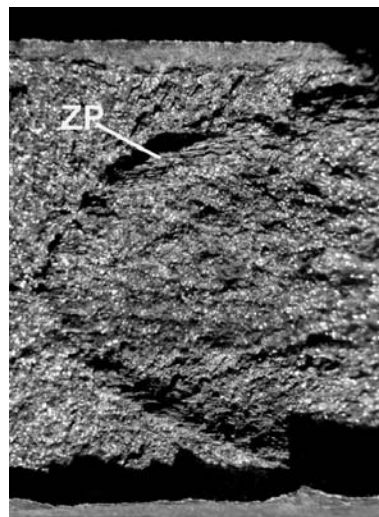
The presence of chevron patterns in the static fracture portion indicates the initiation of unstable growth, in the middle of the plate thickness where plane strain condition was dominant. Partial crack arrest (Fig. 15) along with unstable fracture indicated that the fracture occurred above nil-ductility transition temperature (NDTT), in the brittle range. According to Pellini, /16/, a material can arrest the crack only if the applied stress is lower than $0.5R_{p0.2}$. In this case, this is 185 MPa, well below allowed operating stress.

ZP-crack arrest (opuštanje prsline)

Figure 15. Crack arrest zone.
