Investigation into the causes of fracture in railway freight car axle

Zoran Odanovic, Mileta Ristivojevic, Vesna Milosevic-Mitic

To appear in: *Engineering Failure Analysis*

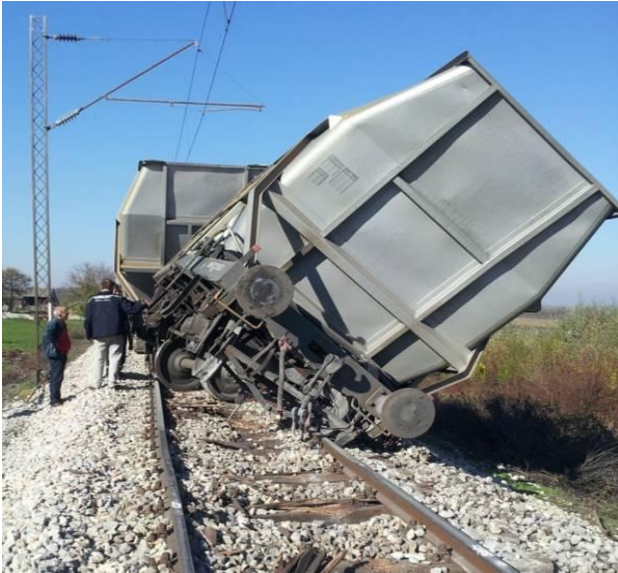
The freight car for coal transportation from the mine to the thermal power plant has two axles. The failure has taken place on an industrial gauge used for coal transport, as shown in Fig. 1. Under exploitation conditions nominal axle load amounts to 200 kN, while railway car speed of motion is up to 70 km/h. The stopping and braking of railway car is done by brake shoes. Accordingly, under exploitation conditions, the axle is bending stressed only.

Fig. 1. Appearance of damaged railway car

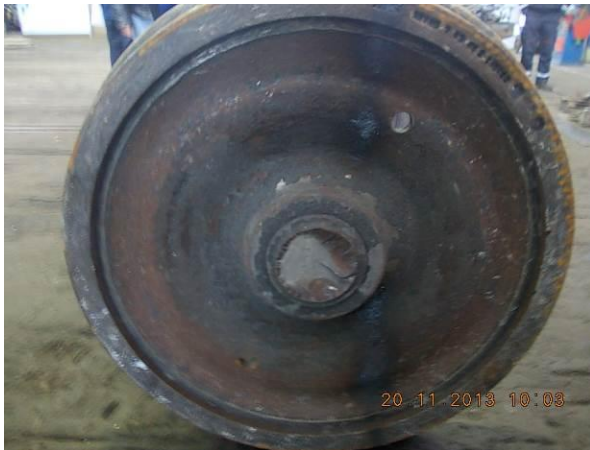
Available data show that the railway axle is regularly periodically inspected and overhauled. However, irrespective of this fact, the axle fracture was detected on the axle assembly journal of the railway rear axle, on the transition radius, on the location of the source of stress concentration, between the roller bearing journal and railway wheel seat. The fracture was not identified on the other end of the axle. The location of the axle fracture is shown in Fig. 2, whereas Fig. 3 represents the journal on the side of the axle where fracture has not occurred.

Fig. 2. Appearance of the railway axle fracture location

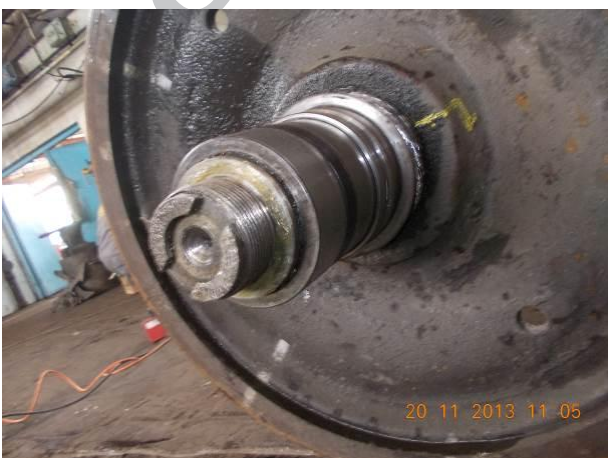
Fig. 3. Journal on the side of the railway axle where fracture has not occurred

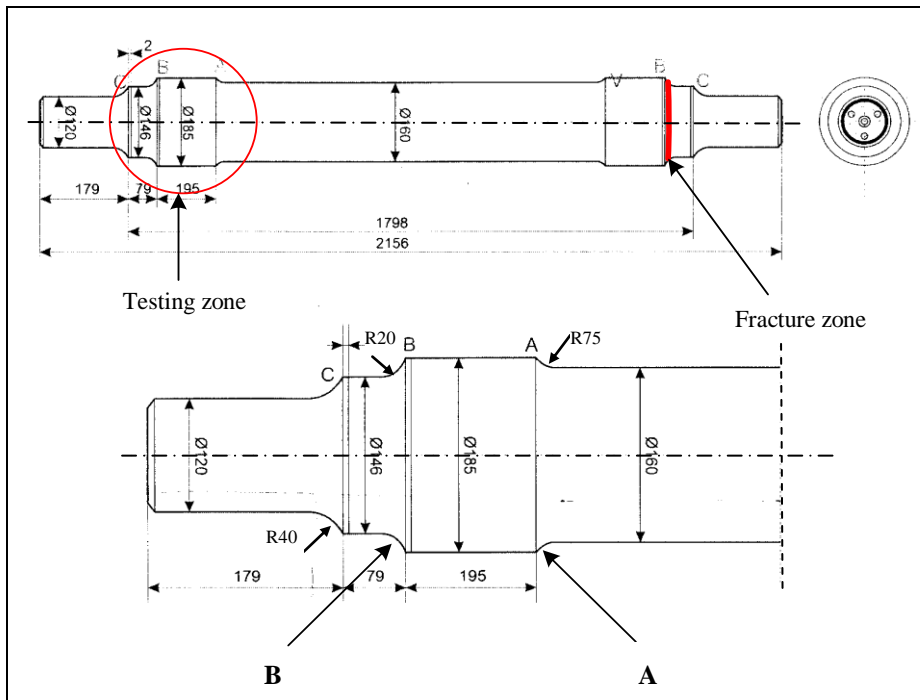
A drawing of the solid railway axle with designated fracture cross-section and the testing zone is given in Fig. 4. Working load conditions are identical in both axle fracture cross-section (Fig. 2) and a corresponding cross-section on the other part of the railway axle that has not suffered a fracture (Fig. 3). Accordingly, crack formation should also be expected in this cross-section zone. For that reason this zone has been chosen for testing. The Non-Destructive Testing methods were applied such as Magnetic particle testing and Ultrasonic testing.

Fig.4. Drawing of the tested railway axle with the fracture location and zone examined by the NDT methods

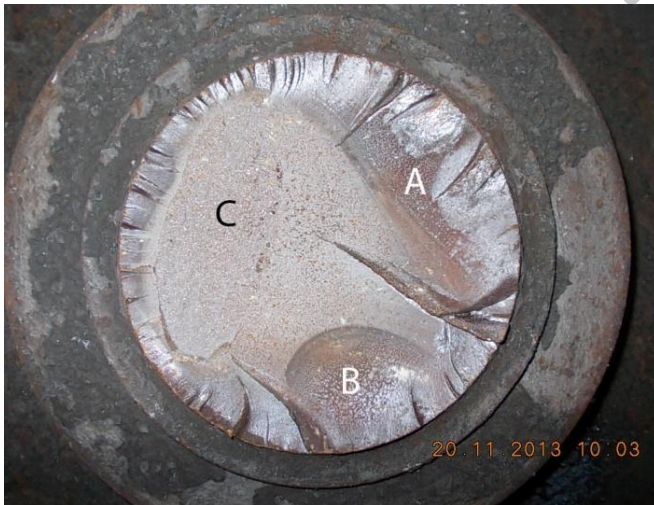
The appearance of the fractured surface of the railway axle is shown in Fig. 5. On the fracture surface a few characteristic zones could be distinguished. The first one is the stress concentration zone around the circumference of the fractured cross section of the axle with tooth like numerous initial cracks of different size. Shape and size of these initial cracks could be explained by observing the appearance of the indications presented in Fig. 6. Numerous initial cracks are formed on the outer surface of the critical axle radius. Due to high stress concentration they were spread parallel to the axle cross section or they were connected and integrated with parallel initial cracks of similar kind. This way they formed specific shape of ratchet, tooth like initial cracks. On these ratchet marks presence of corrosion was evidenced. Next characteristic zones are signed on the Fig. 5 as zone A and B. Appearance of these zones is similar in morphology, but different in shape. It can be concluded that they were initialised at the ratchet marks and propagated by the fatigue

mechanism. These zones are highly oxidised which indicates long presence in axle exploitation. Zone A and B are separated by the radial crack. Based on their deepness it could be concluded that these zones were formed around the same period of the exploitation, but in parallel cross sections of the axle. The static-final axle fracture surface accounts for approx. 30 – 50% of the cross-sectional area and it is a light-coloured surface in Fig. 5 signed as zone C. Generally, it can be concluded that the crack initiations are caused by corrosion pits at the surface of the critical radius of the axle. The newly formed cracks than propagated by the fatigue mechanism until the axle fracture occurred.

Fig. 5. Appearance of the fracture surface with zones characterized by certain types of fracture

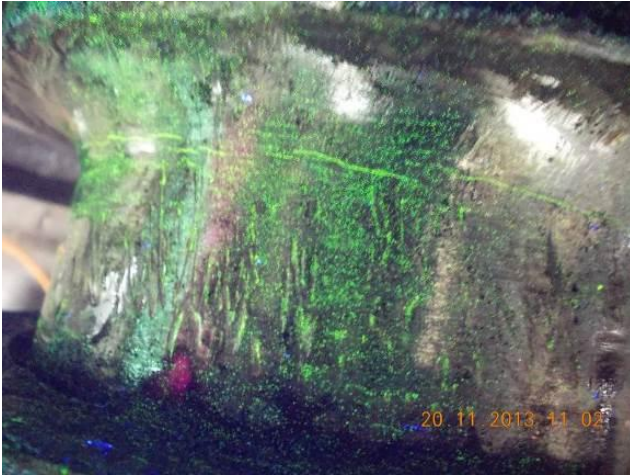
In order to test the axle material homogeneity at the location of the source of stress concentration, in railway axle zones A and B, where the fracture hasn't occurred (Fig. 4), magnetic particle testing was applied. In the railway axle zone B, surface radial cracks 10 to 160 mm long were detected. The appearance of cracks recorded by the magnetic particle test method on the axle journal radius, where fracture has not occurred in zone B, is shown in Fig. 6. A series of parallel short cracks and an individual crack 160 mm long were detected. An ultrasonic testing was performed at these locations to identify the depth of cracks. These tests indicated that the depths of cracks were up to 30 mm. The reason for formation of cracks with different lengths could be presence of the metallurgical imperfections in the axle material. This means that the eventual presence of the numerous non metallic inclusions in axle cross section could stimulate connection and spreading of the already formed cracks. In the railway axle zone A (Fig. 4), the surface cracks were not recorded. On the basis of the performed non-destructive examinations, it was concluded that further mechanical properties tests and microstructural investigations, with special care at the fracture location, are needed for clarifying reasons for fracture initiation.

Fig. 6. Appearance of cracks registered at the source of the stress concentration in zone B where railway axle complete fracture has not occurred

In order to prevent the repetition of resulting damage, it is necessary to improve the control of the corrosion protection and the inspection of the axle shaft from the aspect of the initial cracks during the regular maintenance.

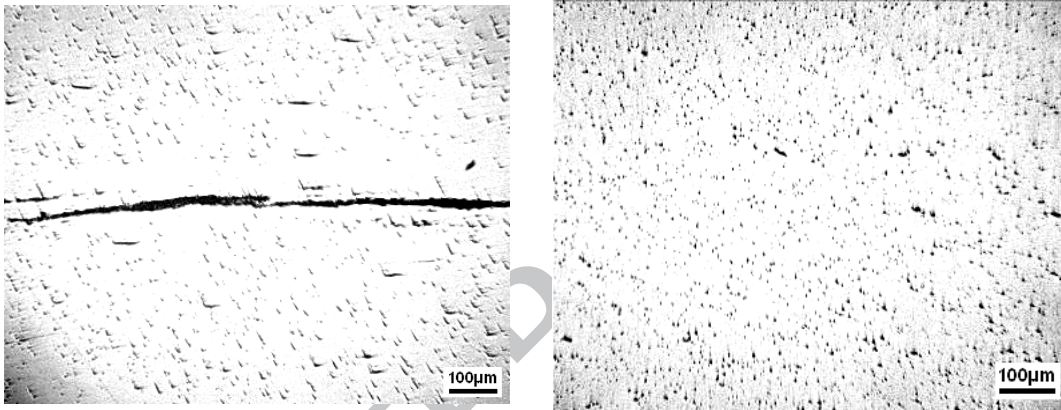
To examine the contents of non-metallic inclusions the comparing method with reference charts, according to the standard ISO 4967, was applied. Investigations were performed at the three levels of the axle cross section, near the surface, in the mid-radius and in the axle centre. On the basis of the results, it was concluded that non-metallic inclusions of the A, B, C and D type are present in the axle material microstructure. Their sum, in this case, is not greater than specified by standard EN 13261:2003 for A, B and C type. But in the samples gathered from locations near the axle surface and from axle centre, inclusions of type C (silicate) and type D (globular oxide) were identified in the amounts above allowed. Also a few individual coarse non-metallic inclusions of 0.7-1.7 mm long and approximately 20 μ m in thickness were noted near the axle surface. These coarse non-metallic inclusions are potential sources for cracks initiation and formed cracks could easily propagate through the axle material which has mechanical properties below the required, as it was noticed before. Presence of the non metallic inclusions is illustrated by Fig. 7.

Fig. 7. Non-metallic inclusions near the external surface of the axle

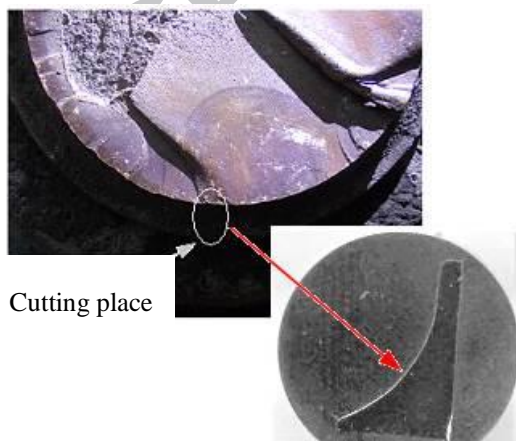
Decarburization was tested by the microscopic method. The specimen location for decarburization testing is shown in Fig. 8. The test piece was taken from the radius location in the direction of the axle plastic deformation directly at the axle cross-section surface. Based on the analysis results, it can be concluded that decarburization was not observed in the axle material surface layer on the examined test piece.

Fig. 8. Sampling location and decarburization-testing location

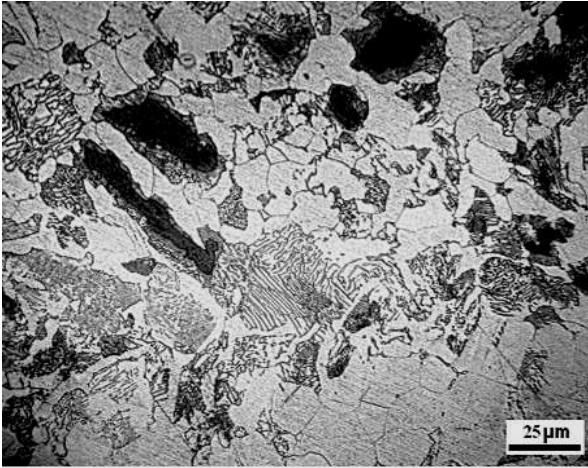
Microstructure analysis of the tested material was performed according to the standard EN 13261:2003 requirements. The microstructure of the examined material is banded in the longitudinal direction and ferritic-perlitic microstructure is shown in Fig. 9.

Grain size was determined according to standard EN ISO 643:2012 using the method of linear segments. The results of grain size index analysis presented in Fig. 9 indicate that grain size is approx. $G = 5$.

Fig. 9. Lamellar pearlite and ferrite in the axle material microstructure

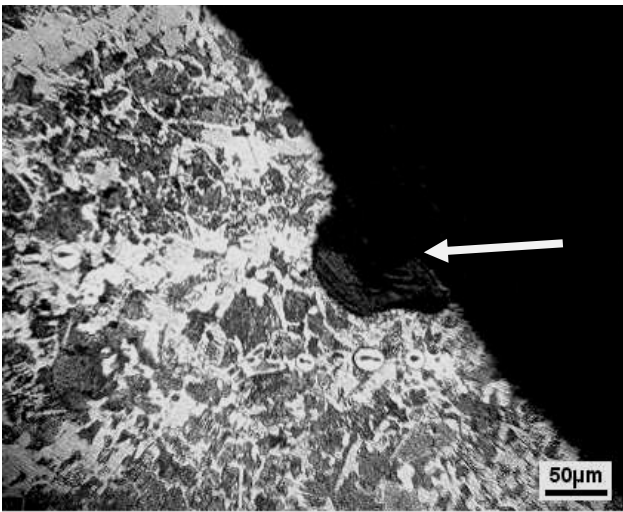
In the structure, locations with corrosion pits are observed in the material surface layer in the transition radius zone, and in the vicinity of the cross-section where the axle fracture occurred. The presence of corrosion pits is shown in Figs 10 and 11. The size of corrosion pits ranged from approx. 25 to 100 μ m in diameter and from 12 to 100 μ m in depth. Characteristic corrosion pit is presented in Fig. 10. Corrosion pits were noted to connect with non-metallic inclusions, approx. 100 μ m long, which is displayed in Fig. 11. Existing corrosion pits are associated with non metallic inclusion in soft ferritic matrix. Presented corrosion pits could be defined as the potential sites for the crack initiations, and the connection of these pits with evidenced non metallic inclusions enables the crack propagation. The combination of weak axle material, connection and spreading of cracks,

subsequently followed with their propagation cause the fatal fracture of the axle. Pits formation is the result of the damaged axle coat which is evidenced on the both investigated critical radiuses of the axle. As presented before in Fig. 5 and Fig. 6 crack initiations as well as cracks themselves were identified on the whole critical radius of the both sides of the axle. This fact leads to the conclusion that corrosion was initiated from the locations of damaged coat, and from below the coat to the whole surface of the critical radius thus creating conditions for pits forming.

Fig. 10. Corrosion pit in the axle material surface layer in the transition radius zone

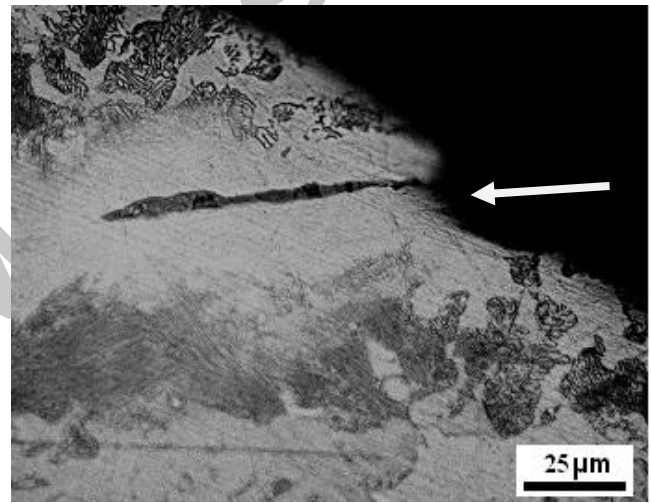
Fig. 11. Corrosion damage in the material surface layer with subjoined sulphide non-metallic inclusions located in a ferritic band

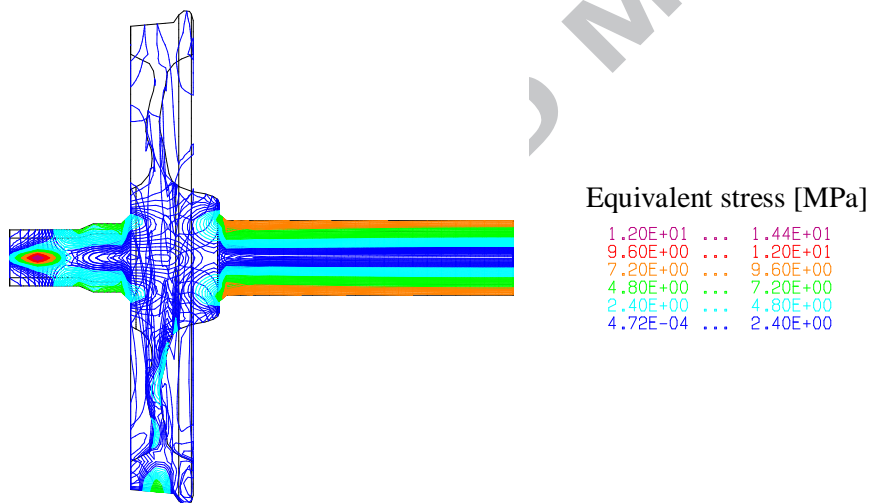
The results from Fig. 13 indicate that the highest stresses are generated in the cross-sections at the location of the source of stress concentration. It is the cross-section with the source of stress

concentration located in front of the wheel, \varnothing 146 (B), where the axle fracture has occurred, and the cross-section with stress concentration located behind the wheel \varnothing 160 (A). While only vertical force is acting, maximal equivalent stress amounts to 60 MPa in the critical cross-section in front of the wheel and 65 MPa in the critical cross-section behind the wheel. The horizontal force does not affect stress increase, on the locations where axle fracture B has occurred, but it increases stress in the critical cross-section behind the wheel, which then equals 95 MPa.

Fig. 13. Equivalent stress according to the Hencky-Misses hypothesis

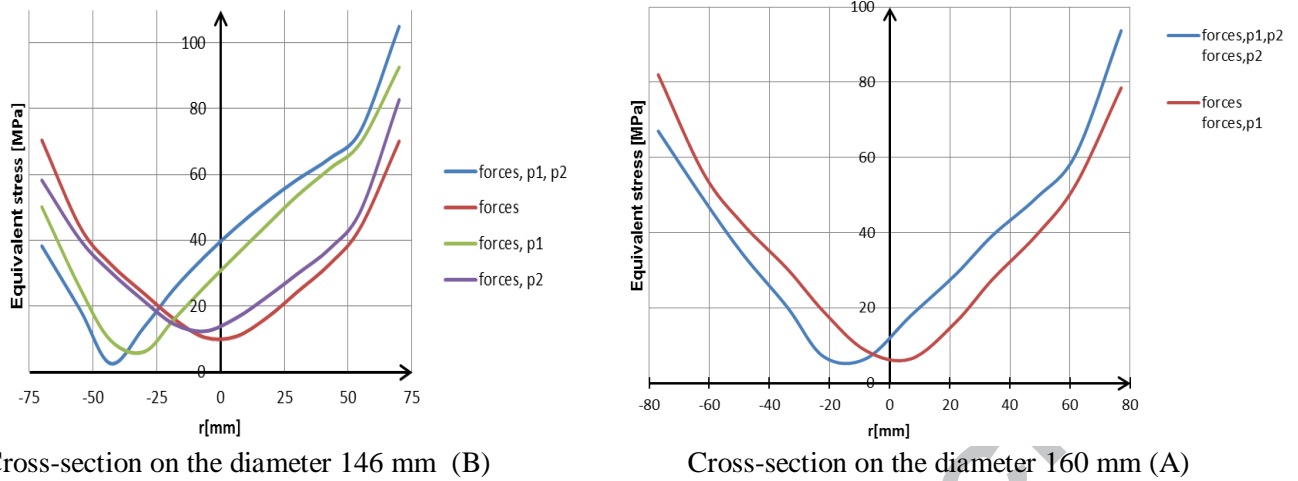
It is evident from the diagrams given above that the stress value in the critical cross-section where the axle fracture has occurred, \varnothing 146 mm, is affected by both pressures, whereas the stresses in the other cross-section are not affected by pressure p_1 .

Fig. 18. Diagrams of stress distribution in the observed cross-sections

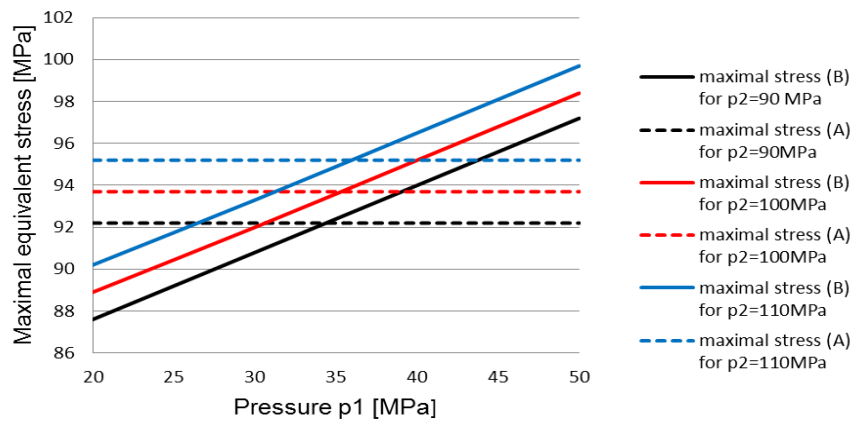
varied. Figure 19 shows maximal equivalent stresses in the cross-sections considered at $p_2 = 90/100/110$ MPa. In the presented diagram it is noticeable that when the values of pressure p_1 are larger than 35 MPa, the axle critical cross-section is the one where the axle fracture has occurred.

**Fig. 19.** Maximal equivalent stress on positions (A) and (B) as a function of p_1
