SANACIJE I REKONSTRUKCIJE ROTORNIH BAGERA REPAIR AND RECONSTRUCTION OF BUCKET WHEEL EXCAVATORS

REPAIR AND RECONSTRUCTION OF OPERATING WHEEL ON EXCAVATOR C700 O&K (OPEN-CAST MINE KOLUBARA LAZAREVAC)

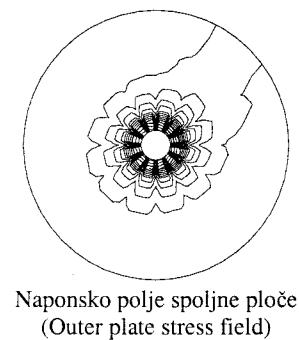
Slika 2. Naponsko polje i raspodele
Figure 2. Stress state and the distributions.

Numerical results of the existing model clearly point out that the largest stress is located at the position of yielding of the operating wheel.

The distribution of normal and shear stresses indicates large presence of shear stresses. Membrane stresses are dominant. The analysis undoubtedly shows that the failure is caused by insufficient thickness of the outer plate.

Adding a ring of increased thickness (2 cm instead of 0.8 cm) to the outer plate led to significant stress decrease (from 21.6 to 13.6 kN/cm²) and also to a decrease in the shear stress effect. The wheel has continued to operate successfully.

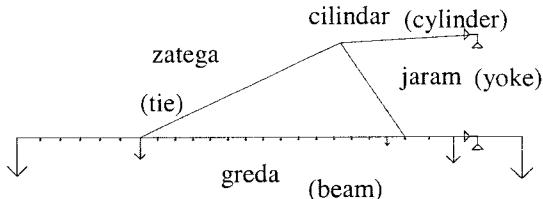
Slika 3. Ravanski model strele i deformacija strele ($f_{\max} = 10.4 \text{ cm}$)

During excavator service life, poor dynamic behaviour of the unloading beam is frequent, i.e. with resonant oscillations, amplitudes up to 60 cm. This may result in cracking of certain cantilever elements. The structure consists of one beam element and three truss elements (tie, yoke and cylinder).

Figure 3 shows the cantilever model and strain pattern. Strain energy is distributed as follows: beam (72.2%); tie (16.8%); cylinder (10.5%); yoke (0.5%). Static calculation has concluded: too large tilting of the beam in the support joint; the axial force in tie and cylinder is too large, but rather low in the yoke; the bending moment of the beam is large in yoke link; and dominant strain energy in beam.

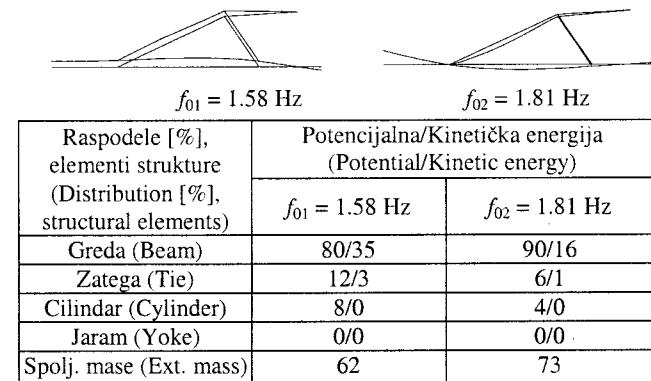
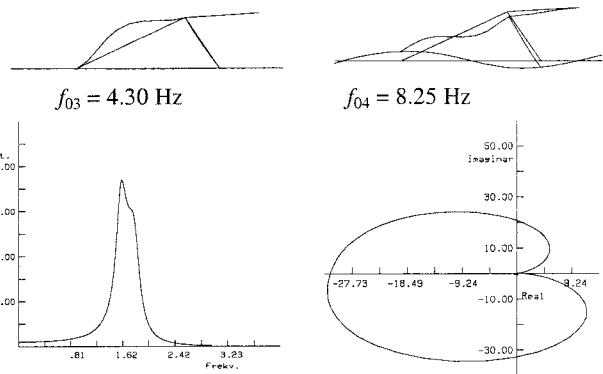
Slika 4. Prva četiri glavna oblika oscilovanja, raspodele i jedan frekventni odziv
Figure 4. First four major forms of oscillation, distribution, and one frequency response.

Dynamic calculations conclude: the first two frequencies are very low, nearly equal, and coincide with static deformation; the dynamic reinforcement factor is too high; the imaginary part of frequency (unstable system) and strain energy are dominant in the beam and in external masses.

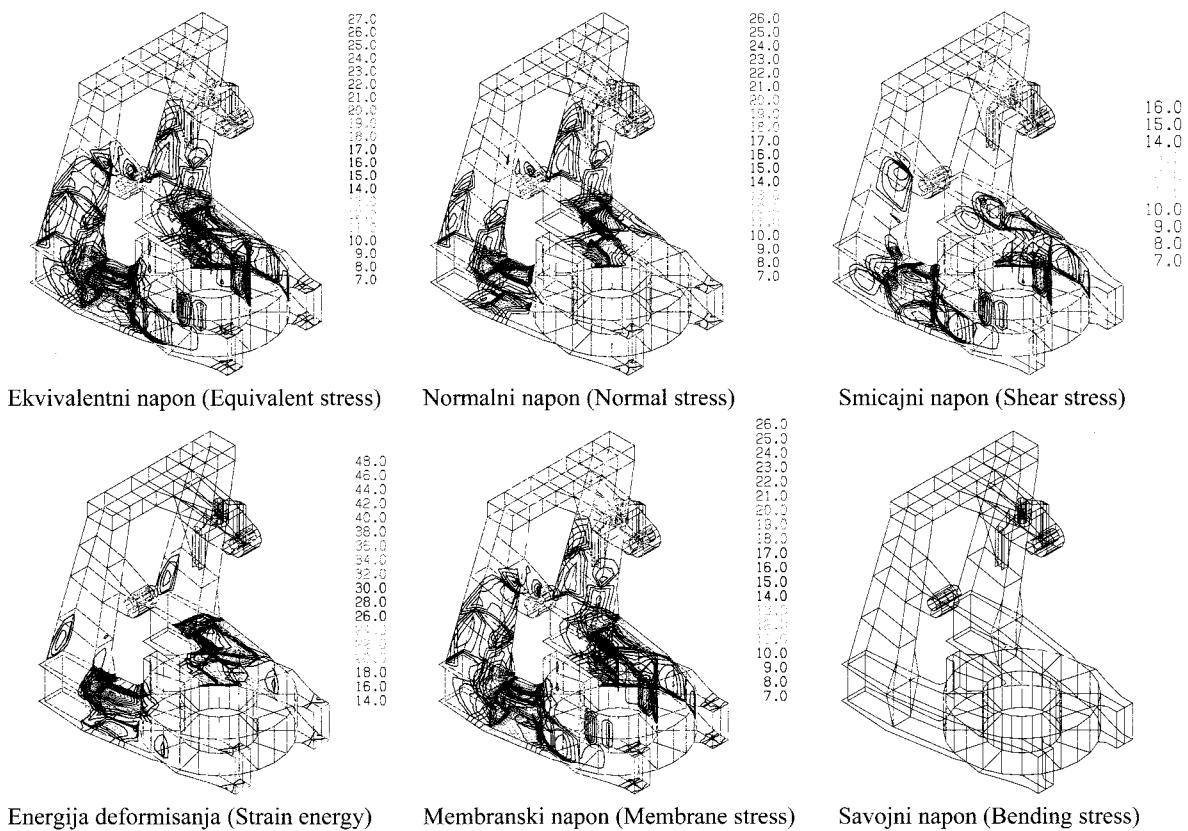
Slika 9. Raspodela napona [kN/cm^2] i energije deformisanja [kNm]
 Figure 9. Stress [kN/cm^2] and strain energy [kNm] distribution.

- support–cylinder connecting elements have the largest stress, stress concentration, and strain energy,
- support and cylinders have a low stress level on a large surface with a high contribution of stress and energy,
- the yoke has the least significant effect on the behaviour.

Inproper upper assembly behaviour can be corrected by increasing thickness of upper and lower horizontal plate connecting elements. An upper plate thickness increase of 15 mm, i.e. a total of 39 mm was approved, while lower plate thickness was increased 10 mm (34 mm total). The maximum strain value is now $f_{\max} = 4.669$ cm. Figure 10 shows strength diaghnostics of reconstructed upper assembly elements, and Fig. 11 shows the reconstructed assembly.

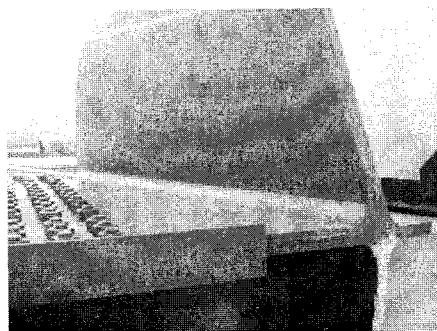
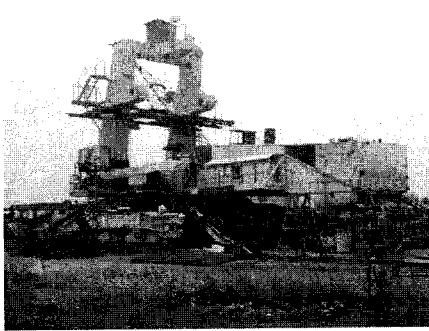
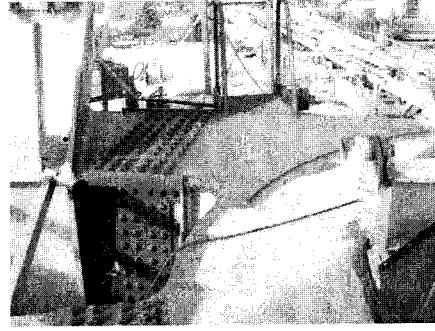
Slika 11. Izvedena sanacija i rekonstrukcija gornje gradnje
Figure 11. Performed repair and reconstruction of upper assembly.

The analysis is aimed in determining and resolving cracking causes of support and cylinder connection and poor dynamic behaviour of upper assembly. Upper assembly numerical model and strain pattern with worst loading case are shown (Fig. 8). Upper element strength diagnostics and detailed analysis of lower assembly behaviour are shown below.

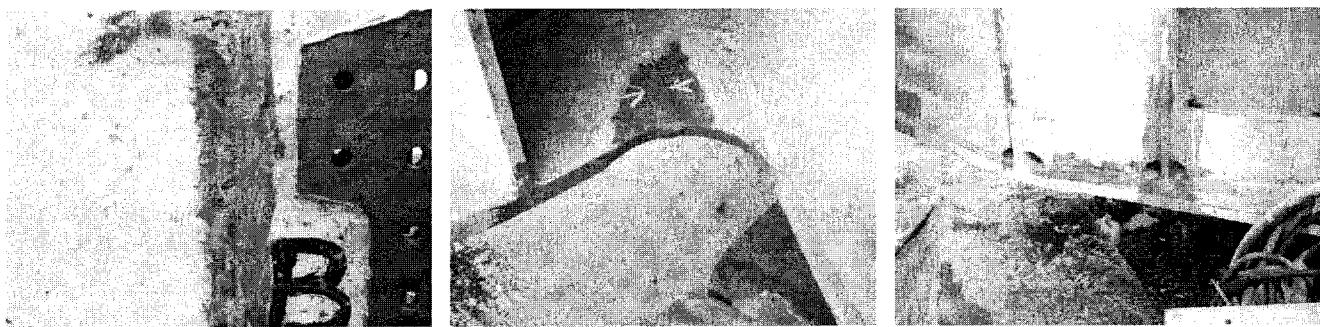
Slika 12. Oštećenja veznih nosača donje gradnje transportnog bagera
Figure 12. Damaged connection beams in the excavator lower assembly.

The excavator lower assembly suffered several partial and complete cracking of assembly connection beams (see Fig. 12). Model and numerical results are shown in Fig. 13 and 14. Table 2 shows the analysis of the old and new solution.

Inappropriate lower assembly structural behaviour can be repaired by adding vertical plates. Behaviour would also be significantly improved by increasing horizontal plate and cylinder thickness, but this is technically not reasonable.

The vertical added plates cover both sides of four "I" cross-sectional beams. The effect of added plate thickness was tested in detail. Approved plate thicknesses are 25 mm and 15 mm, for outer and inner plates, in respect.

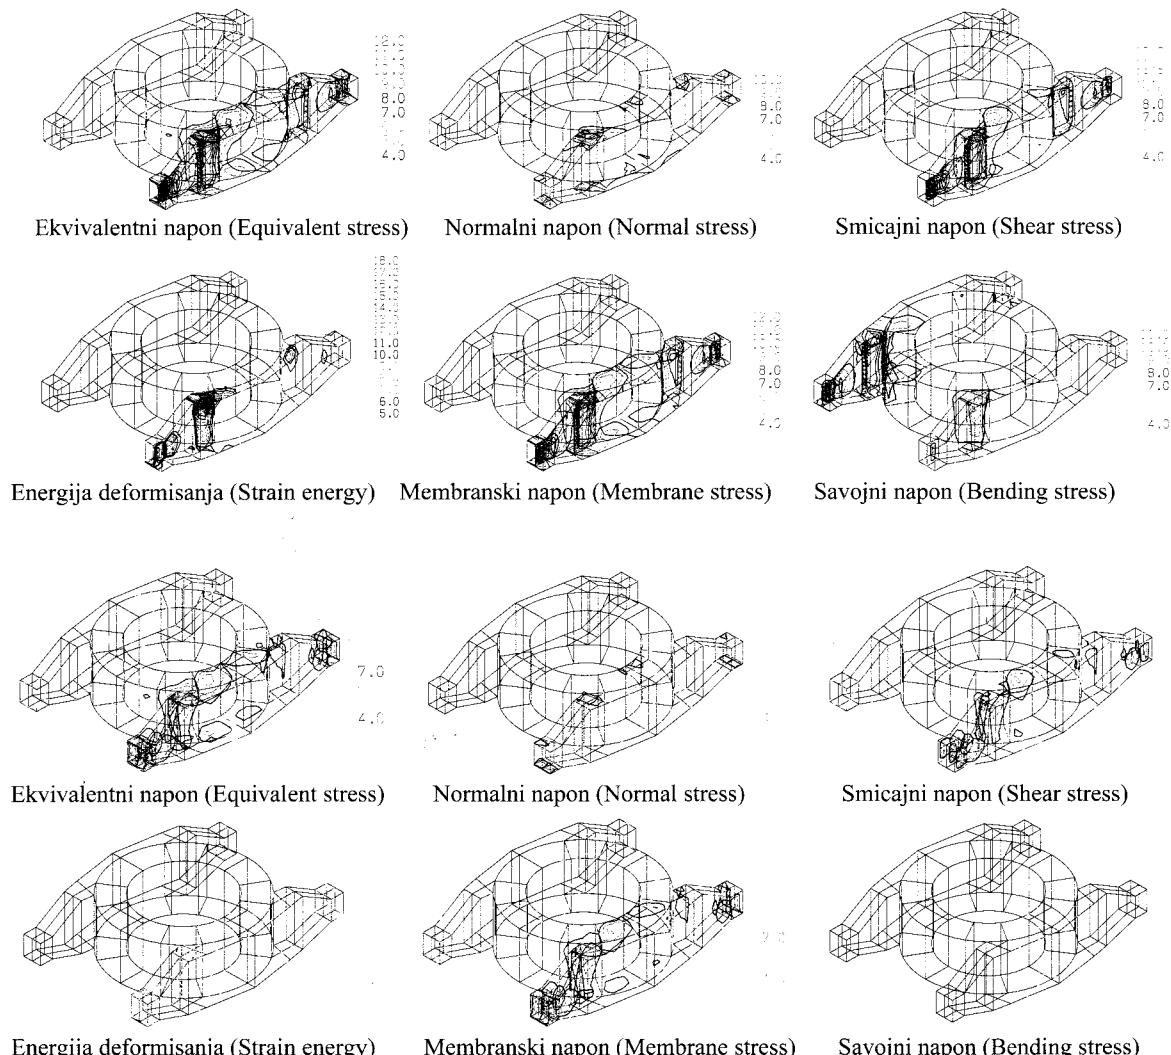
- vertical plates have the largest stress and strain energy,
- horizontal plates have a high stress level in a small area,
- the stress level in cylinders is low in a large area, along with a high percentage of the stress and energy,
- diaphragms pose the least significant effect on behaviour.

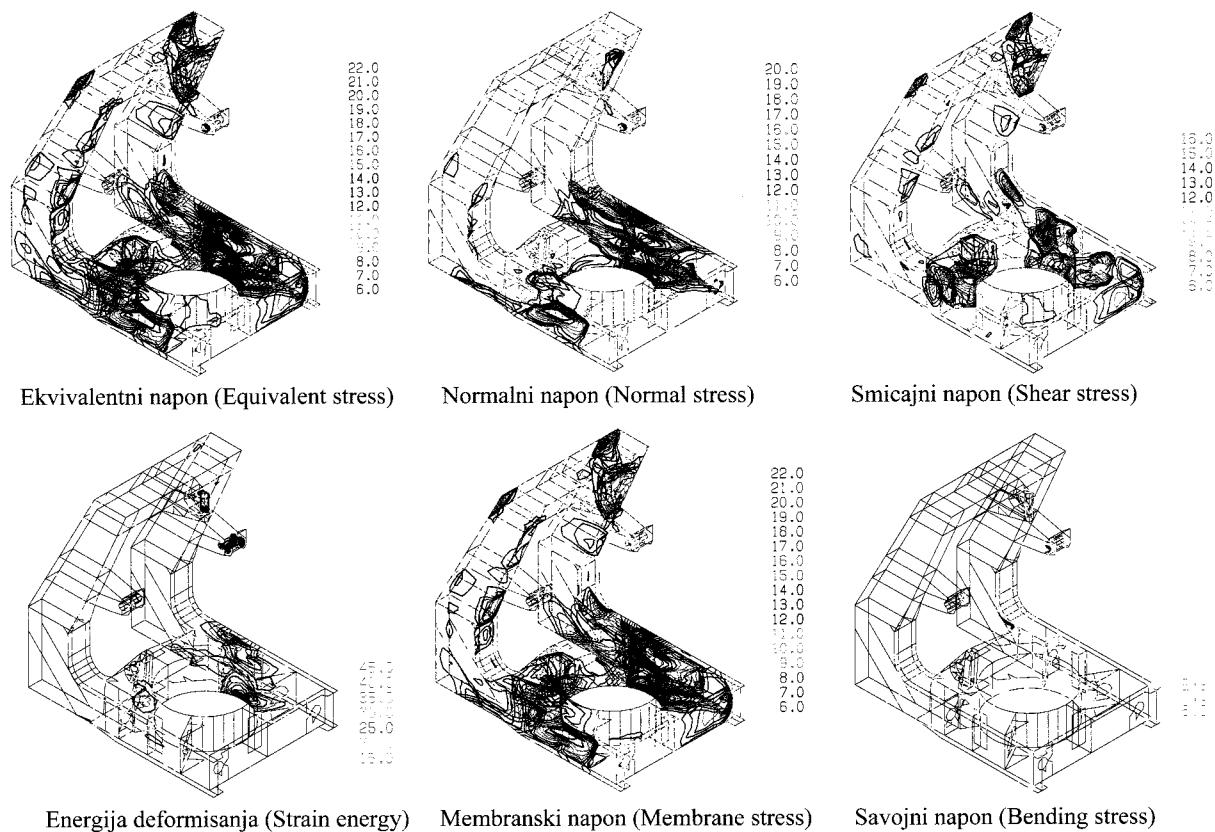
Slika 17. Raspodela napona [kN/cm^2] i energije deformisanja [kNm] stare konstrukcijeFigure 17. Stress [kN/cm^2] and strain energy [kNm] distribution of the old construction.

The excavator suffered constant cracking in the lower assembly. The hindering crack in the cylinder-lower horizontal plate joint was 2 m long. Also, cracks appeared at the top of support. Determining causes for cracking requires detailed structural strength diagnostics of the upper assembly for all dynamic loading cases. The computational model, worst load case, deformed structure pattern and reconstructed elements are shown in Fig. 16. Stress and strain energy distributions are given in Fig. 17. The reconstructed upper assembly is shown in Fig. 18.

Diagnostics conclude the following: large strain, very high level of stress and its concentration, high normal membrane stress and strain energy appearing in the same location. Such behaviour makes the problem easier to solve.

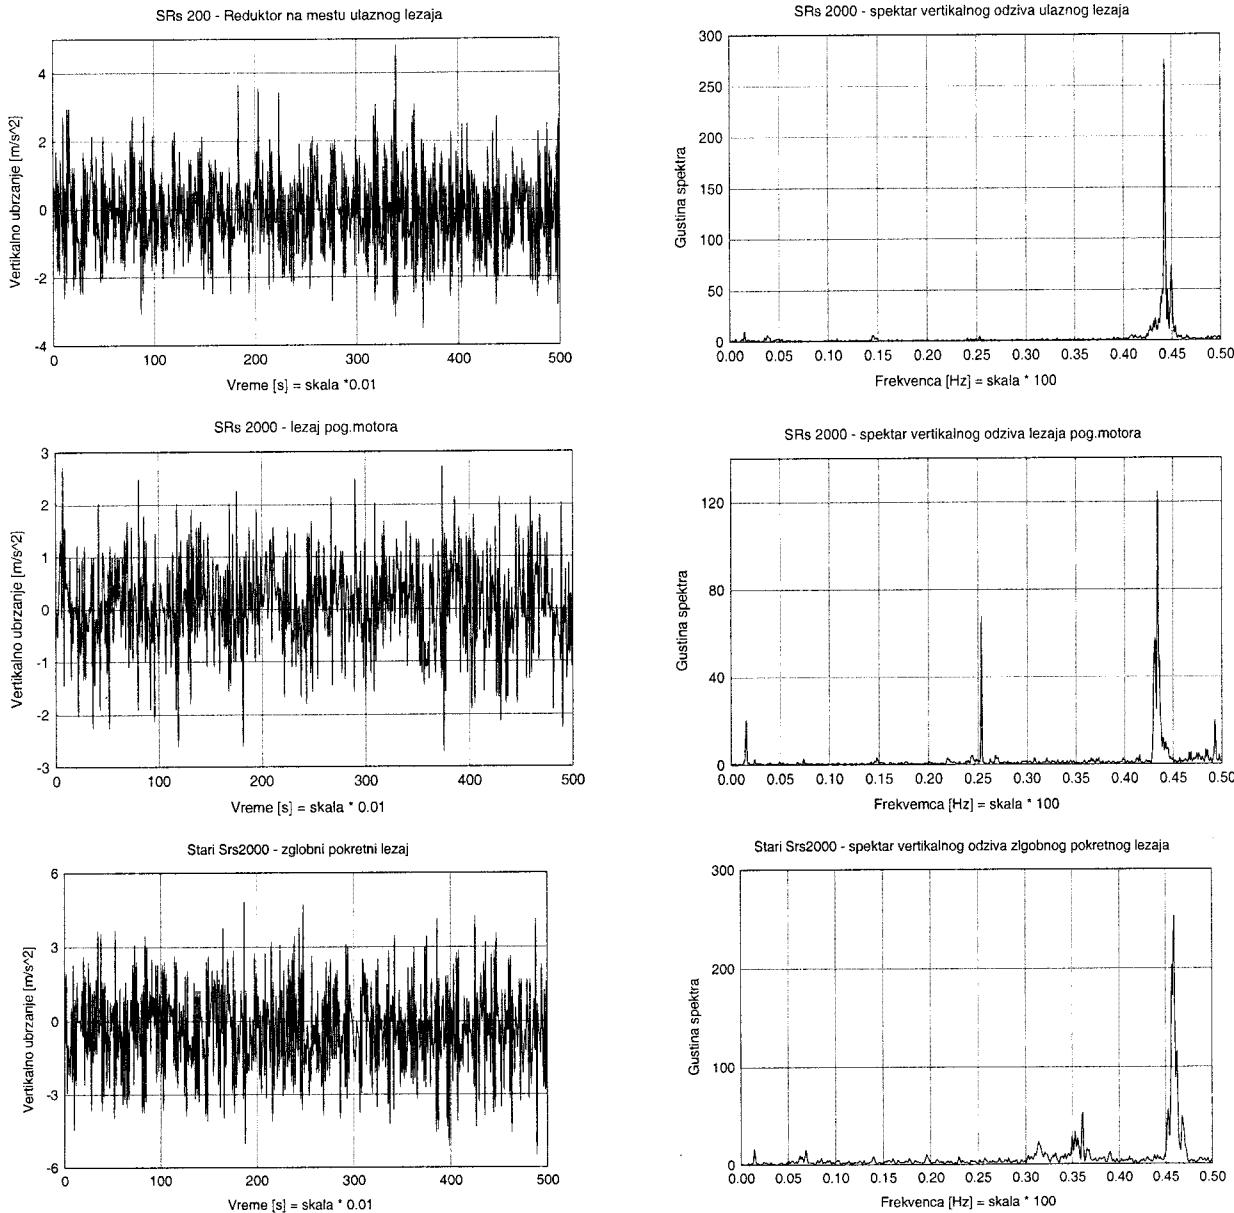
Slika 20. Vertikalno ubrzanje u vremenskom (levo) i gustina spektra u frekventnom domenu (desno)
Figure 20. Vertical acceleration in time (left) and spectrum density in frequency domain (right).

Combined numerical-experimental diagnostics of dynamic power system behaviour gives qualitative parameters for the cause of frequent bearing damage at the transmission driving shaft (after 7 days service). The excavator power system was monitored three times, during which the acceleration of motor- and transmission bearings, as well as the support structure were measured in all three directions. Visual control showed that the supporting structure and the power system/transmission joint had loosened, with significant gap in the spherical support transmission axle. Figure 20 shows measured acceleration in time and frequency domain. Accelerations are close to allowed, and oscillations of both bearings of about 44 Hz, are unacceptable. The cycles of the motor had caused an induced frequency of 24.6 Hz (14800/min) and next frequency of $2 \times 24.6 = 49.2$ Hz. Oscillations of motor bearings, about 1.5 Hz, being close to digging frequency suggests that the support structure of

cantilever-placed transversal motors must be reinforced. The similarity between induced frequencies of the motor and transmission bearings suggests that either the transmission or the driving shaft have very poor dynamic characteristics (the first eigen-frequency should be above 50 Hz). The frequency drop is caused by installed heavy couplings and from the dislocating their centre of mass to 150 mm from driving bearings. Free joint support oscillations with highly developed oscillations in bearings and with high accelerations and response amplitudes are also shown.

Successful transmission operation in the following four months (until replacement for other reasons) was achieved only by increasing the rigidity of transversal motor beams. It was impossible to replace the coupling with a lighter one.
