SANACIJE I REKONSTRUKCIJE TRANSPORTERA I ODLAGAČA REPAIR AND RECONSTRUCTION OF BELT WAGONS AND STACKERS

REPAIR AND RECONSTRUCTION OF THE SUPPORT ON THE LOWER ASSEMBLY OF THE ARS1400 O&K STACKER (OPEN-CAST MINE TAMNAVA ISTOK)

RECONSTRUCTION OF THE SUPPORT OF STACKER ARS1400 O&K (OPEN-CAST MINE TAMNAVA ISTOK)

REPAIR AND RECONSTRUCTION OF ROTATING STACKER PLATFORM ARS 1400 O&K

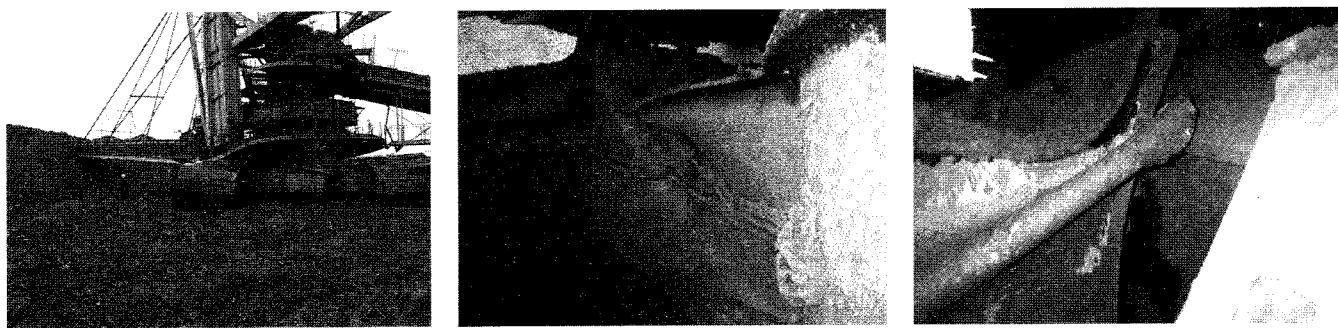
This stacker has suffered severe damages during service. The latest failure is shown in Fig. 1.

The strain is shown in Fig. 2. Stress and energy distributions are given in Fig. 3. High stress level in a vertical critical plate, a high stress concentration and dominant shear stress are noticeable. The critical calculated Euler's shear stress value in this plate is 13 kN/cm² (calculations give a value of 11.5 kN/cm²).

The conclusion is that the given plate has been working under very unsuitable stress field. Its buckling, followed by cracking, occurred due to close values of the working and critical stress. This is what had caused failure.

Slika 1. Havarija na odlagaču ARS1400 O&K
Figure 1. Damage on the ARS1400 O&K stacker.

Performed repairs and reconstruction had included: two existing vertical plates of identical width had remained, a vertical stiffener was added on the half length of the plate, and two vertical plates 2.5 cm thick were added at 10 cm distance from the vertical plate. The supporting element on the other side was merely reconstructed.

After repair and reconstruction the stacker continued working successfully.

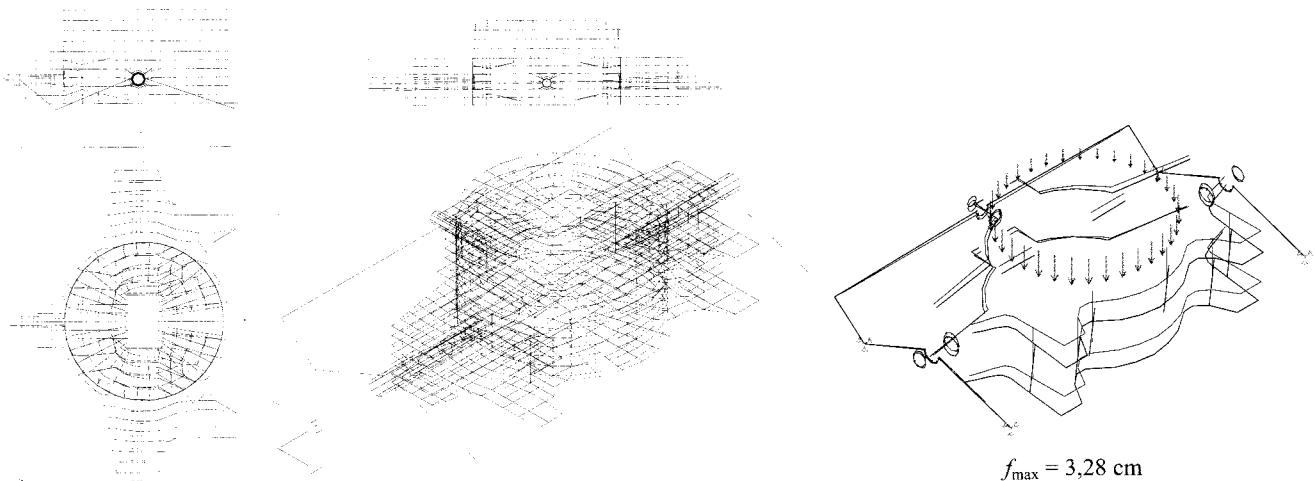
The numerical model of the structure is given in Fig. 2. The most unfavourable load value of 4560 kN is centred at a radius of 100 cm and 60° from the longitudinal axis.

Slika 2. Računski model i deformacija
Figure 2. Numerical model and strains.

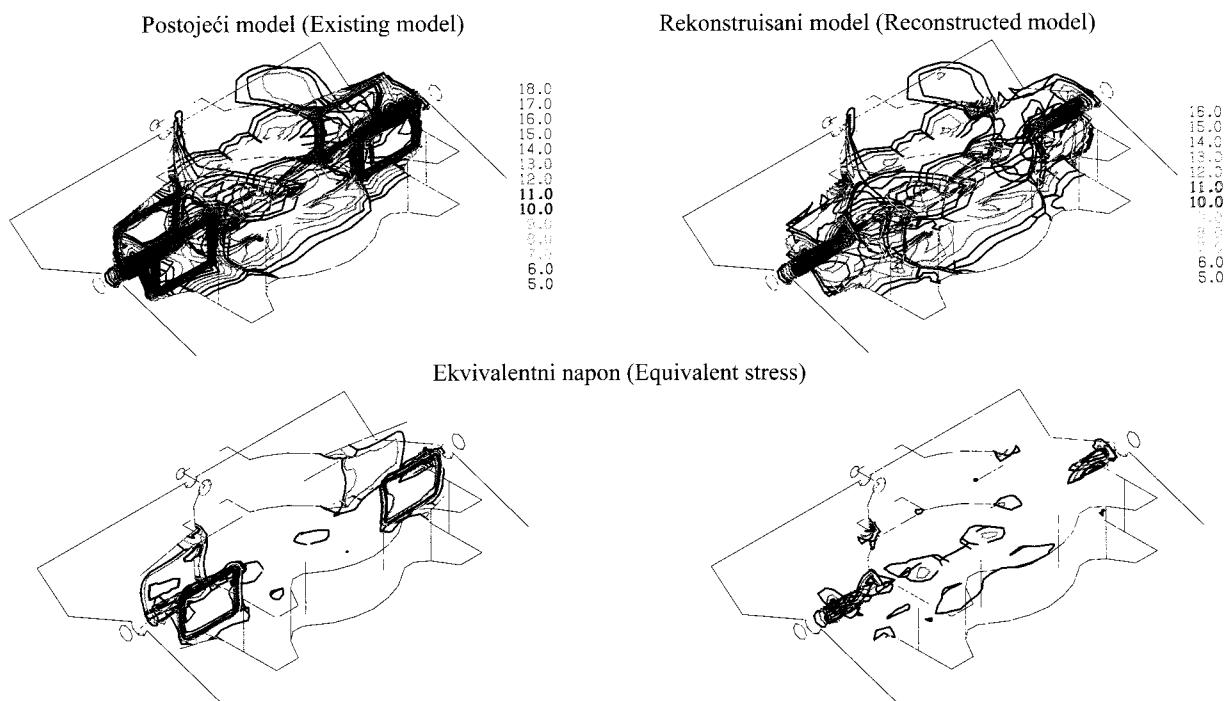
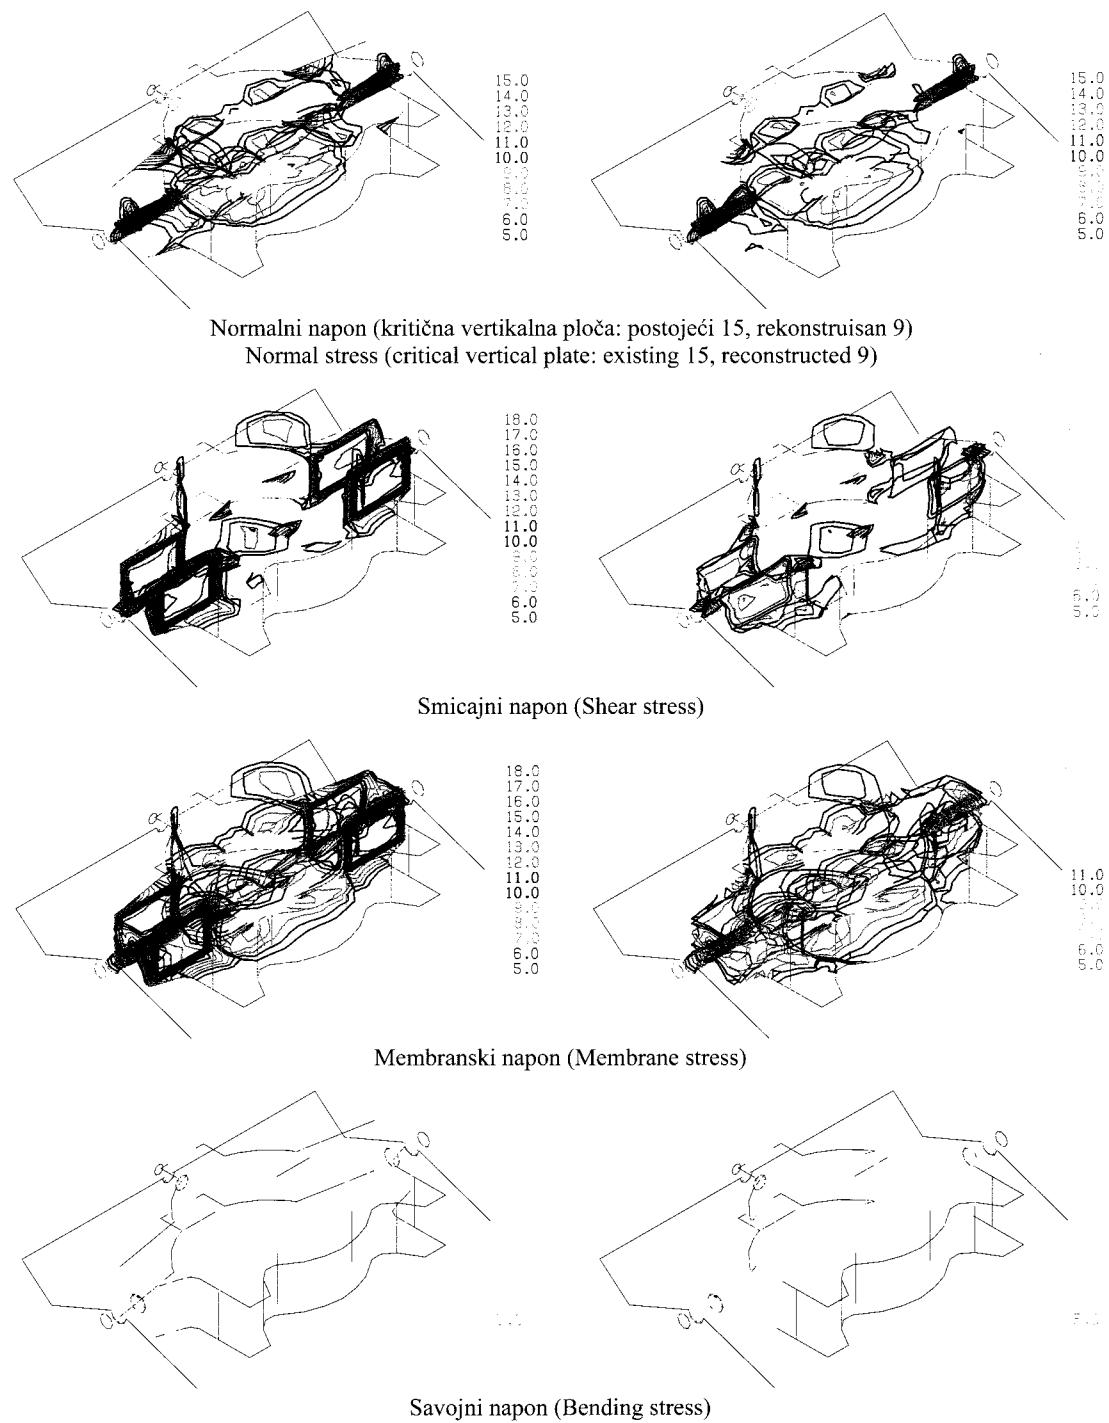
Slika 3. Raspodela napona [kN/cm^2] i energije deformisanja
Figure 3. Stress [kN/cm^2] and strain energy distribution.

Slika 3. Raspodela napona [kN/cm^2] i energije deformisanja [kNcm] (nastavak)
Figure 3. Stress [kN/cm^2] and strain energy [kNcm] distribution. (continued)

Stress and energy distributions are shown in Fig. 3.

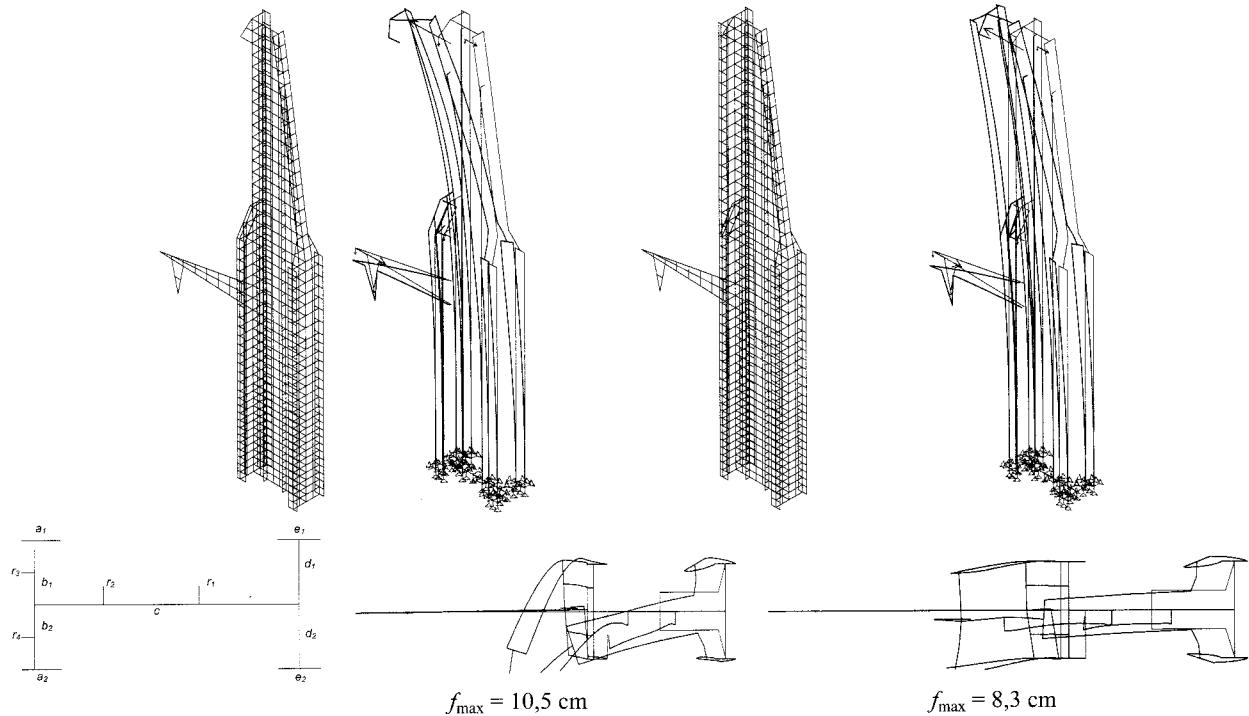
Slika 4. Računski modeli stuba odlagača (postojeći i rekonstruisani).

Figure 4. Numerical models of the stacker support (existing and reconstructed).

The numerical model is shown in Fig. 4. The suggested reconstruction was performed by extending the plate b_2 and its reinforcement a_2 (thickness of both plates is 10 mm) up to the top of the support, and also by partial plate reinforcements d_1 and d_2 with plates $500 \times 1500 \times 20$ mm.

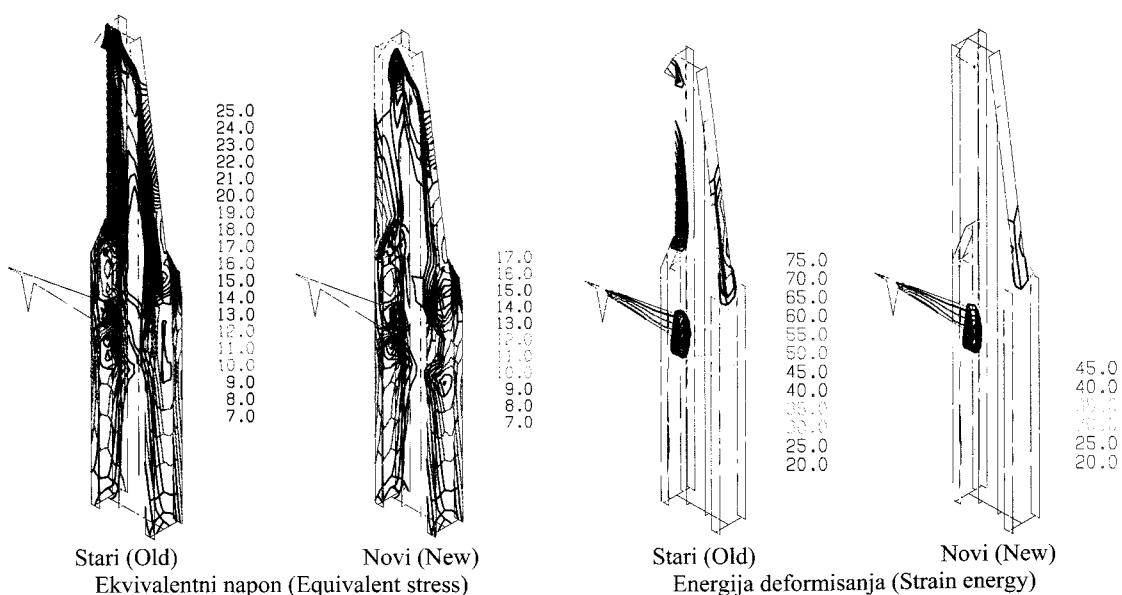
Slika 5. Raspodela napona [kN/cm^2] i energije deformisanja [kNcm].

Figure 5. Stress [kN/cm^2] and strain energy [kNcm] distribution.

The reconstruction led to the elimination of torsion on the support, a significant reduction of bending, decrease of stress by 37.5%, and reduction in stress concentration.

Numerical results of the existing structure and the reconstruction are both given in Fig. 5 and in Table 1.

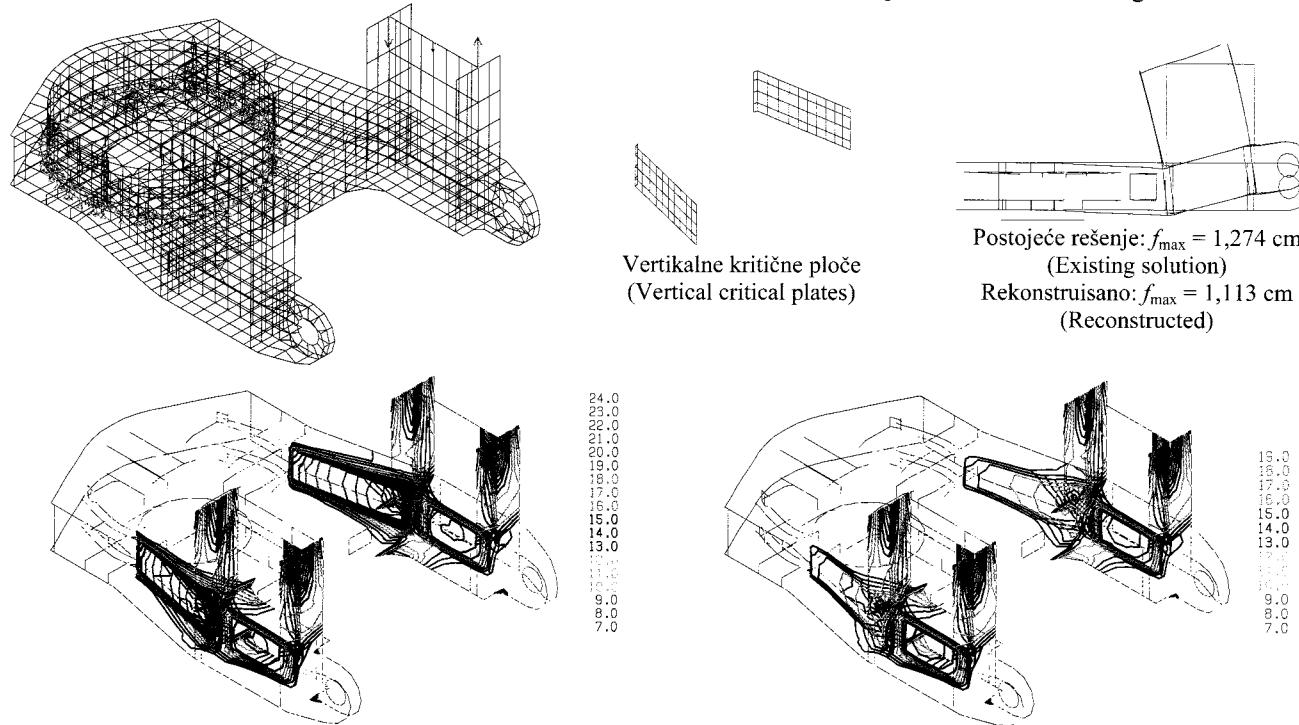
The vertical (critical) plate of the rotating stacker platform (ARS) experienced in-service buckling. The numerical model of the platform including few supports, in the worst case of load, strain and equivalent stress, for existing and reconstructed platforms is shown in Fig. 6 and Table 2.

Vertikalna kritična ploča $\sigma_{\max} = 24 \text{ kN/cm}^2$. Postojeće rešenje.

Vertical critical plate $\sigma_{\max} = 24 \text{ kN/cm}^2$. The existing solution.

Vertikalna kritična ploča $\sigma_{\max} = 14 \text{ kN/cm}^2$. Rekonstruisano.

Vertical critical plate $\sigma_{\max} = 14 \text{ kN/cm}^2$. Reconstructed.

Slika 6. Računski model obrtne platforme odlagača
Figure 6. Numerical model of the rotating stacker platform.

The vertical critical plate has the largest stress, stress concentration, and strain energy values. The identified behaviour entirely corresponds to structural behaviour in service. Significant stress decrease and elimination of stress concentration is achieved by increasing vertical plate thickness. Apart from this, small amount of bending stress are indicates proper design.

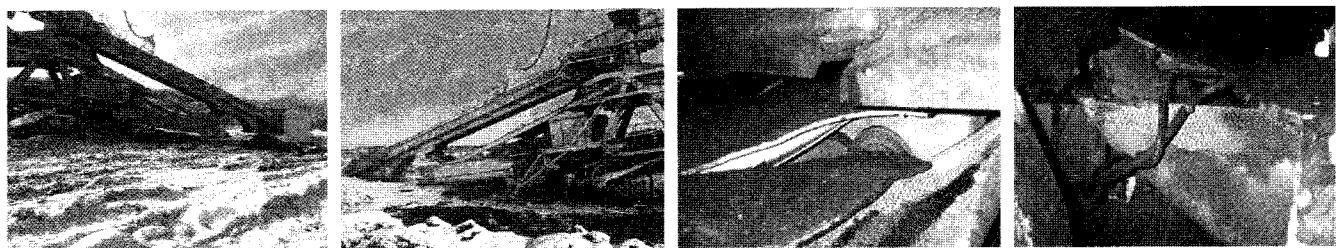
The belt wagon on crawlers failed at its support (Fig. 7).

Slika 7. Havarija transporteru u osloncu
Figure 7. Failure of the belt wagon at the support.

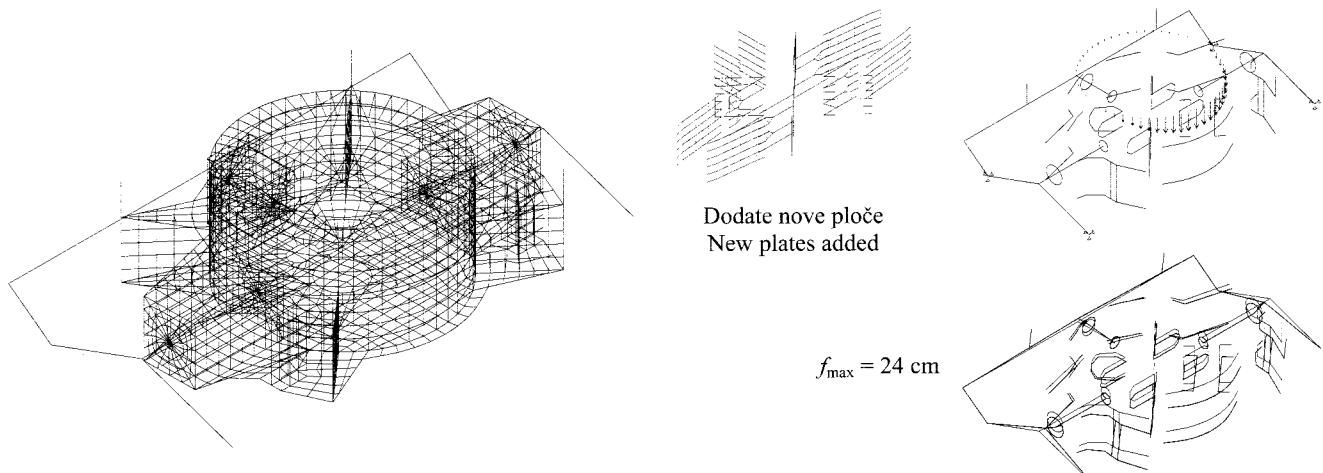
The supporting structure of the lower assembly of the belt wagon on crawlers is a 3-D plate structure (Fig. 8). Structure modelling must be performed using the finite element method for a plate. Adequate stiffeners on particular plates may be modelled by a beam finite element.

Slika 8. Model i predložena rekonstrukcija donje gradnje transporteru
Figure 8. Model and proposed reconstruction of the lower belt wagon assembly.

Parts of upper and lower plates, and intermediate plates form a girder box (2 pieces), connecting cylindrical part to the mobile mechanism through the axle. This beam is called the critical box beam. The suggested reconstruction of the lower assembly includes placement of plates (Fig. 8).

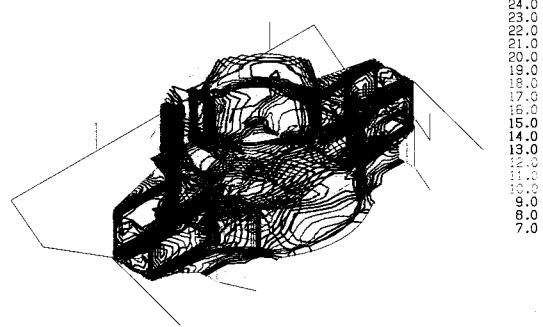
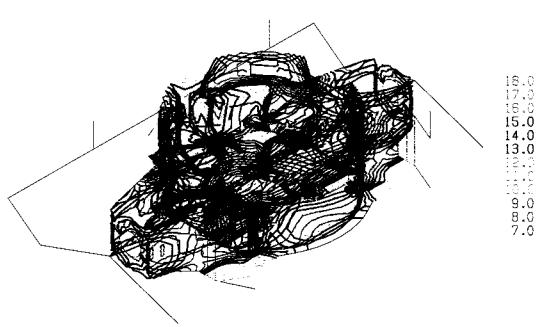
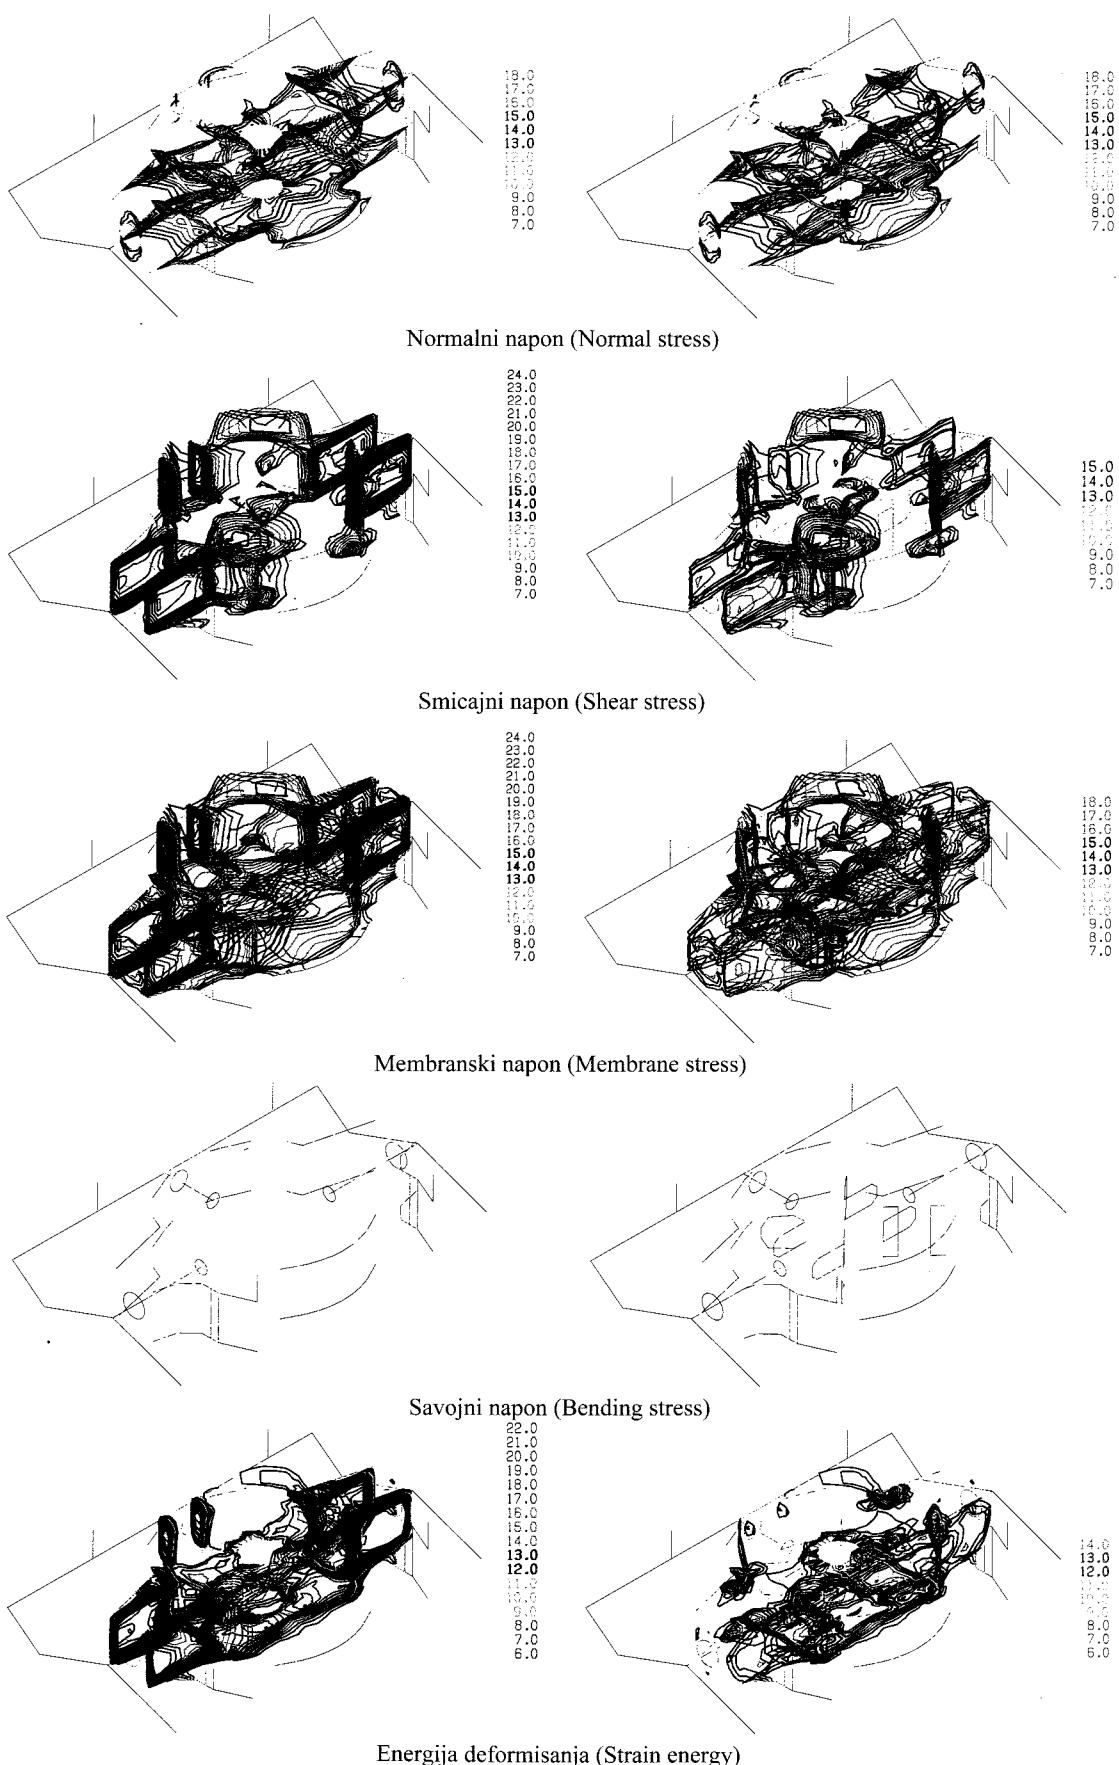
Slika 9. Raspodela napona [kN/cm²] i energija deformisanja [kNcm]
Figure 9. Stress [kN/cm²] and strain energy [kNcm] distribution.

The comment on numerical results states as follows: almost the entire lower assembly is under loading influence; a very high stress level develops in vertical plates of both first and second girder box axle support beams at the connection to the balancer, with very high stress concentration; shear stresses are dominant; the mentioned girder box beams have a dominant effect (by carrying most of the membrane and shear stresses, while most of the external loads' energy is spent on beam strains); the plates were subject to a very unsuitable stress state.

The proposed reconstruction provides drastic decrease in stress (especially shear stresses) and strain energy.

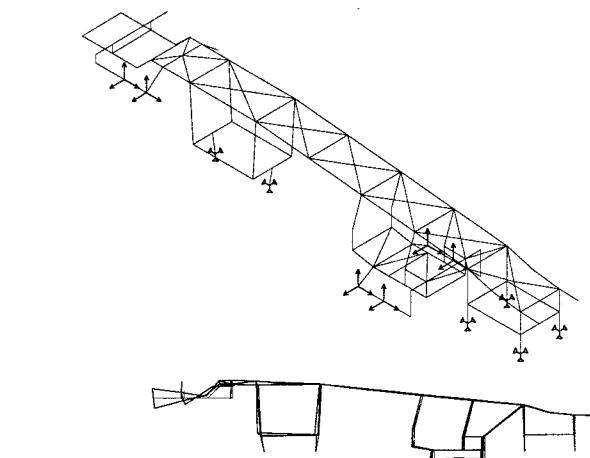
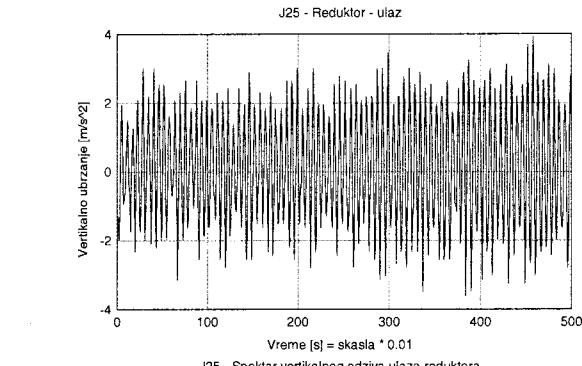
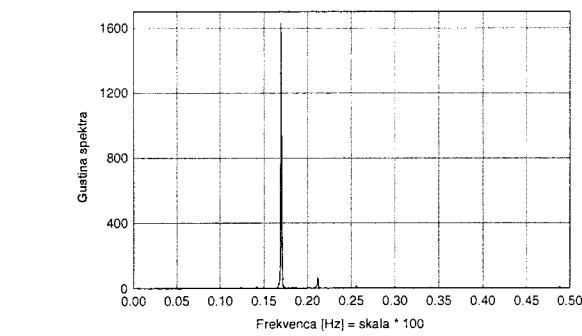
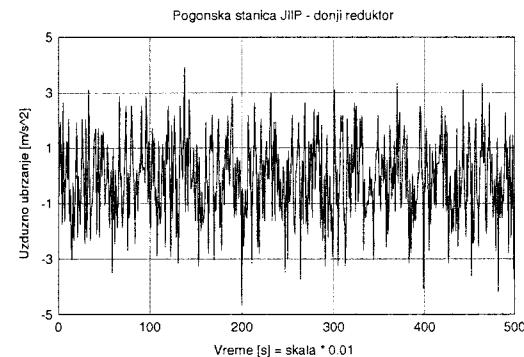
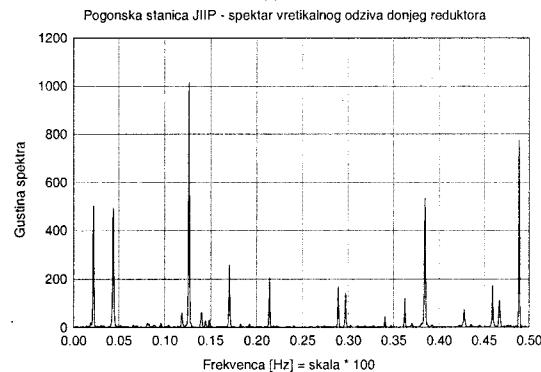
$$f_{09} = 15,26 \text{ Hz}$$

Globalno savijanje u horizontalnoj ravni, lokalno uvijanje gornjeg pogona oko podužne ose, izrazit "prelom" vratila gornjeg pogona i manji donjeg

(Global bending in horizontal and vertical planes, local torsion of upper transmission about longitudinal axis, shaft dominantly "broken" in upper transmission, and partially in the lower.)

Slika 10. Redukovani dinamički model stanice (gore), vertikalno ubrzanje (sredina levo) i uzdužno ubrzanje (sredina desno) u vremenskom domenu i gustina spektra u frekventnom domenu (dole)

Figure 10. Reduced dynamic model of unit (top), vertical acceleration (middle left) and longitudinal acceleration (middle right) in frequency domain, and spectrum density in time domain (bottom).

Globalno savijanje u horizontalnoj ravni sa malim globalnim uvijanjem oko podužne ose
(Global bending in a horizontal plane with small global torsion about the longitudinal axis.)

Globalno uvijanje oko podužne ose
(Global torsion about the longitudinal axis.)

Globalno savijanje u horizontalnoj i vertikalnoj ravni, izrazit "prelom" vratila donjeg pogona i manji gornjeg
(Global bending in horizontal and vertical planes, axle dominantly "broken" in lower transmission, and partially in the upper.)

According to calculations, measurements and analysis of results, it is concluded that power station problems appearing during operation are caused by its insufficient volume stiffness, manifesting in eigen-frequencies that are close values of starting frequencies.

This serious setback in the structure is a global characteristic. Eliminating it entirely is not technically justified, since it would require large reconstruction. Therefore, it is necessary to re-enforce locally the unit structure and reduce the unwanted effect of poor structural design.

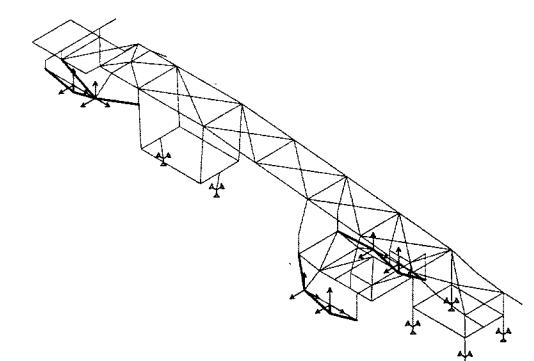
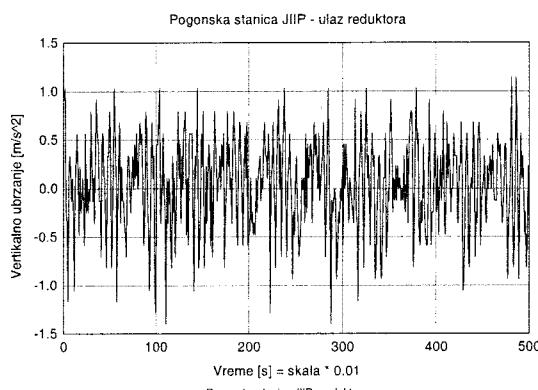
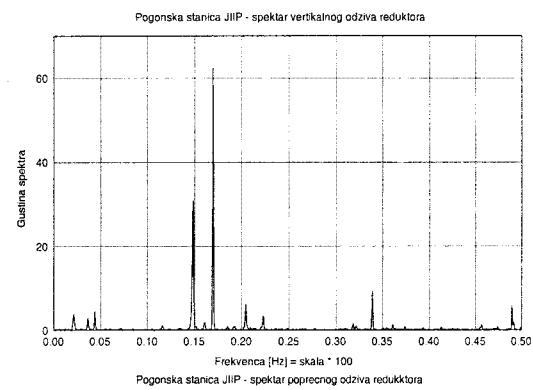
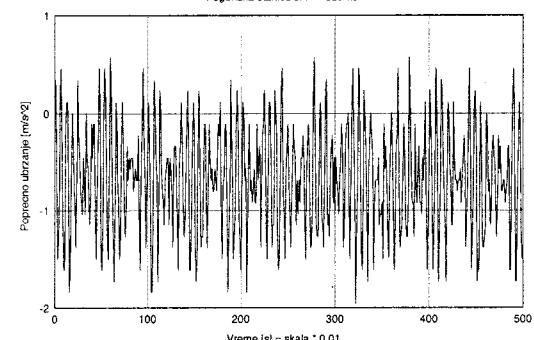
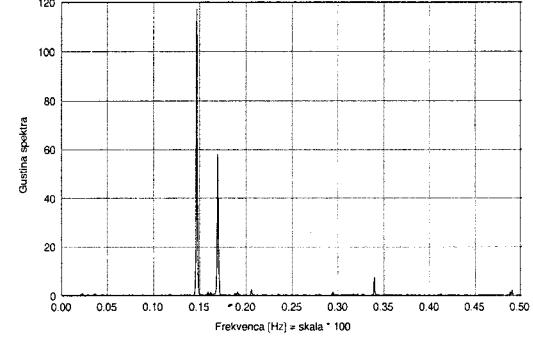
Globalno savijanje u horizontalnoj ravni sa malim globalnim uvijanjem oko podužne ose
(Global bending in a horizontal plane with small global torsion about the longitudinal axis.)

Lokalno uvijanje nosača gornjeg pogona i bočno oscilovanje donjeg
(Local torsion of upper unit support and lateral oscillation of the lower unit support.)

Slika 10. Računski model rekonstrukcije (gore), vertikalno ubrzanje (sredina levo) i poprečno ubrzanje (dole levo) u vremenskom domenu i gustina spektra u frekventnom domenu (desno, sredina i dole)

Figure 10. Numerical model of the reconstruction (top), vertical acceleration (middle left), and transversal acceleration (bottom left) in time domain, and spectrum density in frequency domain (right, middle and bottom).

Rezultati proračuna pokazuju samo osam (umesto 12) glavnih oblika oscilovanja ispod pobudne frekvencije motora, nema više oscilacija oko pobude motora, ne-povoljno dinamičko ponašanje konstrukcije stanice je značajno smanjeno. Prikaz najbitnijih merenja dat je na sl. 11.

A proposed solution for reinforcement was obtained by computer calculation, based on a number of models.

Repeated acceleration measurements on the reinforced structural unit verified the correct reinforcement solution.

Uzrok havarija je otkriven i njegov uticaj minimiziran.
