ASSESSMENT OF THE FATIGUE BEHAVIOR OF REPAIRED ALUMINUM CARBODY STRUCTURE

Abstract – Aluminum carbody structures vs. steel structures have an increasing share in rail vehicle passenger fleet. New trams for Belgrade city transport with aluminum carbody structure after approximately three years of service, suffered from cracks. The first repair made by manufacturer was only partially successful. Two years after repair some cracks reappeared. This paper deals with some specificity of the aluminum structures repair process. The issue of the aluminum structures fatigue is compared with the fatigue of common carbody steel structures. Stress measurements in the repaired welding zone after second repair and reinforcement are presented. The test was performed with fully loaded tram under typical service conditions. Assessment of the future fatigue behavior is made based on the analysis of measured data.

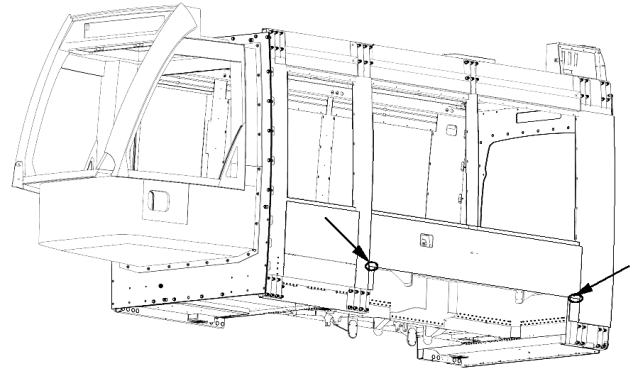
Fig.2. Carbody structure of the module C1 with initial crack positions

The first cracks arise in the corners of the cuts for bogies, along horizontal welds, marked in the figure 2 with arrows. In some units initial cracks appeared after only 20.000 service kilometers. In the next phase, the cracks propagated along vertical weld connecting vertical posts with horizontal profiles (figure 3).

- high vibrations as consequence of the bad infrastructure,
- welding quality failures and
- lower weld thickness caused by esthetical outside weld grinding.

- corrective welding at all places where vertical cracks appeared and all places where window post horizontal cracks appeared, including added backing,
- in the corners of the bogie space, in the whole fleet the 4 mm plates were replaced with 6 mm plates. A rib supporting a plate was added,

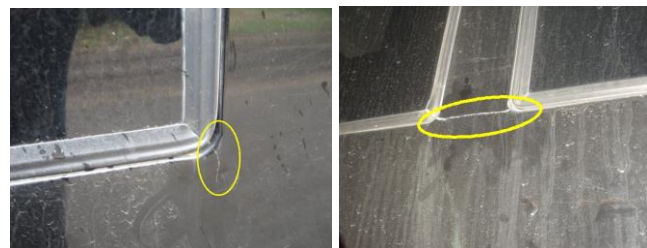
Fig.4. Cracks along window welds

Later, some cracks appeared in the lower corners of the windows and in some cases along horizontal welding connecting small post between windows with horizontal profiles (figure 4).

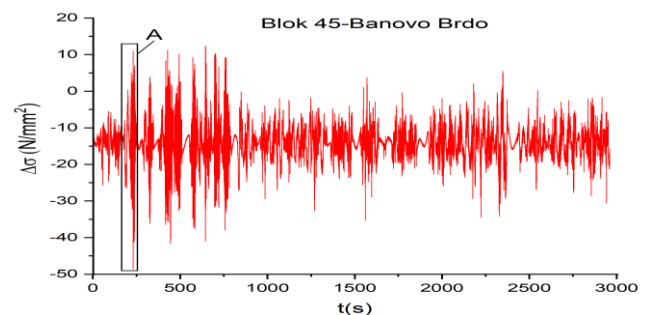
Fig.6. Measured stress, worse track

Figure 6 shows the example of stress measurements between stops Blok 45 and Banovo Brdo. It can be seen that the first part of the track is in a worse state, giving larger stress spans.

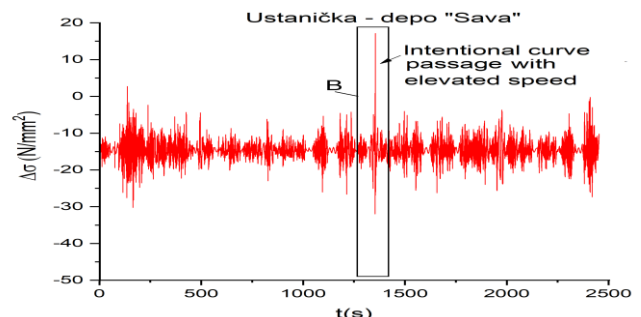
Fig.7. Measured stress, better track

Figure 7 shows the example of the stress measured between stops Ustanička and depot "Sava". The smaller average stress spans are consequence of better track quality. There is one exception. In order to test effect of longer stroke to rotational stoppers of

carbody, intentionally passing of the curve to Resavska street was at speed of approximately 18 km/h instead of regular 10-12 km/h (detail B).

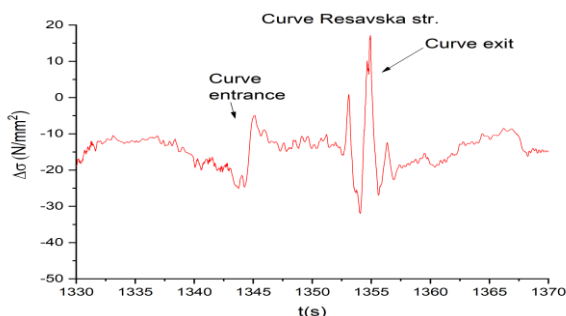
Fig.8. Detail B (curve Resavska str.)

Figure 8 shows the detail B of the curve passing, where on the exit from the curve the singular stress span reached 50 N/mm².

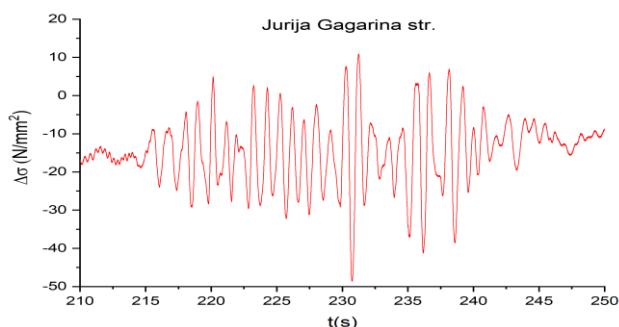
Fig.9. Detail A (J. Gagarina street)

In the same scale figure 9 shows detail A from figure 6 corresponding to straight track passing in Jurija Gagarina street. It can be seen that stress continuously pulsate with spans from 30 to 60 N/mm². Correlation with acceleration measurements shows that these stress alterations origin from roll movement caused by track twist i.e by carbody torsion.

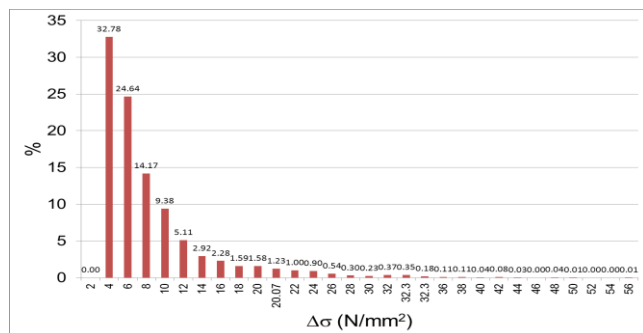
Fig.10. Stress distribution histogram

Figure 10 shows resulting distribution histogram of the stress ranges. The data are extrapolated on 30-year service life and presented in S-N diagram in figure 11. Calculation of accumulated damage according to Palmgren-Miner damage hypothesis gave value 3.3.

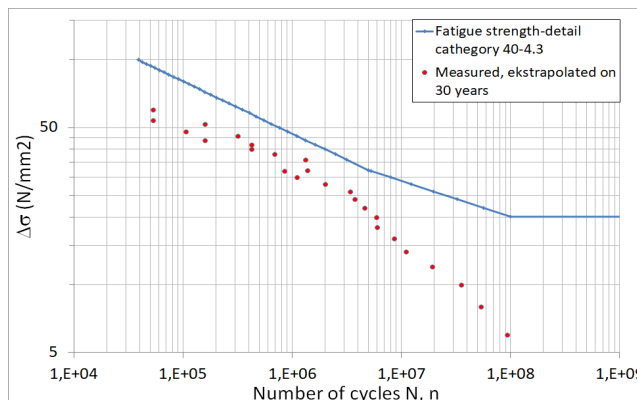
Fig.11. Extrapolated S-N diagram basd on test

Stress analysis made using results obtained from service like test revealed that the majority of high stress ranges originate from roll movement i.e. from carbody torsion. Result of calculation of accumulated damage based on Rain-flow method cycle count and Palmgren-Miner linear damage hypothesis indicates possible repetition of cracks after estimated mean service time of approximately nine years. However, several parameters can influence this estimation. Having in mind that the test was performed with full load, under average load a longer period to new crack initiation can be expected. Deterioration or renovation of tracks in such a long period is also parameter that shall be additionally taken in account. Supposed welding quality is also an influencing parameter, etc.
