# 'Design-in' Faults - the Reason for Serious Drawbacks in High Capacity Bucket Wheel Excavator Exploitation

<sup>1</sup>University of Belgrade - Faculty of Mechanical Engineering

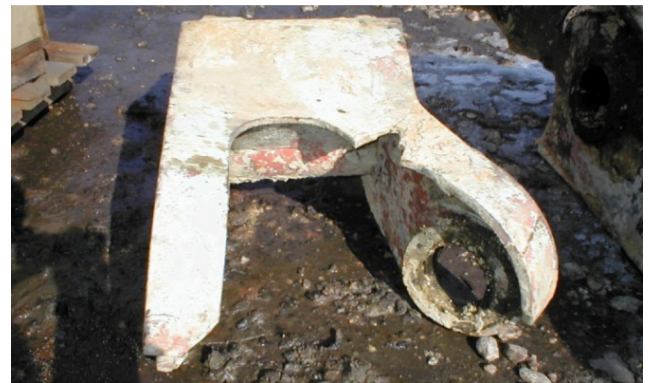
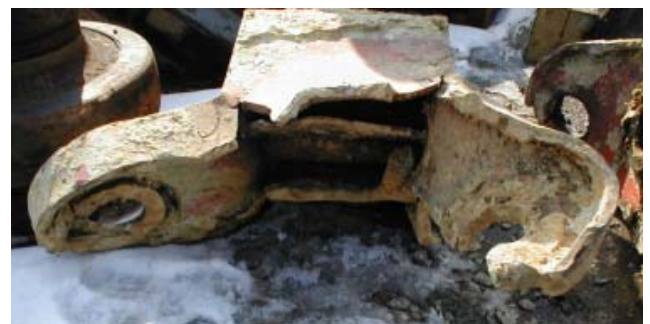
Defect inspection showed that the majority of TWB structures suffered the same problems, plastic deformation and crack occurrence in the vertical plate clamping zone and shearing of the axle nut. Frequent failures, followed

Figure 2: Typical failure of the TWB structure

Fig. 5 shows the main TWB subassemblies. It can be observed that there is no connection between the vertical plates in the TWB structure under the hole for bedding the track wheel axles. On the other hand, based on the looks of the TWB damaged structure, shown in Fig. 2, it is conclusive that the main cause of its failure is insufficient strength during the action of lateral forces which are dominantly applied during the BWE curve travel [5]. The verification of this conclusion is done by applying the linear FEA.

The authors of this paper strongly suggest the conservative approach to calculating the TWB structure, using models which do not include the track wheel axles, since it provides sufficient TWB carrying capacity even in the case of unforeseen loads, the appearance of which is quite possible having in mind the extremely hard working conditions.

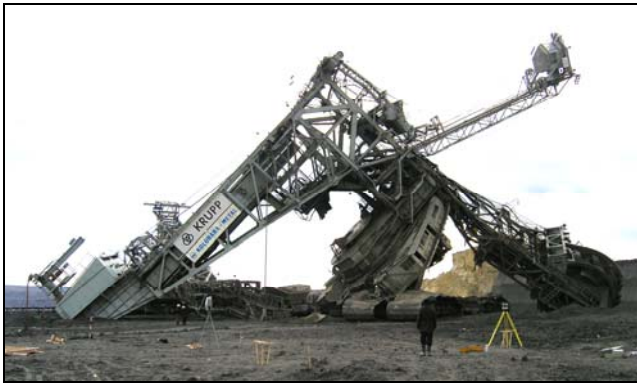
On 3<sup>rd</sup> of December 2005, after merely sixteen years of exploitation, a heavy accident caused the total collapse of the machine, Fig. 3. Revitalization process, which included dismantling of the complete BWE structure, transport to the erection site, repair and manufacturing of almost every part of the superstructure, erection, testing and putting back to service, lasted for almost five years. On 22<sup>nd</sup> of October 2010, BWE SchRs 1760 was, once again, included into the production process. Direct expenses in terms of material and labour were estimated to be around fifteen million Euros.

Figure 3: BWE Sch Rs 1760 after the collapse

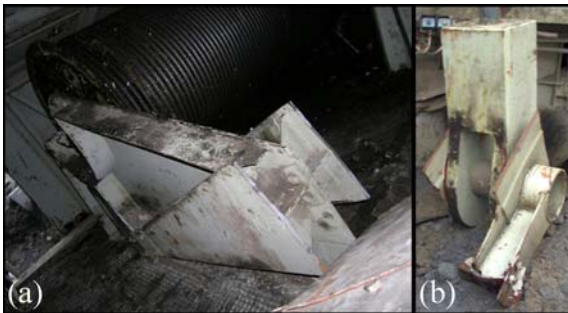
Damage diagnostics, conducted immediately after the breakdown, concluded that the straightforward cause of the BWE collapse is the failure of the end eye connection of the support of the right portal tie-rod, Fig. 4, which will be analyzed as Case 2 of this paper.

Figure 4: Broken-down support of the right portal tie-rod: (a) element on the counterweight arm and (b) broken-away part.

The high stress state of the designed support structure of portal tie-rods, conjugated with the detrimental effects of the welding seam (not welded through root, porosity, inclusions) perpendicular to the force direction, as presented in [10] and dynamic character of loads, is the principal reason of the end eye connection failure and the BWE collapse.

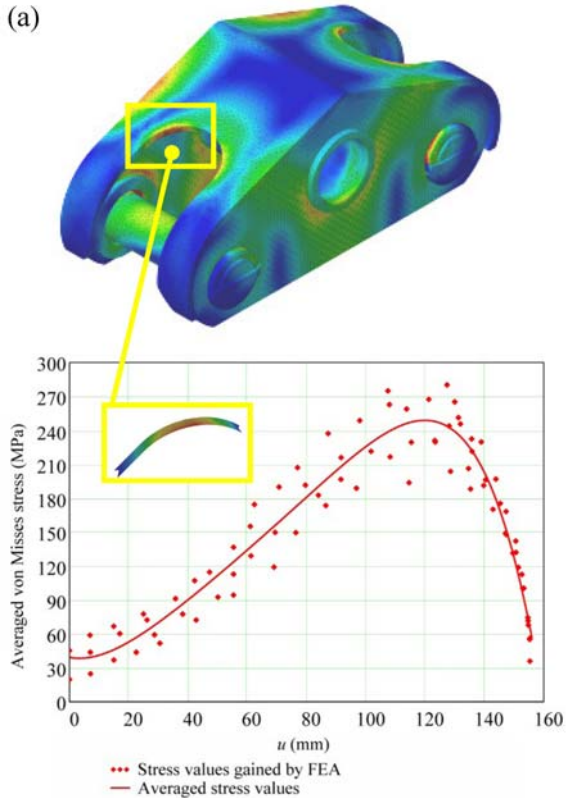
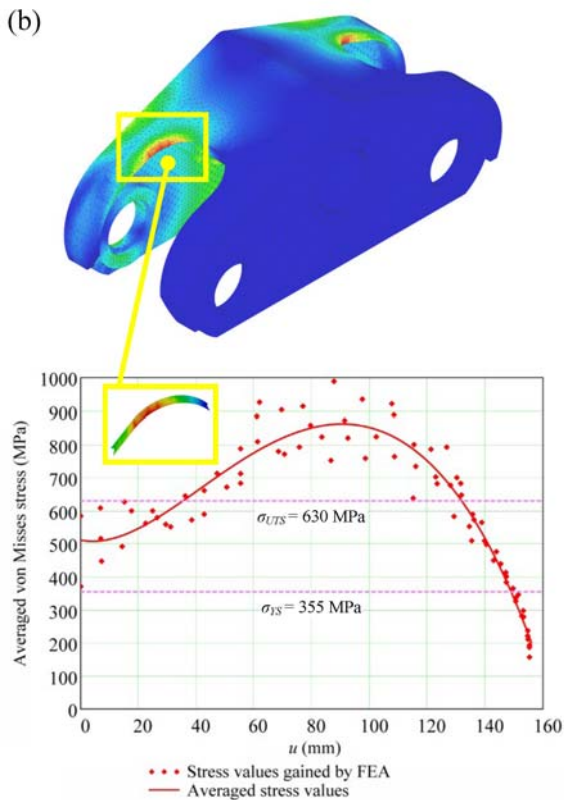
Figure 8: Distribution of averaged von Mises stresses in critical zones

The maximum calculated stress values appear in the vertical plate clamping zone. Distribution of von Mises stresses in the critical zone is shown in Fig. 8, while averaging of the calculation stress values along the upper plate thickness is done according to [8].

If the track wheel axles are included in the model of the TWB structures, the maximum averaged von Mises stress (MAvMS) for the original (249 MPa) TWB structure is lower than the minimum yield stress value ( $\sigma_{YS}=355 \text{ MPa}$  for steel quality grade S355J2G3). But, if track wheel axles do not distribute the lateral loads, MAvMS (862 MPa) for the original TWB structure is considerably greater than the ultimate tensile strength ( $\sigma_{UTS}=630 \text{ MPa}$ ). This fact fully explains the occurrence of cracks in the case of an axial gap between the TWB structure and the track wheel axle subassemblies.

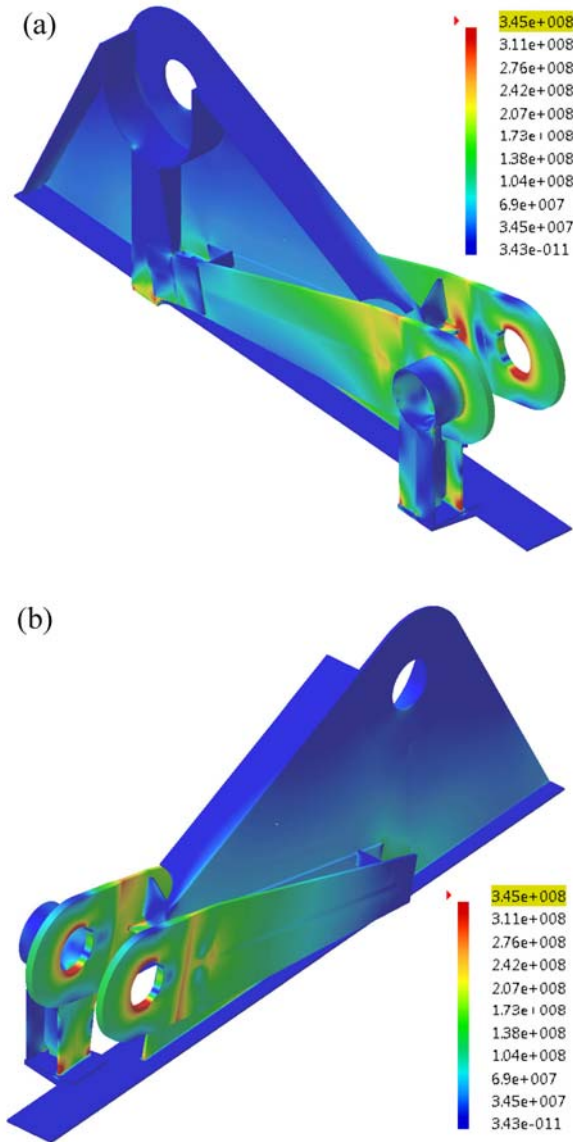
Maximum value of uniaxial stress, calculated according to the Huber–Havky–von Misses hypothesis, is obtained in the left eye, in the zone of its connection with the lengthwise supporting plate, Fig. 10.

Figure 10: Uniaxial stress field of the portal tie-rod support structure for LC HZS1: (a) right side view and (b) left side view (values higher than yield stress are red coloured)

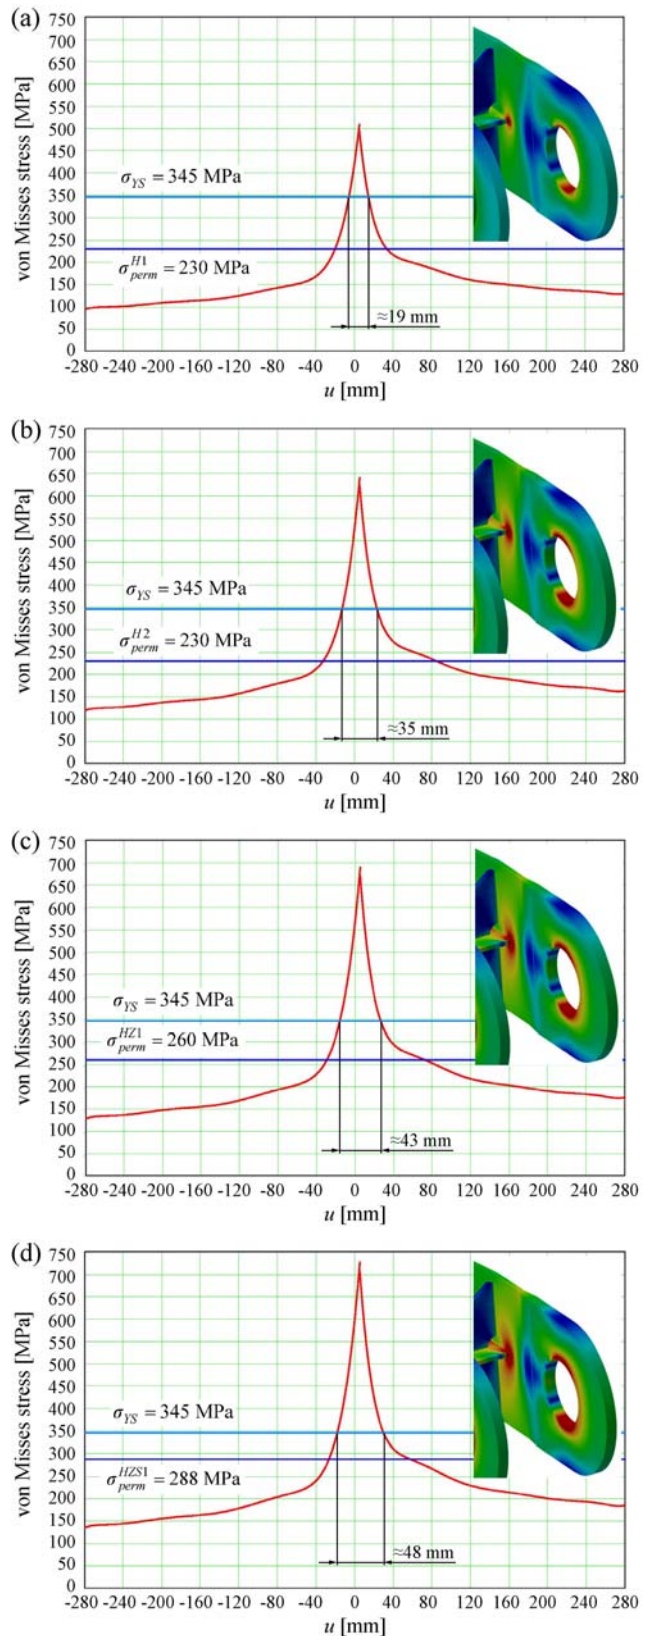
Distribution of von Misses stresses in the critical zone, as well as calculation stress values along the crack initiation and propagation line are shown in Fig. 11. The maximum von Misses stress (MvMS) values and the permissible stress intensities (PSI) for all analyzed load cases are presented in Tab. 1.

Figure 11: Distribution of von Misses stresses along the crack propagation line: (a) LC H1, (b) LC H2, (c) LC HZ1, (d) LC HZS1 (values higher than yield stress in stress field figures are red coloured)

- Due to the prompt incursion of the lengthwise supporting plate into the eye structure and the proximity of the location where the load is applied, the pronounced stress concentration occurs in the failure zone of the eye;

- In all load cases maximum von Mises stresses are considerably greater than permissible stress values (2.2 times for LC H1; 2.8 times for LC H2; 2.7 times for LC HZ1 and 2.5 times for LC HZS1);
- The reserve of elasticity is also depleted, since  $M_{vMS}$  are 1.5, 1.9, 2.0 and 2.1 times greater than yield stress value ( $\sigma_{YS} = 345$  MPa for steel quality grade S355J0 and plate thickness of 20 mm, [9]) for load cases H1, H2, HZ1 and HZS1 respectively;
- The size of the high stress state zone (values higher than yield stress intensity) is expanding with the increase of load intensity from 19 mm for LC H1 up to 48 mm for LC HZS1.
