**Mladen Mladenović, Miodrag Arsić, Zoran Savić**

## INFLUENCE OF DEGRADATION OF PARENT MATERIAL AND WELDED JOINTS ON THE INTEGRITY OF THE BREECHES PIPE LOCATED AT PIPELINE III OF HYDRO POWER PLANT 'PERUĆICA'

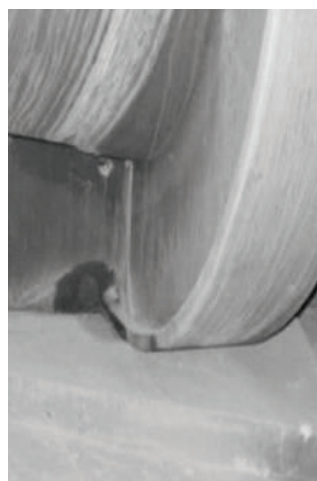
Significant problems at hydro power plant 'Perućica' refer to the parent material and weld metal of the breeches pipe 1A located at pipeline III. Significantly lesser problems were detected at parent material and weld metal of breeches pipes 7B, 8A and 8B. Pipeline and breeches pipes were made of microalloyed steel 'Nioval 47' (steel mill 'Jesenice'). Stresses that occur at pipelines in service during the process of execution of functional tasks (stationary and dynamic loads) and during the disturbed process of exploitation (non-stationary dynamic loads), cause severe damaging of parent material and weld metal at structural components of breeches pipes (collars and anchors), thus endangering the integrity of structure of pipeline III as a whole, figure 4. Role of the collar, which enables the leaning of the breeches pipe on the foundation, is to receive static and dynamic loads (mean pressure of up to 61 bar in pipeline axis, specific load that occurs due to the quantity of water in the pipeline, action of the force of gravity) and displacements which happen due to non-stationary dynamic loads that occur at the pipeline, while the anchor strengthens and balances the mass of the breeches pipe, figure 5a. Significant propagation of damages at the supporting structure of the breeches pipe 1A, especially

a) Proper mutual position of the collar and the anchor

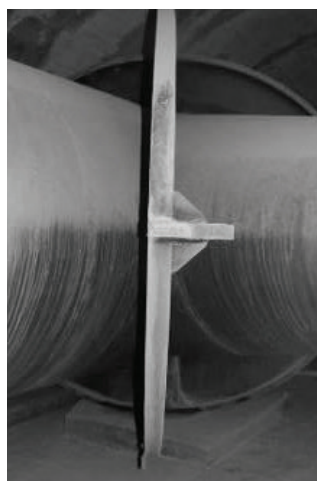
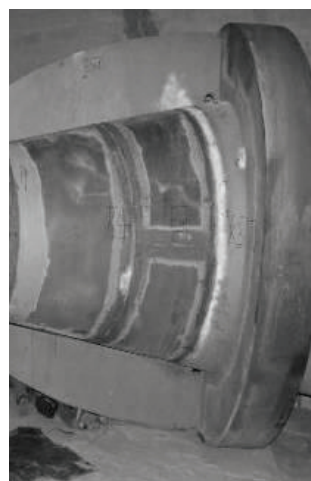
at parent material of the anchor and welded joint between the collar and the anchor, as well as between the pipeline and the anchor, led to the situation that the breeches pipe was leaning not on the collar, but on the anchor, figure 5b.

b) Improper mutual position of the collar and the anchor

Figure 5. Proper mutual position of the collar and the anchor (fig. 5a) and damaging of the anchor caused by bending due to improper mutual position of the collar and the anchor (fig. 5b)

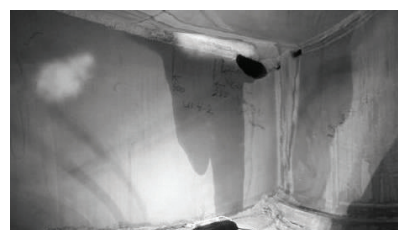
Examples of damages that occurred at parent material of components of breeches pipes 1A, 7A, 8A i 8B detected by

Figure 6. Appearance of characteristic damages that occurred at parent material and weld metal of breeches pipe 1A

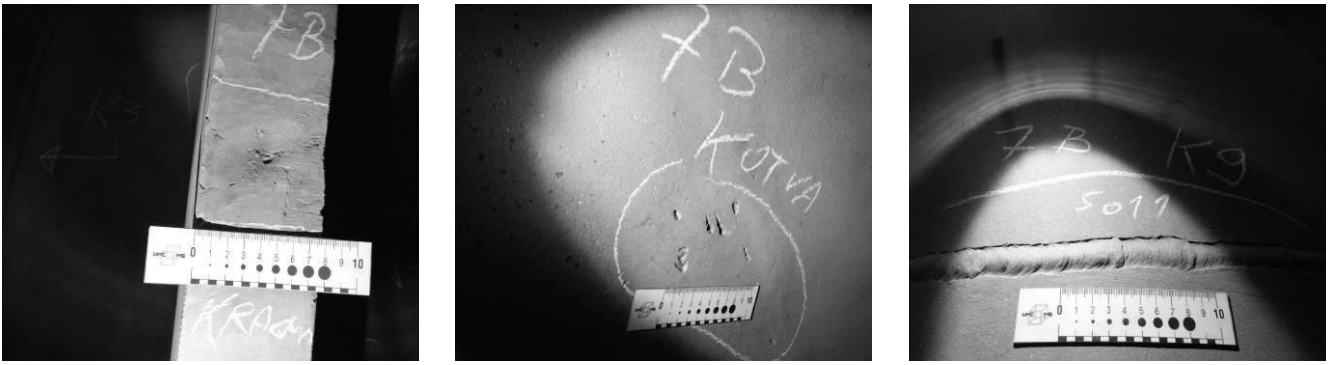
a) Characteristic damages that occur at parent material of the collar and the anchor

b) Characteristic damages that occur at weld metal

**Figure 7.** Appearance of damages that occur at parent material and weld metal of the collar and the anchor of the breeches pipe 7B

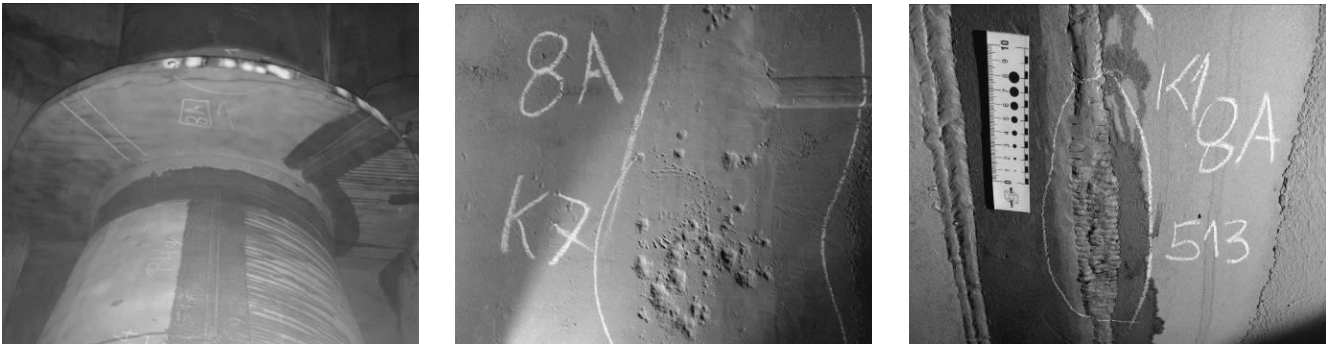
a) Characteristic damages that occur at parent material of the collar and the anchor

b) Characteristic damages that occur at weld metal

**Figure 8.** Appearance of damages that occurred at parent material and weld metal of the collar and the anchor of the breeches pipe 8A

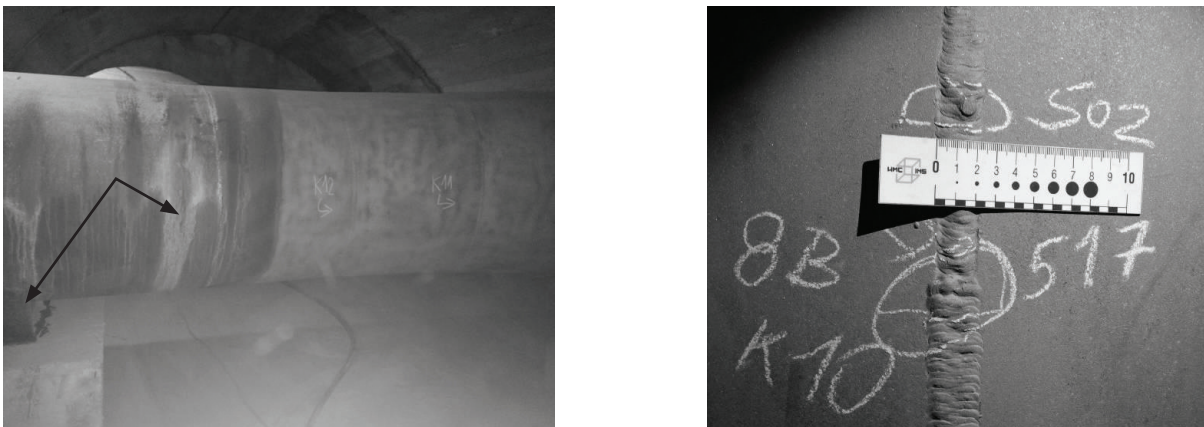
visual testing [3] are presented in figures 6-8, while examples of damages that occurred at parent material and weld metal of breeches pipes detected through the application of magnetic particle testing [4] are presented in figure 9. By ultrasonic testing [5] it was determined that cracks, presented in figures 10, 11 and 12, are 13 – 32 mm deep when it comes to parent material and 25 - 52 mm when it comes to weld metal at structural components of breeches pipes.

a) Characteristic damages that occur at parent material of the collar and the anchor

b) Characteristic damages that occur at weld metal

**Figure 9.** Appearance of damages that occurred at parent material and weld metal of the collar and the anchor of the breeches pipe 8B

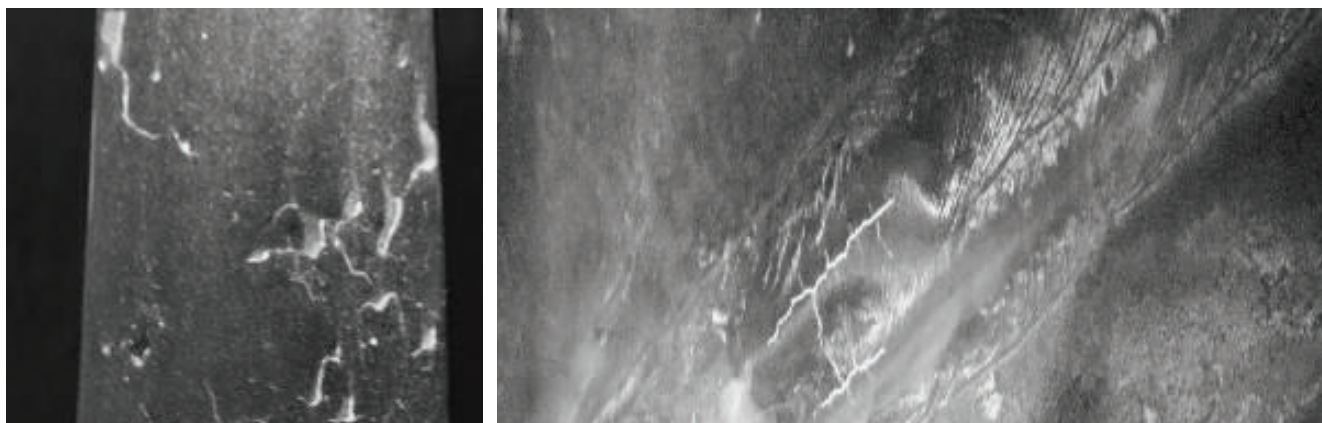
Figure 10. Characteristic damages that occurred in the area of parent material and weld metal of components of breeches pipes 1A, 7A, 8A and 8B

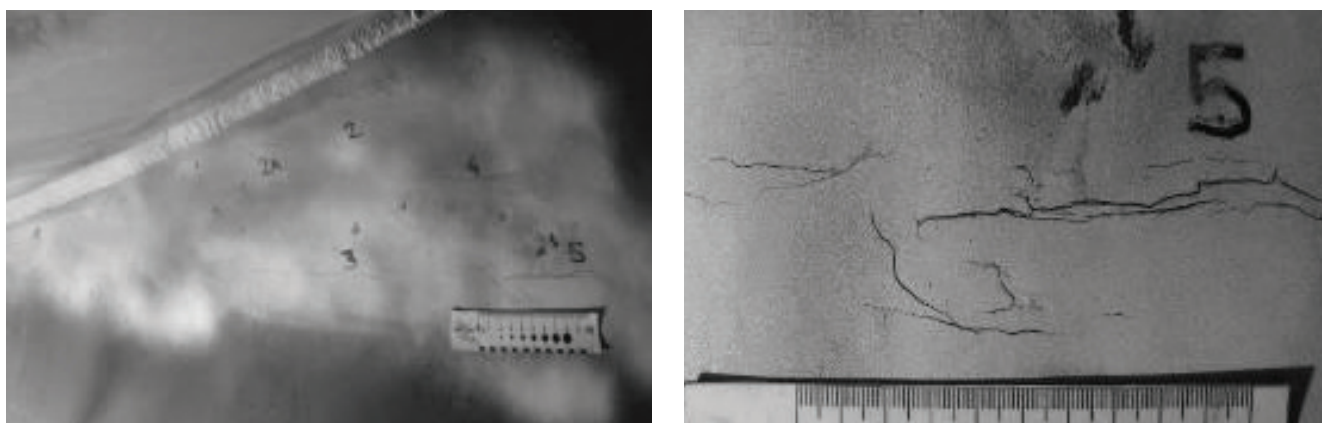
Figure 11. Characteristic examples of cracks detected at parent material of components of breeches pipes 1A, 7A, 8A and 8B

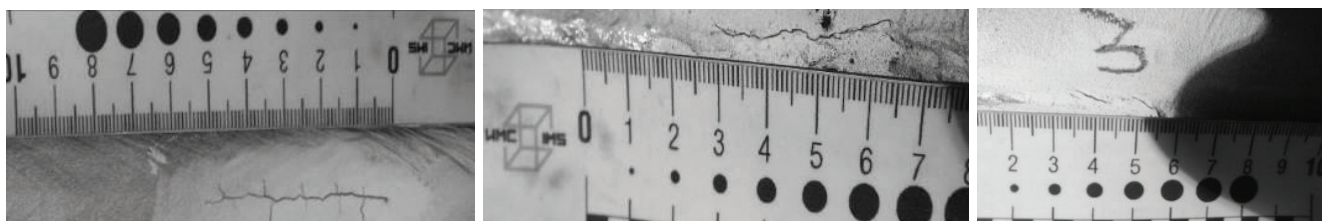
a) Cracks at the surface of weld metal

b) A crack in the heat affected zone

c) A crack in parent material

Figure 12. Appearance of characteristic damages that occurred at the surface of parent material, heat affected zone and weld metal of breeches pipes 1A, 7A, 8A and 8B
