Repair of Damages that Occurred on the Welded Joints at the Body of Guide Vane Apparatus Vanes of the Vertical Kaplan Turbine

Abstract. Vertical Kaplan turbines, with nominal power of 178 MW and manufactured in Russia, have been installed in 6 hydroelectric generating units of hydro power plant 'Djerdap 1'. Experimental tests were carried out by non-destructive methods in order to determine the turbine condition during the rehabilitation of the hydro power plant. Lack of root penetration was detected in V40 welded joints between upper and lower sleeves and bodies of guide vane apparatus vanes. Height of the lack of root penetration was in the range between 5 and 15 mm, while the allowable height of the lack of root penetration is 3 mm, according to the technical conditions. The upper sleeves were made of cast steel 25L (in accordance with GOST 977), while lower sleeves were made of steel forging St 25 (in accordance with standards GOST 1050 for chemical composition and GOST 8479 for forgings). Methodology for the repair of non-penetrated welded joints between the sleeves and body of the guide vane apparatus vane was composed taking into account the results of ultrasonic testing. B

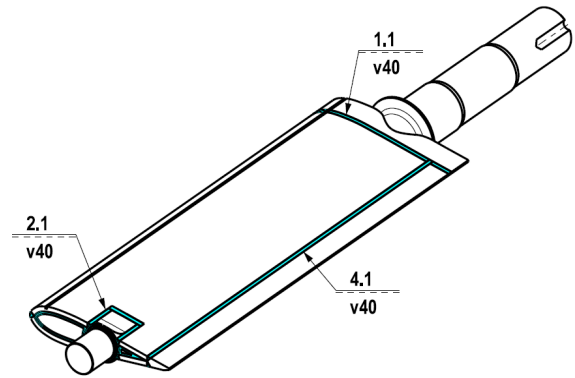
Fig. 2 Appearance of a guide vane apparatus vane with marked V40 welded joints

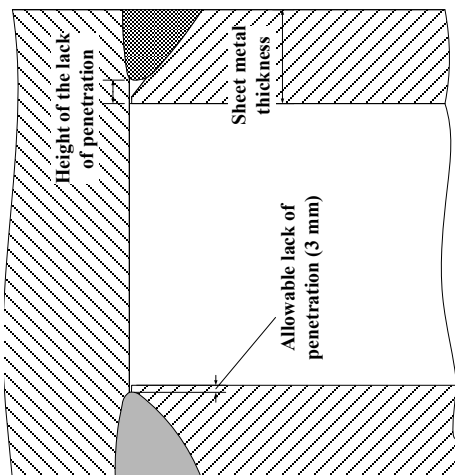
Removal of non-penetrated areas in welded joints. Appearance of a non-penetrated area in welded joint V40 is shown in Fig. 3. Grinding of the section with lowered weld metal thickness should be carried out until reaching the depth which allows easier welding of 2-2.5 mm of sheet metal thickness in root area. Multiple openings with 3 mm in diameter should be drilled in order to check this measure, Fig. 4-6. Length of the section which is being repaired is restricted to 200 mm in one passage in order to reduce the level of deformations. When it comes to longer sections, the repair should be carried out in several passages. Grinded spots should not have sharp edges and should enable accessibility for deposition of layers by welding. Grinded area should be degreased, dry and clean.

Fig. 3 Welded joints with the lack of root penetration at the side of the upper sleeve

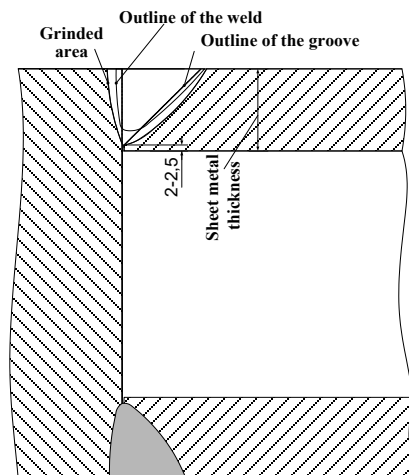
Fig. 4 Appearance of the grinded area at the side of the upper sleeve

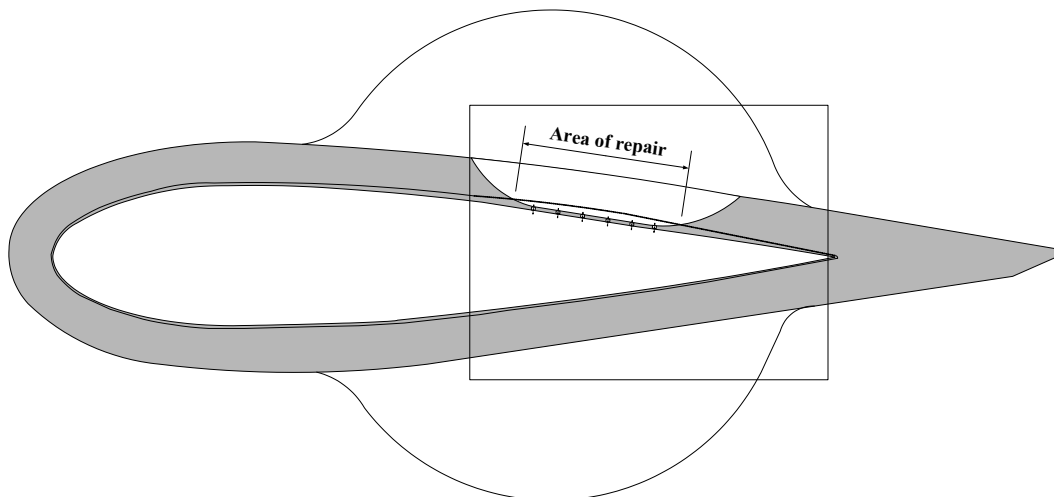
Fig. 5 Repair of sections with the lack of root penetration shorter than 200 mm

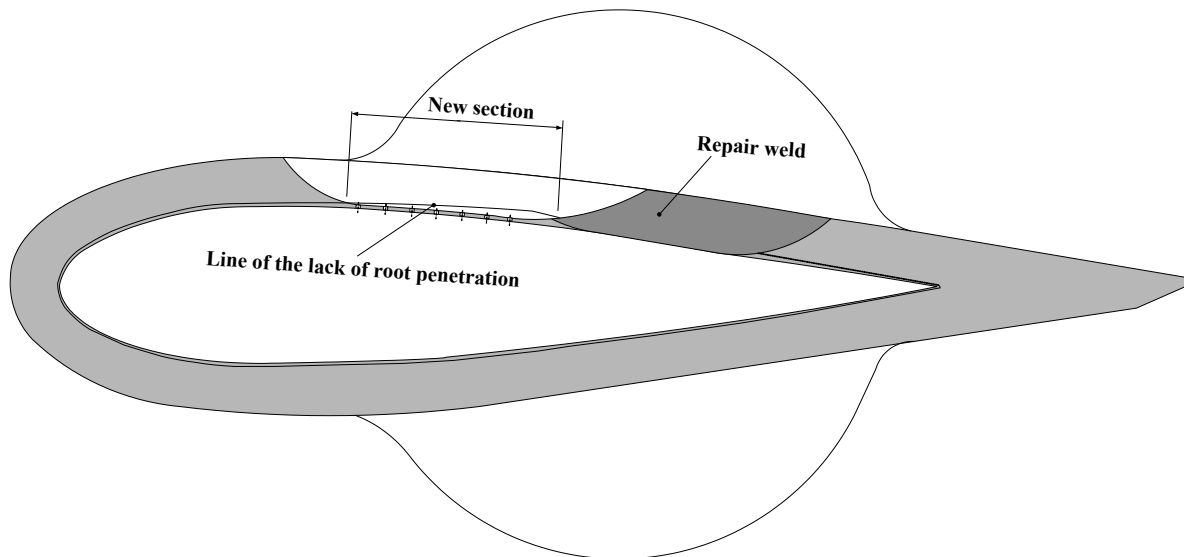
Fig. 6 Repair of sections with the lack of root penetration longer than 200 mm

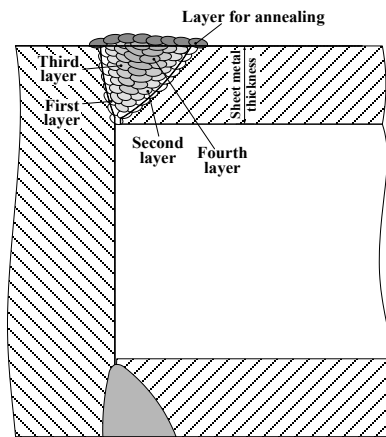
Fig. 7 Appearance of the order of deposition of weld beads along the cross-section

- During the deposition of weld beads system that included overlaying of groove edges, with the finish layer for annealing, which was removed by grinding the face of the weld in order to even it with parent material (Fig. 7) was applied;
- Every layer was treated by pneumatic hammer with rounded top with diameter of 3 mm;
- After grinding was performed wide area (weld metal, heat affected zone and 10 mm of parent material on every side) of the repair weld was treated by pneumatic hammer with rounded top with diameter of 3-5 mm, during which overlapping of prints was required. After hammering the surface had to be polished.

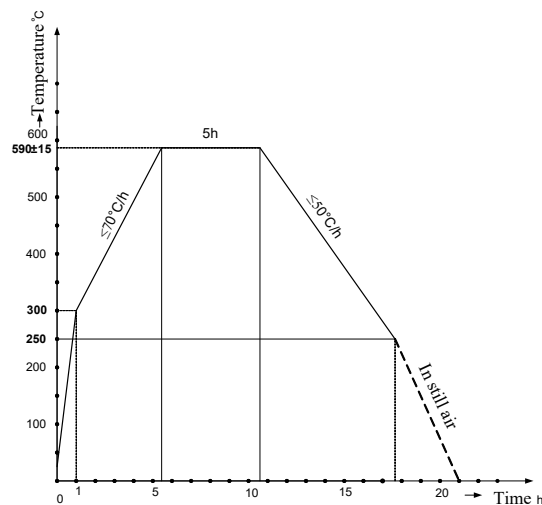
Fig. 8 Diagram that refers to heat treatment of repair welds of guide vane apparatus vanes

Applied parameters that refer to heat treatment, shown in Fig. 8, are as follows:

- Heating until reaching $T = 300^\circ\text{C} \pm 25^\circ\text{C}$ was carried out in 1 hour;
- Heating until reaching $T = 590 \pm 15^\circ\text{C}$ was carried out with rate less than 70°C/h ;
- Keeping the temperature at $590 \pm 15^\circ\text{C}$ was carried out in 5h;
- Cooling until reaching 250°C was carried out with rate less than 50°C/h ;
- Cooling below 250°C in still air.
