# Energija

List Saveza energetičara  
1-2 / Godina XIX / Mart 2017.  
UDC 620.9

Miodrag ARSIĆ, Mladen MLADENOVIĆ, Zoran SAVIĆ

# State Analysis of the Upper Ring of Guide Vane Apparatus at Hydro Power Plant Djerdap 1 Carried out on the Basis of Non Destructive Tests

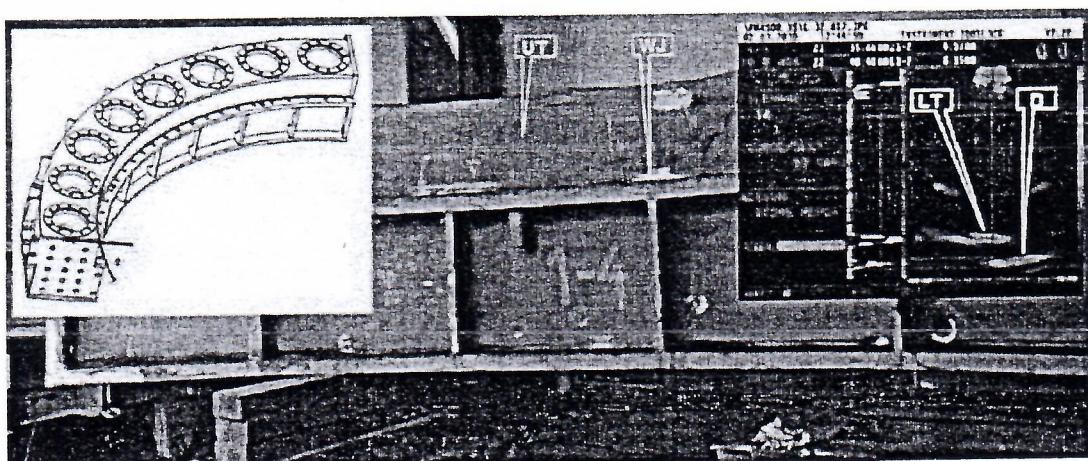
Segment 4-1 of the upper ring of guide vane apparatus, at which lack of root penetration and lamellar tearing were detected, is presented in *Figure 3*. La-

mellar tearing caused pulling of the 40 mm thick sheet metal in the area of fusion of parent material and filler material. Representative echographs that were taken during the ultrasonic test carried out on segment 4-1 are presented in *Figure 4*.

Figure 3. - Appearance of segment 4-1 of the upper ring of guide vane apparatus

- extent, type and form of impurities that occur during steel manufacture,
- residual stresses that occur due to welding and stresses in the direction of sheet metal thickness due to assembly,
- hard structures that occur due to application of inadequate welding technology and proneness to cold cracking.

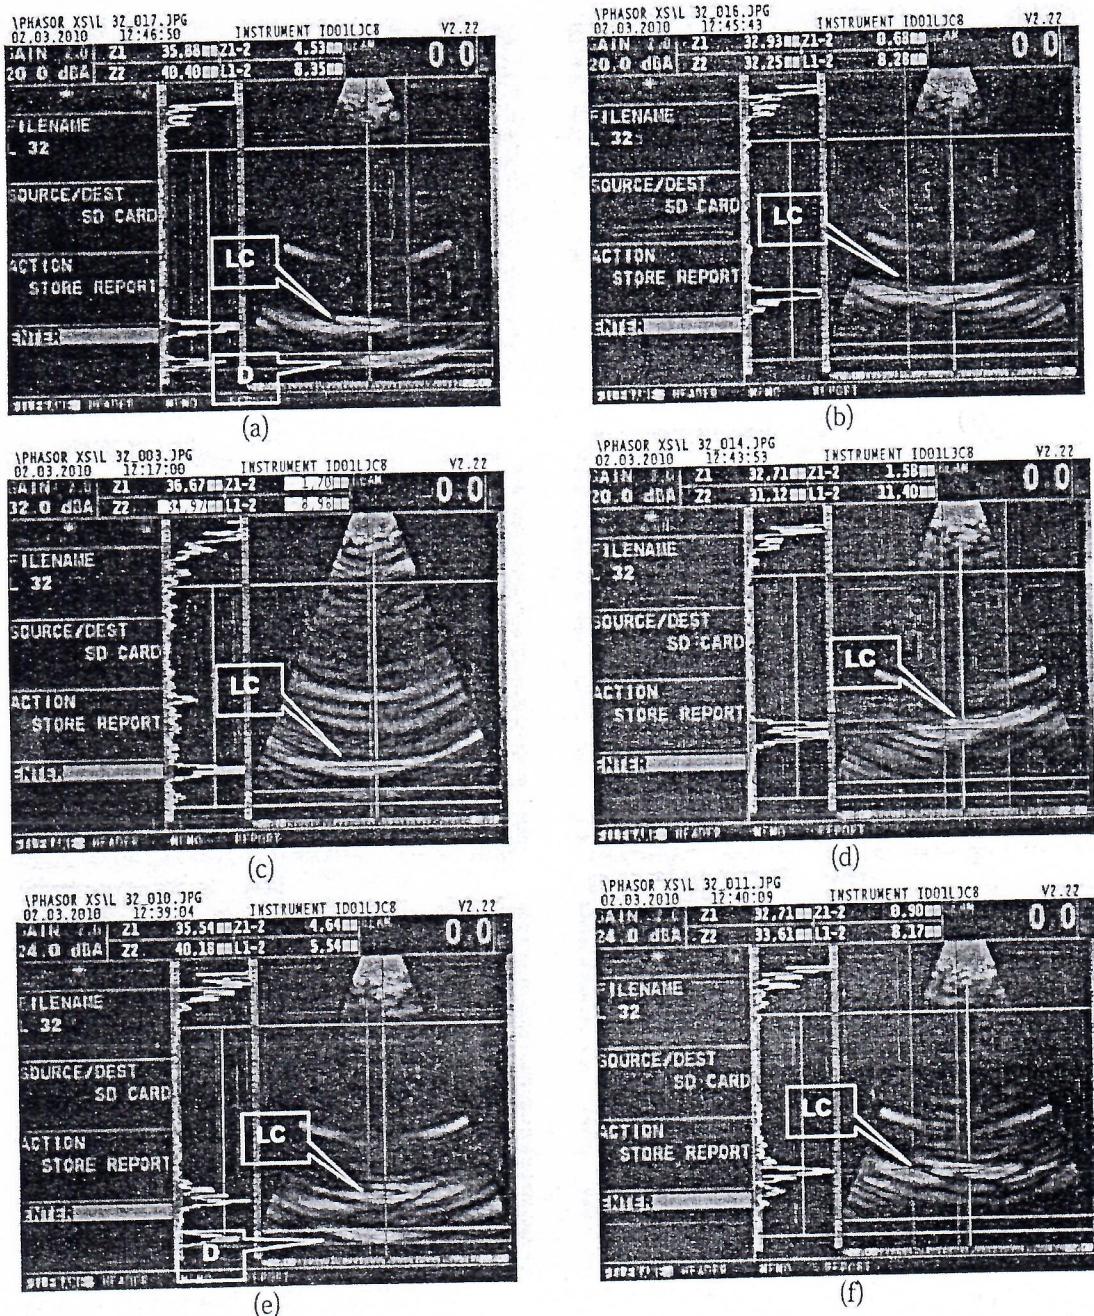
D – indication that refers to the lack of root penetration; LC – indication that refers to lamellar tearing in the root area of the welded joint; Z1 and Z2 – depth of indication measured from the surface; Z-Z2 – distance between indications, depthwise; L1-L2 – distance between indications, projection-wise.

Figure 4. - Appearance of representative echographs
