List Saveza energetičara
Broj 1-2 / Godina XVIII / Mart 2016.
UDC 620.9

Miodrag Arsić, Zoran Savić
 Institute for materials testing, Belgrade, Serbia
 Srđan Bošnjak, Vlada Gašić
 Faculty of Mechanical Engineering, Belgrade, Serbia
 Dušan Arsić
 Faculty of Engineering, Kragujevac, Serbia

State Analysis of Components of the Damaged Structure and Integrity Evaluation of Braces at the Spreader A2Rs - B 5500.55 + BRs

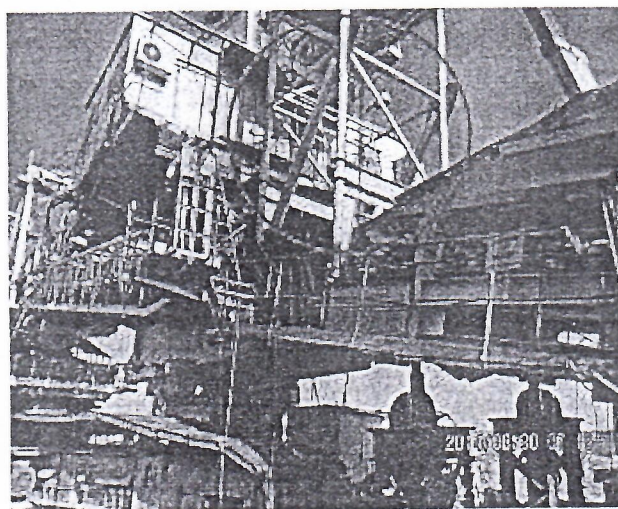
Figure 1.- Appearance of the spreader A2Rs - B 5500.55 + BRs before and after the breakdown

Spreader A2Rs - B 5500.55 + BRs before and after the breakdown is shown in *figure 1*. Breakdown of components of the vital lattice structure which occurred due to the uncontrollable sliding of the machine during the tempest which needed to be made from scratch is marked in *figure 1b* and shown in *figure 2*, while the state of braces in assembled condition is shown in *figure 3*. Some of the braces at which no damage was detected are shown in *figures 4a* and *4b*, while one of them at which the surface crack was detected on parent material, in the near proximity of the welded joint, is shown in *figure 4c*.

b) Appearance of the spreader after the breakdown

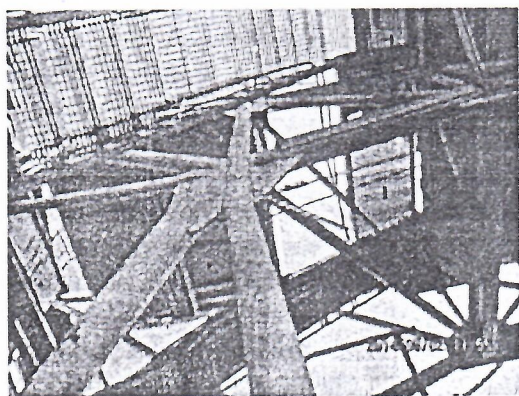
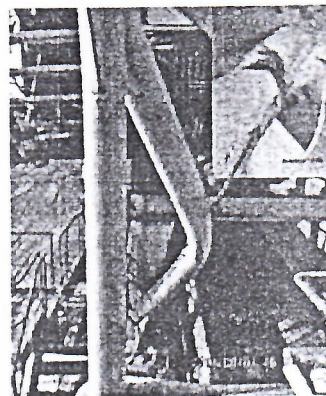
Figure 2.- Appearance of parts of the vital steel structure which needed to be made from scratch

a) Appearance of parts of the damaged vital steel structure

b) Appearance of a part of the damaged vital steel structure

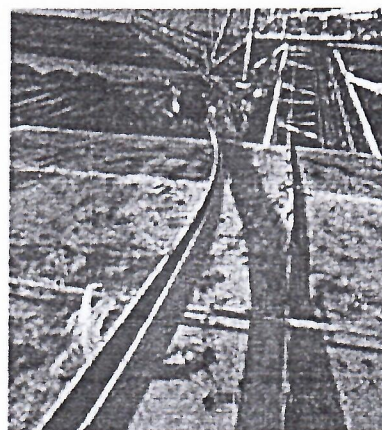
Figure 3.- Appearance of the condition of vital braces of spreader A2Rs - B 5500.55 + BRs before and after the breakdown

a) Appearance of the spreader after the breakdown

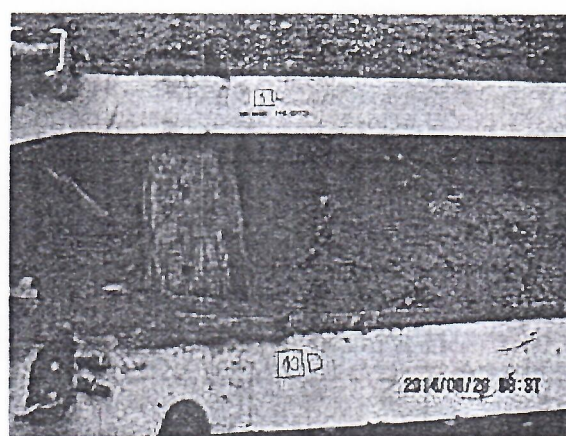
Figure 4.- Appearance of the condition of a number of braces after the breakdown

c) Right brace (10 D) with a surface crack

By visual testing [4] surface crack was detected at parent material of one of the braces of the discharge boom, in the near proximity of the butt-welded joint, which was confirmed by penetrant testing, *figure 4c*.

On the basis of the analysis of results of performed tests it was determined that the integrity of a brace at which the surface crack was detected is not threatened, which could be said about the spreader as a whole after the installation of the new segment of steel structure, figure 6.

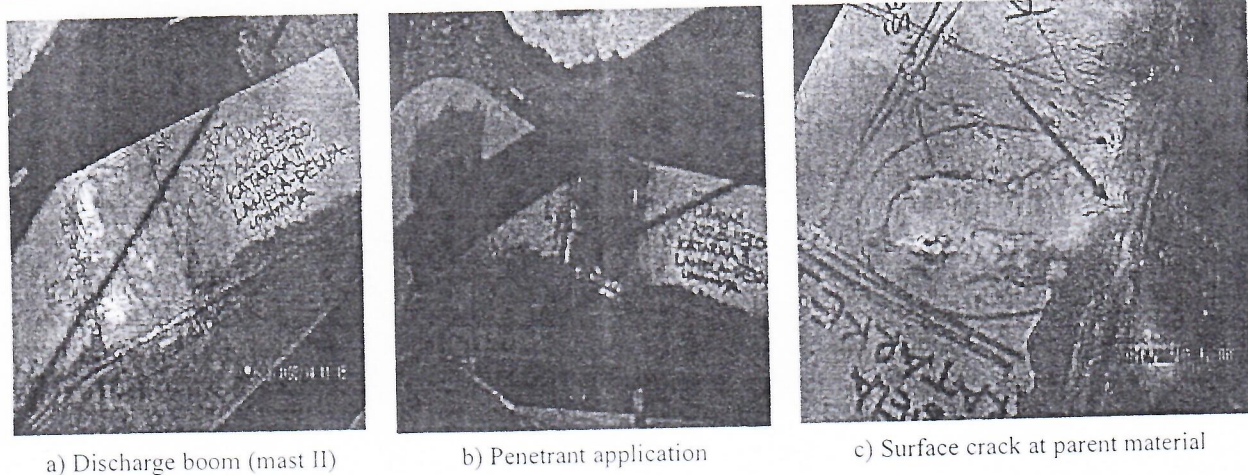
Figure 5.- Appearance of the process of penetrant testing

Results of a penetrant test [5], performed at parent material of one of the braces of the discharge boom, in the near proximity of the butt-welded joint, which was also subjected to the test, are shown in *figure 5*. The crack was approximately 1 mm deep and was removed by fine grinding. Report nr. PT – 025/14 [6].
