REPAIR OF DAMAGED SURFACES AT THE VITAL SECTION OF THE REGULATORY MECHANISM OF THE HYDRO TURBINE GUIDE VANE APPARATUS

Miodrag Arsić*, Srđan Bošnjak**, Vencislav Grabulov*, Brane Vistić*, Zoran Savić*

Vertical Kaplan turbines were installed in 6 hydroelectric generating sets at "Djerdap 1", nominal power 178 MW, that were made in Russia. During the refurbishment of the hydroelectric generating set A1 at the hydro power plant Djerdap 1, experimental non-destructive tests on all of its components were performed in order to determine the state of the turbine as a whole. During the testing the damages and cracks were detected on internal surfaces of cranks and sleeves of guide vane apparatus vanes, which were caused by turbine shaft vibrations. Cranks and sleeves were made of cast steel 25L, in accordance with the standard GOST 977.

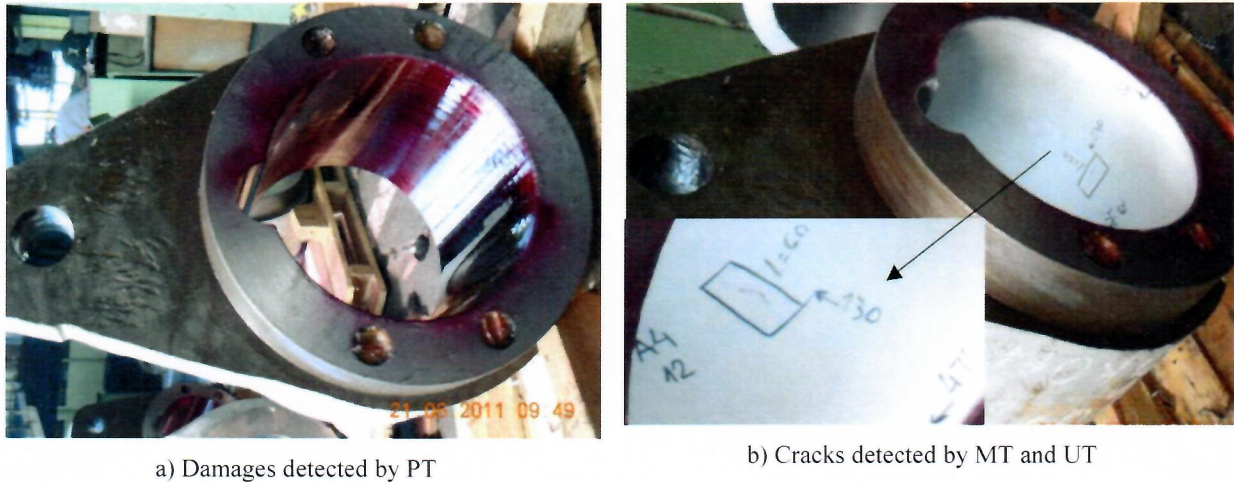
Fig. 4 Appearance of defects positioned along the circumference of the internal area and semi-opening

This technology refers to the activities performed during the repair of cranks and sleeves, on which it was necessary to grind out linear indications and perform welding/surface welding on the internal surfaces of crank hubs, as well as on the surfaces of sleeves.

The first step was to eliminate detected cracks by grinding. Visual testing and magnetic particle testing (or dye-penetrant testing) were performed continuously during their elimination. After the grinding, the preparation of grooves was performed, and finally welding/surface welding was carried out, Fig 5.

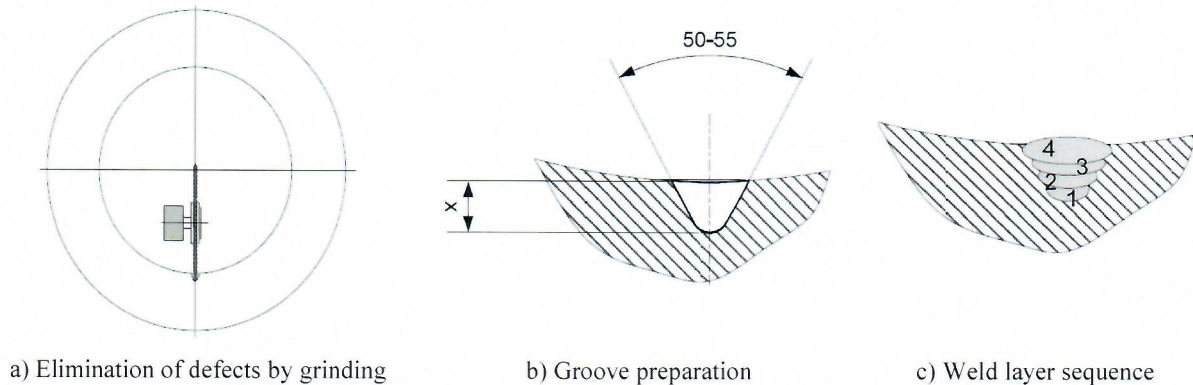
Fig. 5 Elimination of defects, groove preparation and welding process

Based on parameters that influence the selection of welding procedure (weldability of base material, energetic characteristics of the welding procedure, geometric complexity of the structure, comparative economic analysis), welding was carried out through the use of the coated electrode EVB 50 (Elektrode Jesenice d.o.o.) and utilization of procedure 111. Preheating to 150°C was performed through the use of induction heaters, as suggested in russian literature. Preheating temperature inspection was performed by IC thermometers, [4].

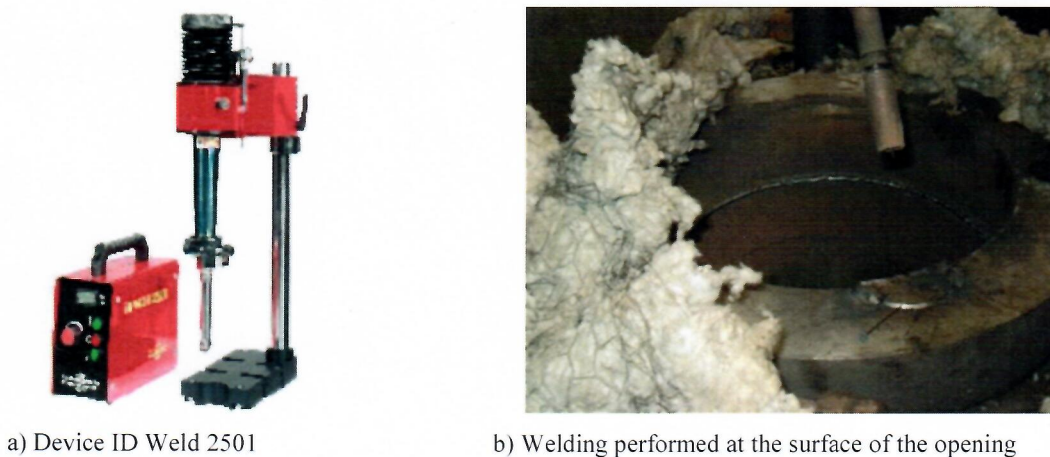
Fig. 5 Device for welding at the surface of the opening (ID Weld 2501)

Surface welding was performed through the use of ID WELD 2501 device on internal surfaces of crank hubs and utilization of procedure 131, by TIG Mo wire, 1.2 mm in diameter (Elektrode Jesenice d.o.o.) according to standard EN 1668 [5], and with the use of protection gas M21 according to standard EN 439 [6], Fig. 6.

The repairing of defects that occurred on the semi-opening for the two-part wedge has been performed using the same device and TIG Mo wire, 2.5 mm in diameter, figure 2. In order to achieve the continuity of the surface during the welding, 5 mm thick plates were temporarily attached, and afterwards grinded away.

- number of revolutions during surface welding: 0.5-1 r/min,
- surface welding: continuous, I = 200 A,
- current source: any standard source for MIG/MAG welding process,
- voltage: U = 20 – 30 V,
- flux of the protection gas: 10 – 20 l/min.

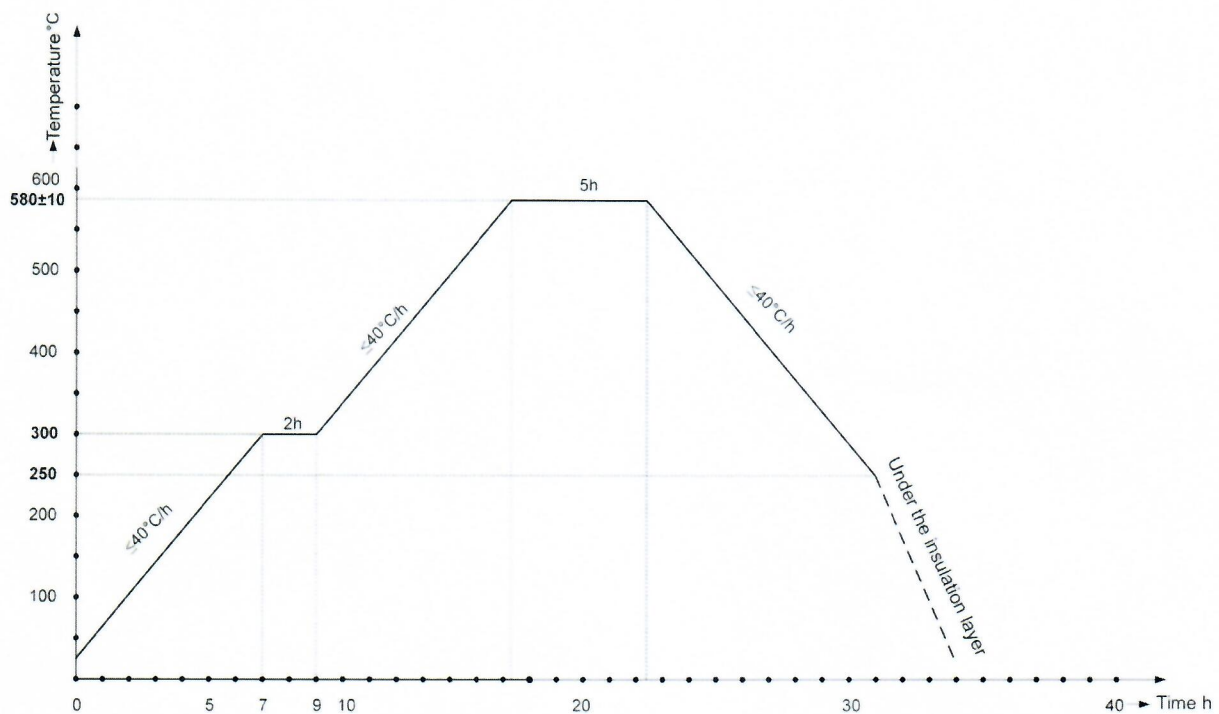
Fig. 6 Heat treatment diagram

In order to reduce the level of residual stresses and eliminate the possibility of occurrence of deformations after welding/repair welding and finish machining, cranks have been heat-treated through the use of technology with the following parameters [4]:

- heating rate max 40 °C/h until reaching the temperature of 300 °C,
- 2h holding time at the reached temperature of 300 °C,
- continuation of heating at the heating rate of 40 °C/h until reaching the temperature of 580 ± 10 °C, prescribed
- not less than 5h holding time at the reached temperature of 580 ± 10 °C, time starts counting when the temperature is reached at all thermometers in the furnace,
- cooling rate not higher than 40 °C/h until reaching the temperature of 250 °C, further cooling under the isolation layer.
