Weld Geometry Defect Influence on Boiler Tube Structural Integrity

WELD GEOMETRY DEFECT INFLUENCE ON BOILER TUBE STRUCTURAL INTEGRITY

Djukic M. ¹, Sijacki Zeravcic V. ¹, Bakic G. ¹, Rajcic B. ¹, Andjelic B. ²

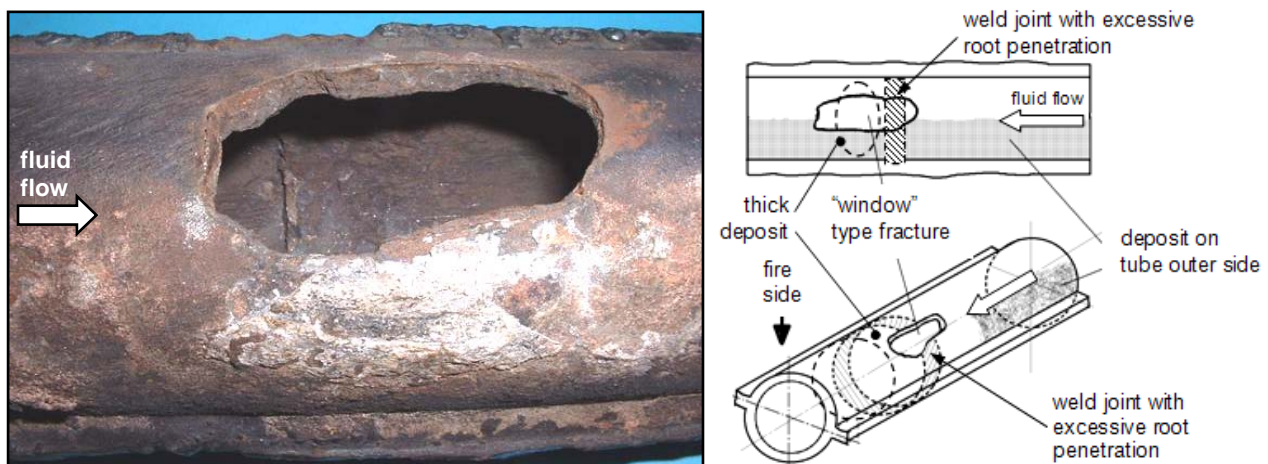
"Window" type thick-edge fracture was observed on tube fireside. The outer surface of the specimens exhibited a general corrosion condition. Thick coarse and hard deposit was visible on inner surface of tube fireside, especially downstream of the welded joint. It is also observed that weld joint in the damaged zone have poor weld overlay in the form of excessive root penetration, Figure 1.

Figure 1 – Macro photo of "window" type fracture with schematic view of the specimen

The results obtained for chemical composition of tube metal are satisfactory. Mechanical characteristics indicated a noticeable embrittlement of material. Yield strength of $R_{0,2}=403$ MPa was significantly higher than minimal designed value, $R_{0,2min}=216$ MPa, and it is close to the minimum value of standard tensile strength of $R_m=420$ MPa. Tensile strength was $R_m=481$ MPa while deformation characteristic, expressed by elongation, $A_5=13.2\%$, was much lower than recommended ($A_{min}=24\%$) which is an indication of a significant increase of the material embrittlement. The hardness values in the range of 155-184HV are higher than 145HV that is generally considered as the upper limit for steel St. 20 in normalized state. The obtained hardness level is in agreement with the tensile test results.

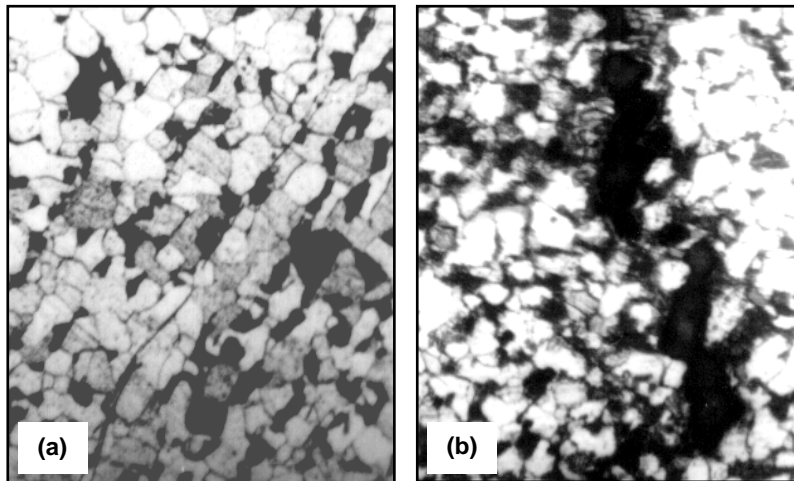
Microstructure in the middle of the sample cross sections was ferrite-pearlite, with the presence of completely degraded pearlite. Also, a distinctly banded structure with non-homogenous distribution of very fine elongated MnS inclusion was visible, Figure 2(a). Due to a complete decarburization, the microstructure was pure ferrite, with macro crack along the boundaries and many discontinuous intergranular micro cracks, closer to the inner side, Figure 2(b). Observed decarburization as well as the degradation of pearlite microconstituent indicate that the hydrogen penetration occurred through the tube wall. Many discontinuous, intergranular cracks and fissures are the result of great pressure effect of methane molecules or molecular hydrogen precipitated along the ferrite grain boundaries.

Figure 2 – Microstructure of the investigated samples
(a) Middle section: Ferrite – pearlite, banded structure, MnS inclusions, 200x
(b) Middle section near inner side: Ferrite, decarburization, intergranular cracks, 200x

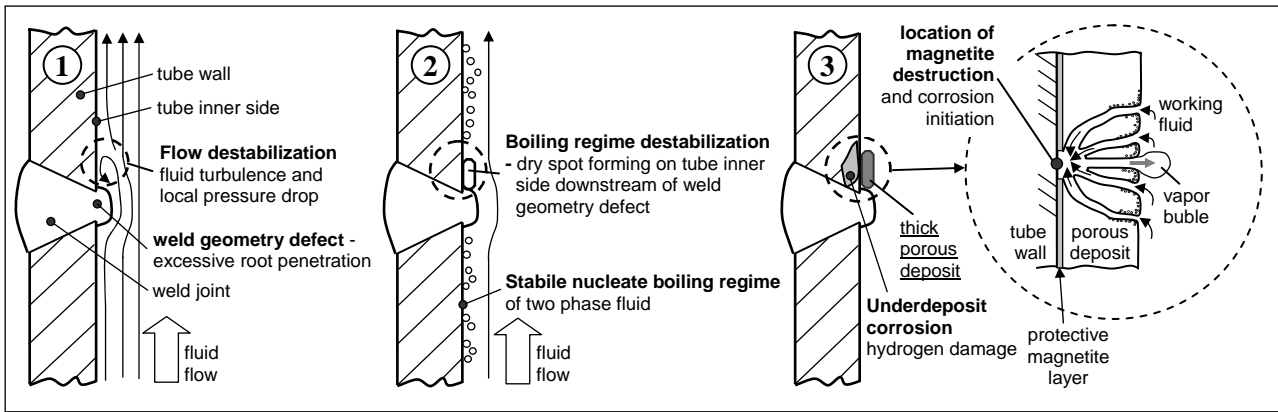
Visually observed joint with excessive root penetration (max. height 1.2mm) act as local flow disrupter which caused flow destabilization in boundary layer: local turbulence and pressure drop, Figure 3-1 [10]. Departure from boiler fluid flow and boiling regime conditions adjacent to the tube wall can be provoked locally by many different factors at lower heat fluxes than critical heat flux. Figure 3 is a schematic representation of how this process occurred in this particular case. This type of hydrodynamic perturbation in boundary layer initiated flow-assisted corrosion mechanism and local dissolution of protective metal oxide-magnetite layer. The local flow disrupter also cause the stable nucleate boiling process to be disrupted and a dry spot, in the form of local steam blanket or bubble, is formed on tube inner side downstream of the weld joint, Figure 3-2. This local area is intermittently dried and then rinsed, and it may be at a slightly higher temperature than the surrounding area which is cooled by the flowing water. Intermittent formation of the dry patches at the tube inner surface provokes the periodical changes of the heat transfer coefficient and the wall temperature oscillations. This, and also fluid turbulence and pressure drop caused the increase in the concentrations of acid/base suspended solids within the boundary layer magnetite-fluid. This process will cause dissolved or suspended solids to begin to be deposited just downstream of the flow disruption and on the hot side of the tube, Figure 3-3. In thick porous deposit, process of wick boiling of fluid further increased the concentration of acid components within the boundary layer defective magnetite-porous deposit due to hydrolysis of salts and tube metal thermal cycling. In deposit area, local pH value drops significantly due to concentration of acidic contaminant. At the sites of local destruction of magnetite resulting from the flow-assisted corrosion, thermal cycling and its chemical decomposition during reaction with the hydrolysis products [12], hydrogen is formed during steam-water corrosion of metal. The so-formed hydrogen easily diffused into the tube surface layer causing the hydrogen attack according to a well defined mechanism [8, 10-15].

Figure 3 – Hydrogen damage mechanism of boiler water wall tube in the vicinity of weld with excessive root penetration

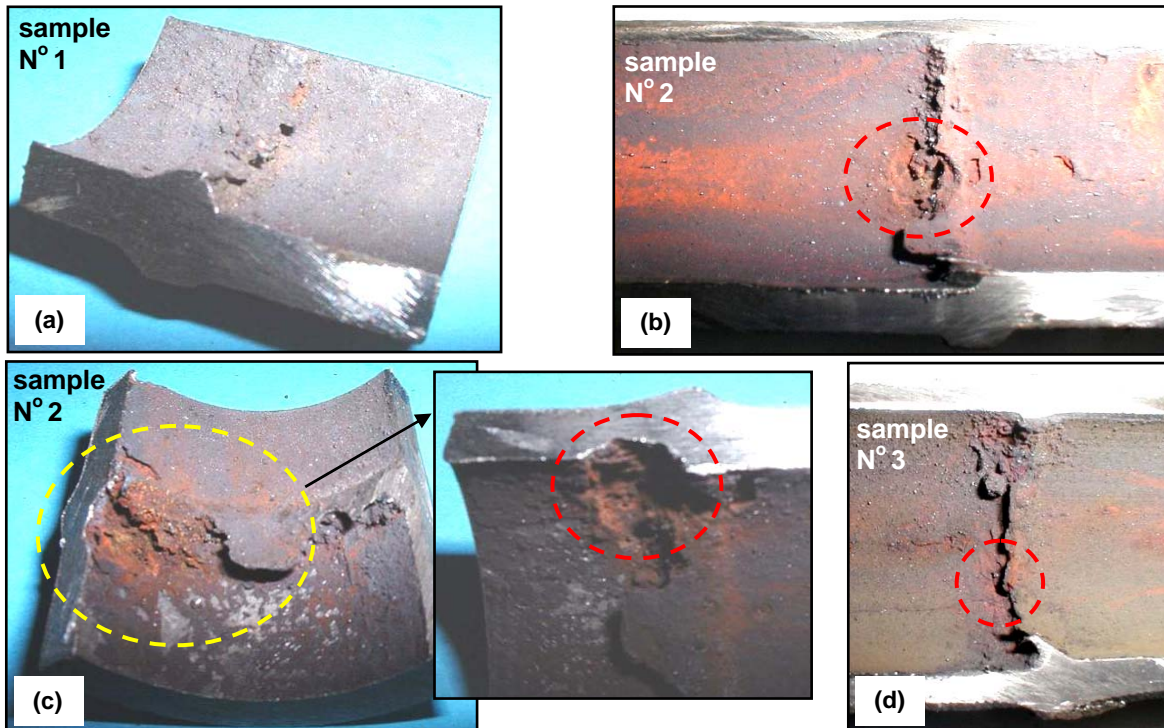
Figure 4(a)-(c) – Macro photo of tube weld defects, "direct" and "indirect" damages

- Weld joint with excessive weld reinforcement with max. height up to 1.8mm and excessive root penetration with max. height up to 2.0mm and also deposit precipitated downstream of the defect on samples N° 1 and 2, Figure 4(a) and 4(b)
- Weld joints with multiple defects: excessive root penetration and mismatch (misalignment) on samples N° 2 and 3, Figure 4(b)-(d)
- Corrosion damages of tube metal and on weld joint downstream and in the vicinity of defective welds on sample N° 2 and 3, marked with red circle dashed lines on Figure 4(b)-(d)
- Burnthrough resulting in "icicles" on the weld root on sample N° 3, Figure 4(d)

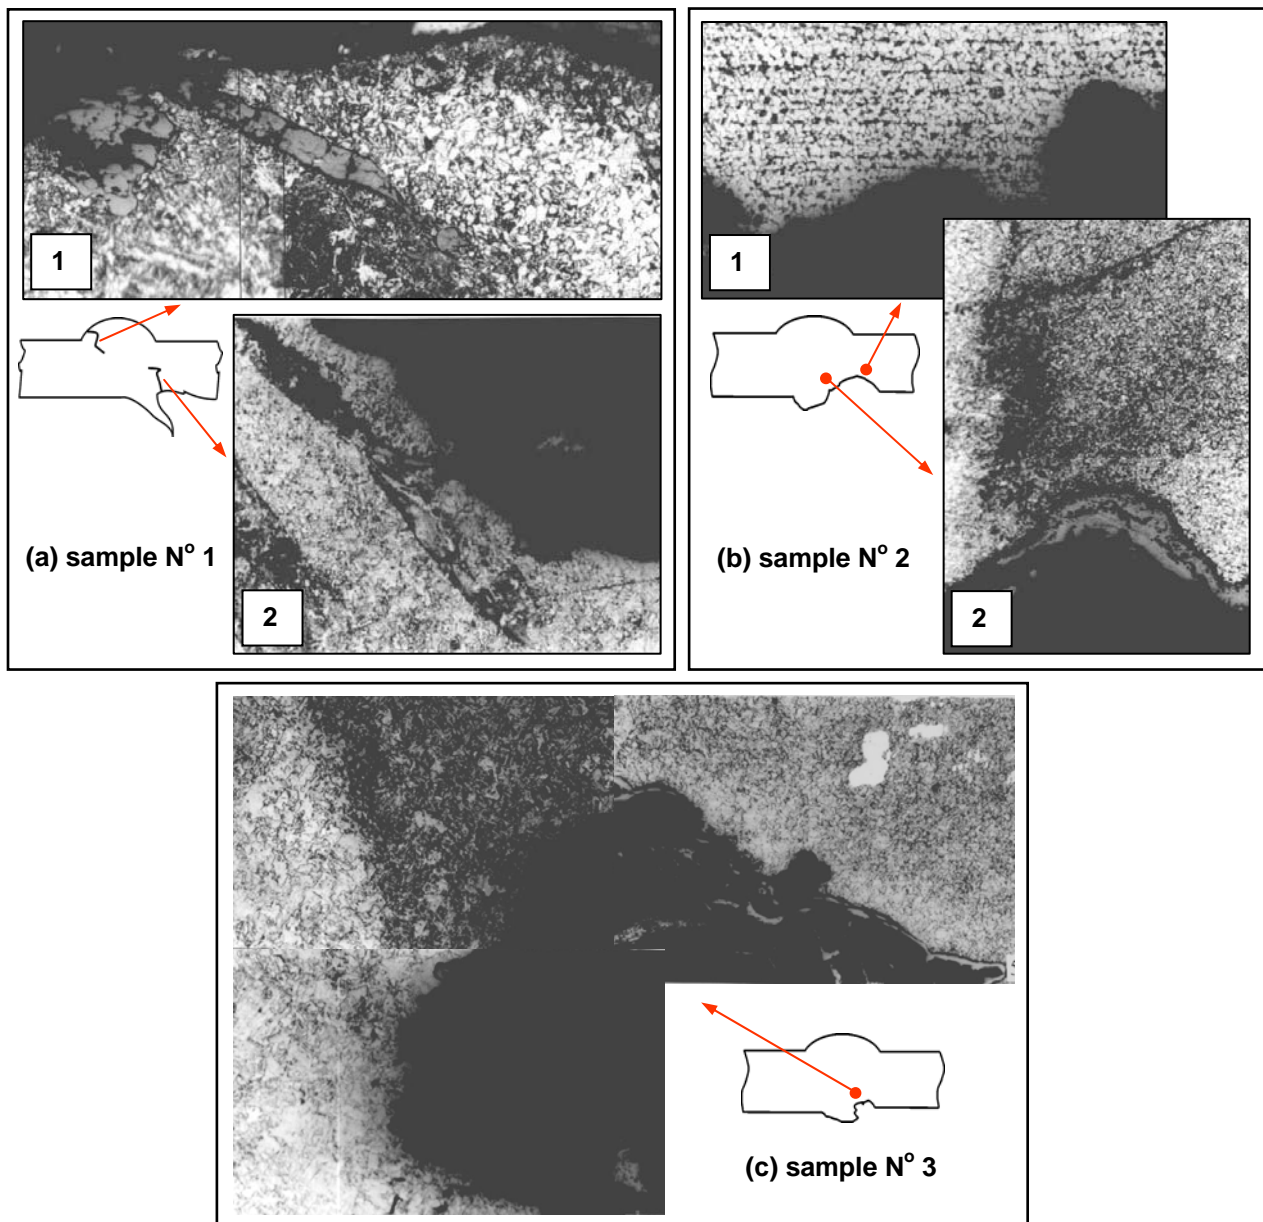
Figure 5 – Microstructure of the investigated samples

- (a) 1 – Weld metal: Fatigue crack, 200x; 2 – Weld metal: Corrosion-fatigue crack, 50x
 (b) 1 – Base metal: Corrosion pits, 50x; 2 – Weld metal: Corrosion pit, deposit, crack, 100x
 (c) Weld fusion zone: Large corrosion pit, deposit, 50x

- "Direct" failures and damages
 - 1) Weld metal fatigue cracks and corrosion-fatigue cracks on the face of weld with excessive reinforcement, Figure 5(a)-1 and in the area of excessive root penetration, Figure 5(a)-2
 - 2) Underdeposit corrosion pits in the weld metal of improper weld with multiple root defects: excessive root penetration and mismatch (misalignment), Figure 5(b)-2
 - 3) Corrosion – fatigue cracks at the bottom of large corrosion pits filled with porous deposits in the weld base metal, Figure 5(b)-2 and in the weld fusion zone, Figure 5(c)
- "Indirect" damages
 - 1) Area with numerous linked corrosion pits in the base metal downstream of butt weld with multiple root defects: excessive penetration and mismatch (misalignment), Figure 5(b)-1

Breakdown or cracking of the magnetite necessary for initiation of oxygen attack is largely due to mechanical and thermal stress induced in the vicinity of weld root with excessive penetration which act as a strong local stress riser. Oxygen pit also act as stress concentration sites, thereby fostering the development of corrosion-fatigue cracks during boiler operation.
