# The Design – in Faults as a Causes of the High Performance Machines Failures

<sup>1</sup>University in Belgrade - Faculty of Mechanical Engineering

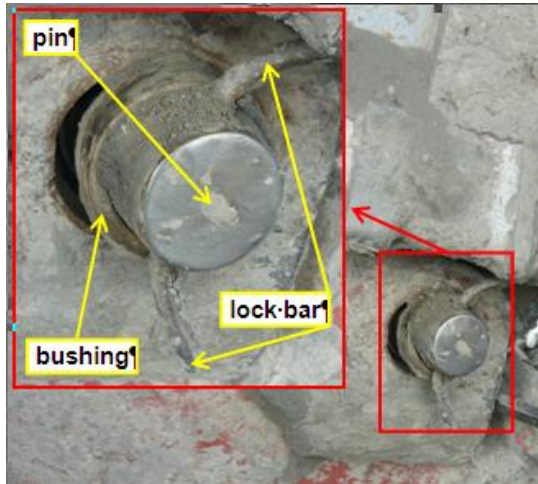
- Damages of the pins and bushing of the bucket eyes, Fig. 4;
- Damages and plastic deformations of the bucket wheel front supporting eyes, Fig. 5;
- Plastic deformations of the bucket wheel rear supporting eyes, Fig. 6;
- Bucket "opening" in the rear support zone, Fig. 6.

Fig. 4. Pushed out bushing of the front bucket eye

In order to eliminate the presented drawbacks, it was necessary to redesign the bucket supporting zones, Figs. 7-10.

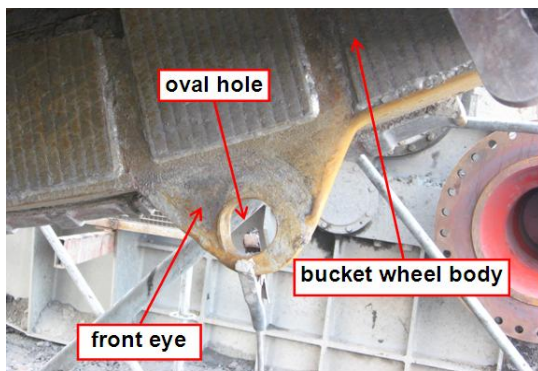
Fig. 5. Plastic deformations of the front bucket wheel eye

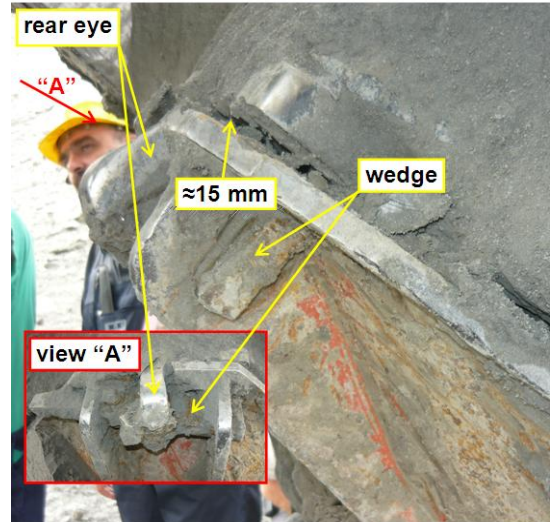
Fig. 6. Plastic deformations of the rear support eye and bucket "opening" in the rear support zone

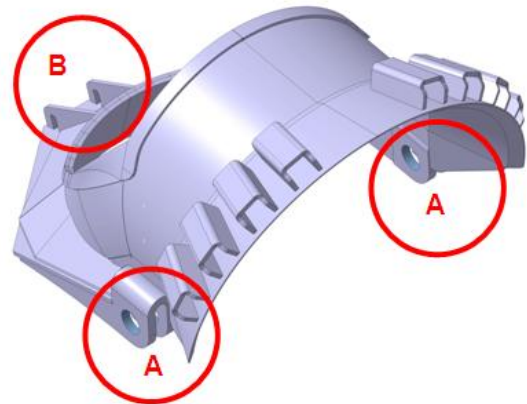
Fig. 7. 3D model of the original bucket: zones of redesign

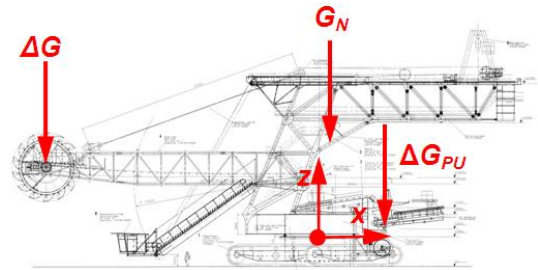
So, the increase of the redesigned buckets' weight cause the change of the center of gravity location. For horizontal position of the bucket wheel boom shifting of the center of gravity is

$$x_{GN} - x_{GN}^* = 0.449 - 0.424 = 0.025 \text{ m} \quad (1)$$

which is allowable.

Fig. 11. Scheme for calculation of the center of gravity location after buckets redesign (superstructure weight  $G_S = 7705.3$  kN,  $x_{GN} = 0.449$  m; part of conveyor weight  $\Delta G_C = 450$  kN,  $x_{\Delta G_C} = 7.95$  m; total weight increase  $\Delta G = 6.1$  kN,  $x_{\Delta G} = -33.083$  m)

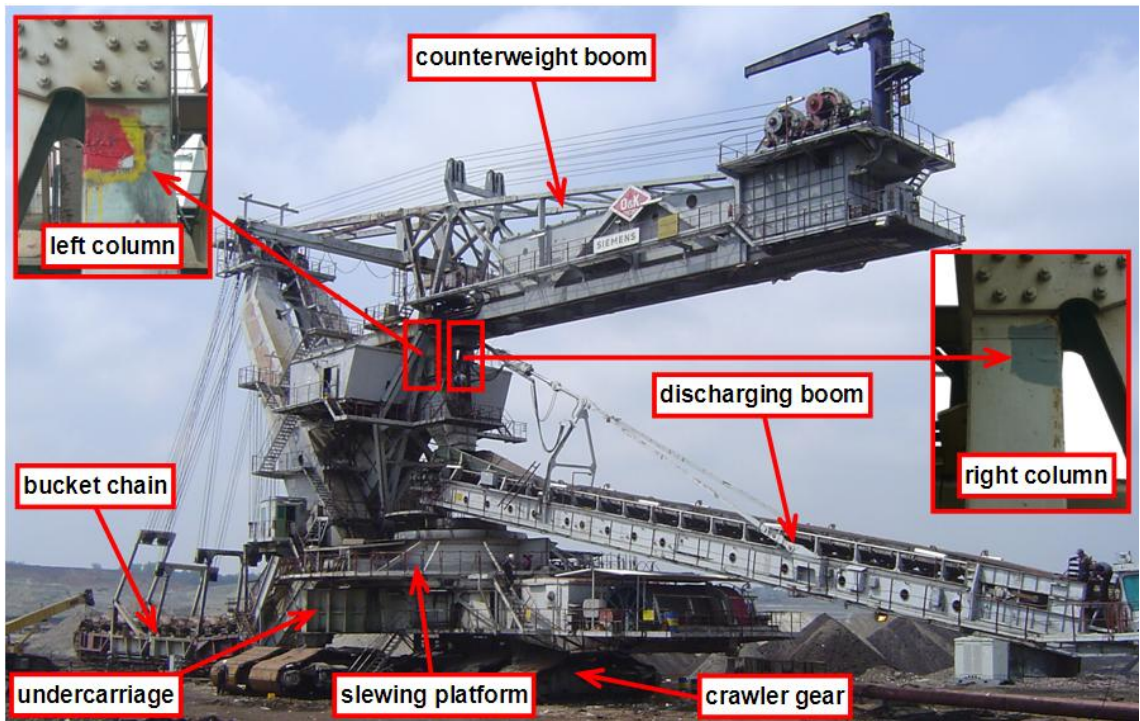
BCE ERs 1000, Fig. 2, is in use in open pit mine "Kolubara". During perennial exploitation cracks were observed on the column heads of supporting truss of the counterweight boom (CWB) Fig. 12. These cracks have been weld repaired, but after some time they appear again, being longer and longer.

The cracks propagation could lead to catastrophic consequences – collapse of the machine, such as described in [1,6]. The goals of the study presented in the paper were to:

Fig. 12. Cracks on the CWB supporting truss columns

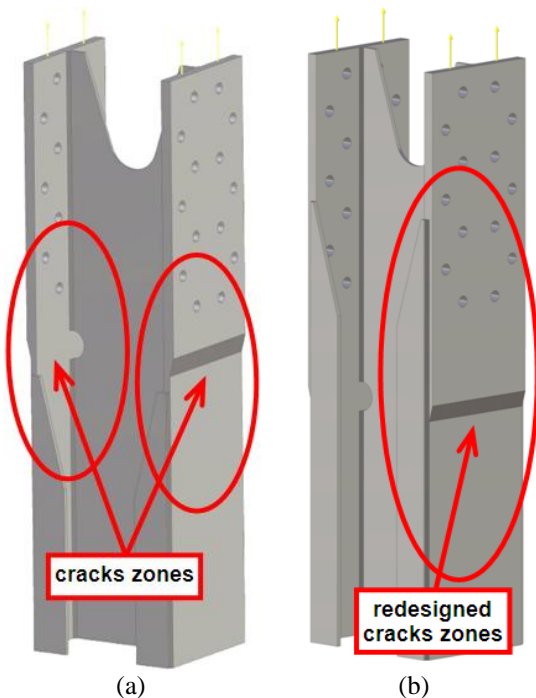
Fig. 13. 3D models of the original (a) and redesigned (b) column head

- a significantly lower stress state ( $\approx 3$  times) in critical zones, where peaks do not exceed allowable values;
- a very short time for manufacturing of the redesigned columns' parts;
- the possibility of performing reconstruction in field conditions, without dismantling the BCE superstructure components.

Based on the results of a comparative numerical analysis of the original and redesigned structure of the column head, the authors conceived a reconstruction solution that meets the following requirements:

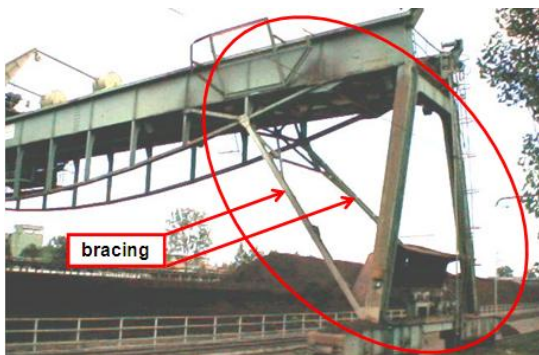
Design-in faults led to buckling of the rigid portal bracing, Fig. 15, and collapse of the machine structure.

Fig. 15. Detail of rigid leg
