INTEGRITY ASSESSMENT OF AUTOCLAVES AFTER RECONSTRUCTION PROCENA INTEGRITETA AUTOKLAVA NAKON REKONSTRUKCIJE

Originalni naučni rad / Original scientific paper
UDK /UDC:

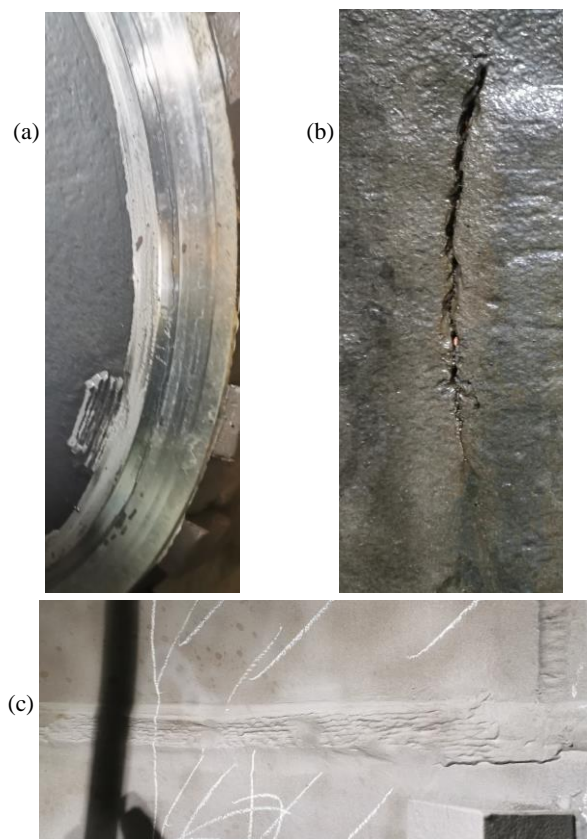
Experience has shown that certain impact forces are generated during loading of the autoclave with coal and discharging of dried coal. Vibrations caused by these 'shock' forces are transmitted through autoclave supports to steel structures carrying the autoclave. Such vibrations cause damages mainly on the autoclave shell, as well as on welded joints, initiating cracks and other damage on welded joints. Some damages observed on autoclaves caused by these impact forces are shown in Fig. 2. Figure 2a shows damage on the lower lid of one of the three autoclaves. Wall damage is caused by abrasion. Figure 2b shows a through-thickness crack on bottom lid of one of the three autoclaves. One of the main problems of the autoclave in this facility is erosion of shell wall material (Fig. 2c). In this case the erosion is on the upper shell of one of the three autoclaves.

Fig. 2. Some observed damages to autoclaves; a) damage on the lower lid of an autoclave, with abrasion damage and cracking; b) through-thickness crack; c) erosion of shell wall material

All of the above affects the need for replacement of lower shell segment, and partly the middle shell segment (in the support zone) as well, due to degradation of Altherm 55

base material, caused by operational and excessive welding activities. Accordingly, the replacement of these fatigue-damaged and worn out segments on three autoclaves must be carried out. Figure 3 shows the reconstruction plan for the lower part of autoclave, i.e. replacement with a new bottom part made of 18MnMo4-5+NT material.

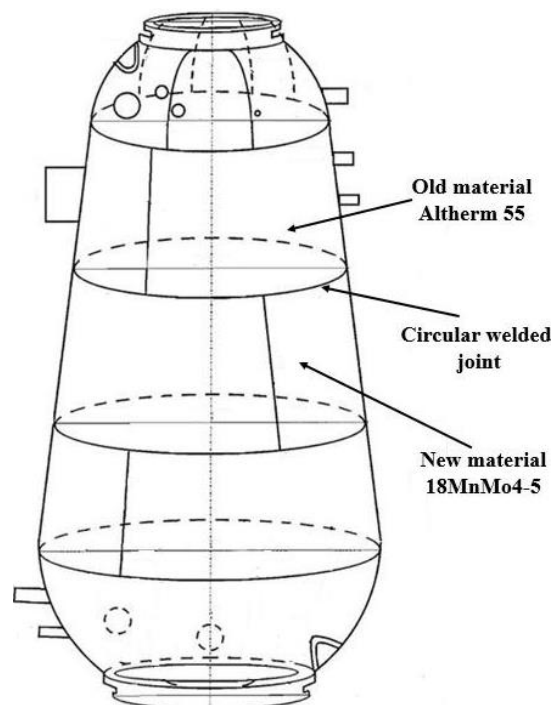
Figure 3. Autoclave reconstruction plan; upper (less damaged) part of Altherm 55, and new lower part of 18MnMo4-5 +NT.

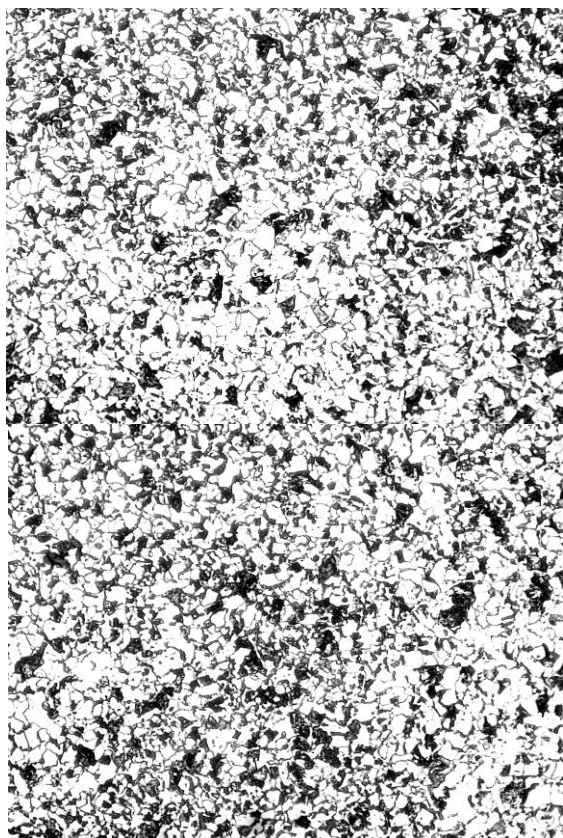
The microstructure of Altherm 55 steel is coarse-grained, with a mixture of ferrite, perlite, and bainite (Fig. 4). Microstructural examination on the upper part of one of the three autoclaves after 40 years operation is shown in Fig. 4. These examinations indicate that the base material is ferrite-perlite and without any serious damage.

Figure 4. Microstructure of Altherm 55 on upper shell segment, magnified 200 \times .

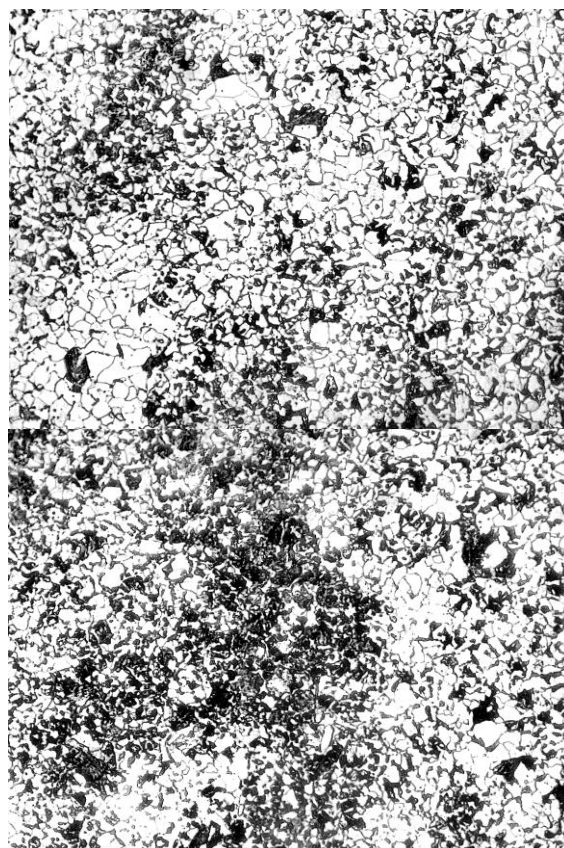
Figure 5 shows the microstructure of Altherm steel 55 taken by replica method from the lid of one of the autoclaves (200 \times magnification). It can be seen that the micro

Figure 5. Steel Altherm 55 microstructure on an autoclave lid, with uneven distribution of perlite, magnified 200 \times .

structure of the lid base material is also ferrite-pearlite with an uneven distribution of pearlite. Microstructure of Altherm 55 with magnifications of 500× are shown in Fig. 6. The chemical composition of Altherm 55 is given in Table 1. Tensile properties are given in Table 2, including the operating temperature of the autoclave, i.e. 250 °C.

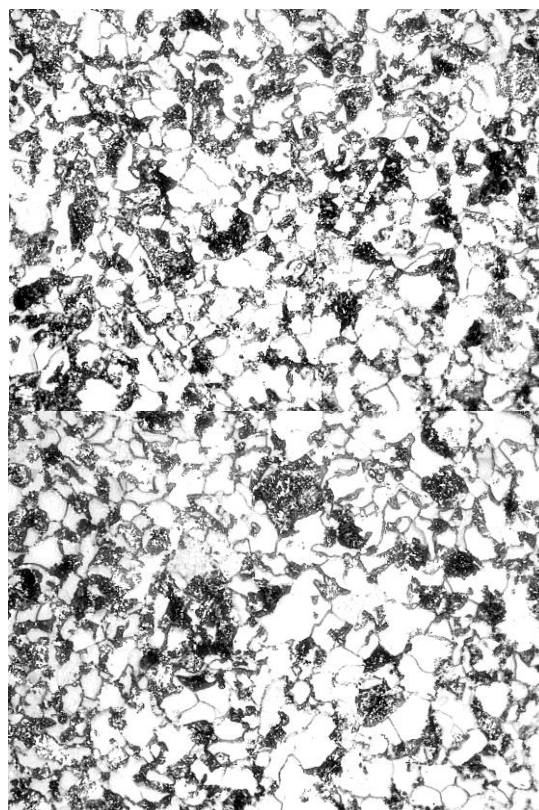
Figure 6. Microstructure of steel Altherm 55 on lid of one of the autoclaves: magnification 500 \times .

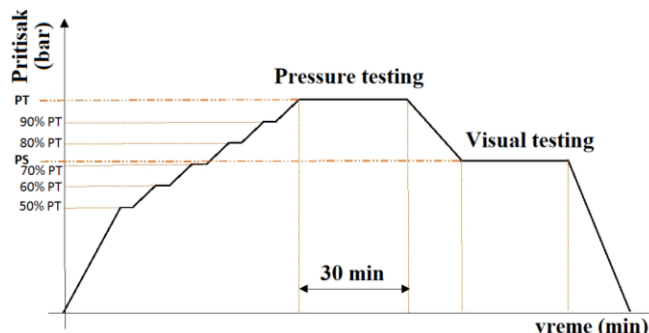
Figure 8. Hydrotest diagram plan of reconstructed autoclaves

Results of the hydrotest show no signs of destruction on reconstructed autoclaves, nor permanent deformation, leakage, and tearing on the welded joints and other parts of the autoclaves, as well as the pressure drop on the control manometer during the test.
