Second International Symposium on Risk Analysis and Safety of Complex Structures and Components (IRAS 2023)

Repairing of cracks on tooth gear ring of a bucket-wheel excavator

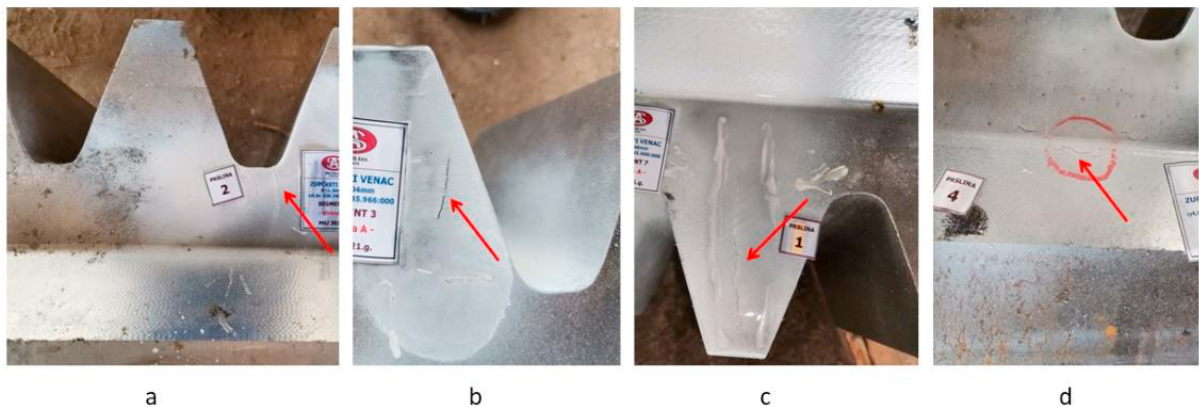
Having in mind aforementioned (concerning parent material characteristics), damage analysis was performed. After casting of gear segments, MT of NDT was applied. MT with a fluorescent suspension of particle size 3 μm was performed for defects detection. Surface indications. i.e cracks, were observed on 8 out of 12 gear segments. The lengths of the cracks varied in range 10-110 mm. Cracks were located in the gear teeth, its main body and the openings used for connections between segments as shown in Fig. 1. Surface cracks were probably caused by inadequate manufacturing process (casting or heat treatment), accurately caused by cooling rate causing cracks forming.

Fig. 1. (a) crack length of 25 mm between gears' teeth; (b) crack length of 30 mm on one of tooth surface; (c) crack length of 110 mm on one of tooth surface; (d) crack length of 10 mm on gear body (ring).

After damage analysis and establishing of the repair welding procedure, the discovered cracks were eliminated by grinding, creating the grooves that should be filled with described electrode. Groove depth goes up 60 mm in some cases. Some of the prepared grooves (with U shape) can be seen in Fig. 2. Before repair welding itself, the grooves were tested with MT and liquid penetrants (PT) of NDT as well in order to make sure that the cracks were removed.

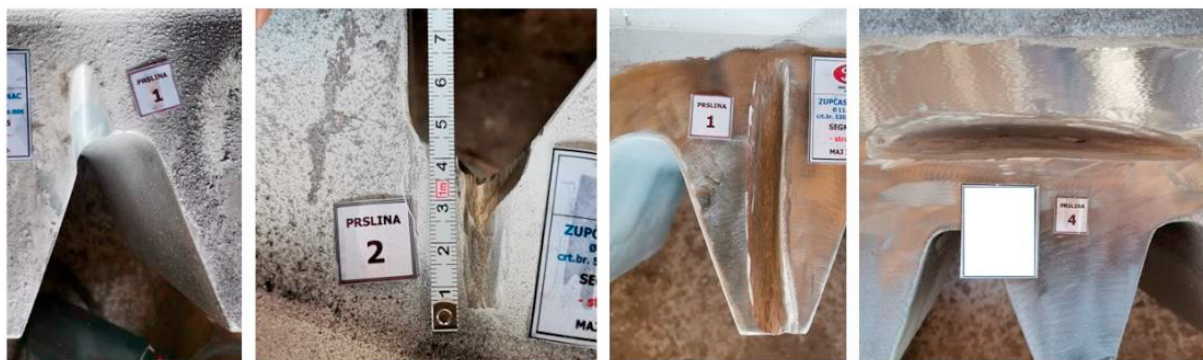
Fig. 2. Examples of prepared grooves on different gear segments.

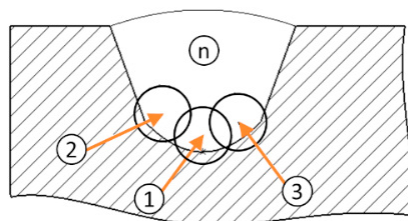
Fig. 3. Filling plan of the grooves: first 3 (root) were filled with electrode diameter Ø2.5 mm; rest were filled with electrode diameter Ø3.25 mm.

Takin into account parent material's limited weldability, as well as propensity to cold and hot crack of GS - 40 MnCrSi3V [6], preheating at 150°C was necessary. Preheating temperature was determined according Seferian's expression [2, 5-6]. Each electrodes were dried in furnace at 350°C for 2h before usage. Welding parameter for each electrode diameters were shown in table 5. Electrode with $\text{Ø}2.5$ mm was used for root layers, while with $\text{Ø}3.25$ mm for filling rest of the grooves, which was illustrated in Fig. 3.

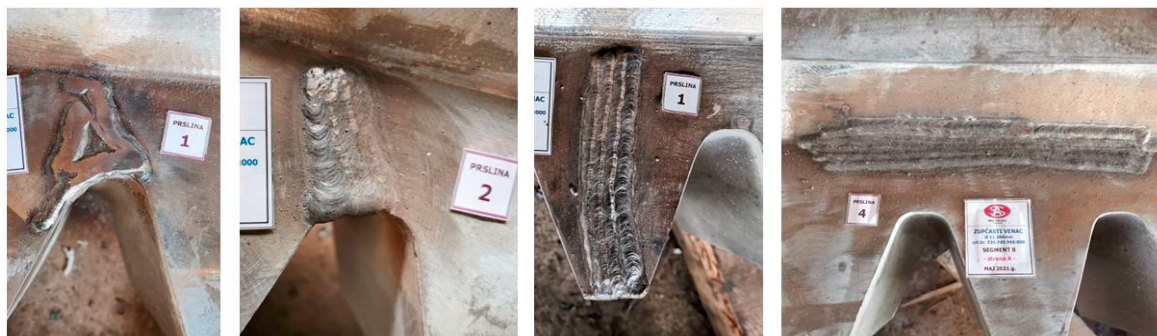
Fig. 4. Filled grooves on gear segments.

Interpass temperature between weld layers did not exceed 300°C . Air-cooling were carried after welding, where welded parts are coated with asbestos in order to decrease cooling rate. Fig. 4 shows some of the welds after welding activities. Upon cooling, grinding and polishing of welded joints were carried out to designed geometry.

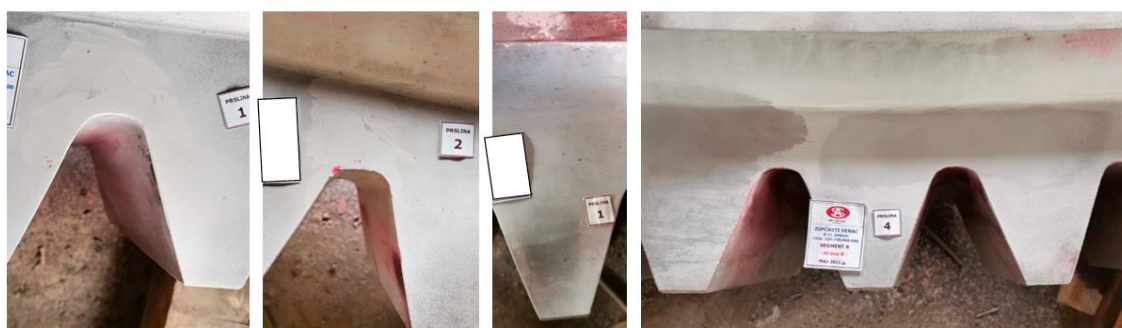
In order to verify applied repair-welding technology, PT was carried out on each weld after polishing, and no defects were discovered. Polished repair gear along with PT NDT results method is shown in Fig. 5.

Fig. 5. Gear segments after polishing and no surface defects after PT.
