RESIDUAL STRESS EFFECTS ON METHANOL STORAGE TANK INTEGRITY

Originalni naučni rad / Original scientific paper
UDK /UDC:

Abstract

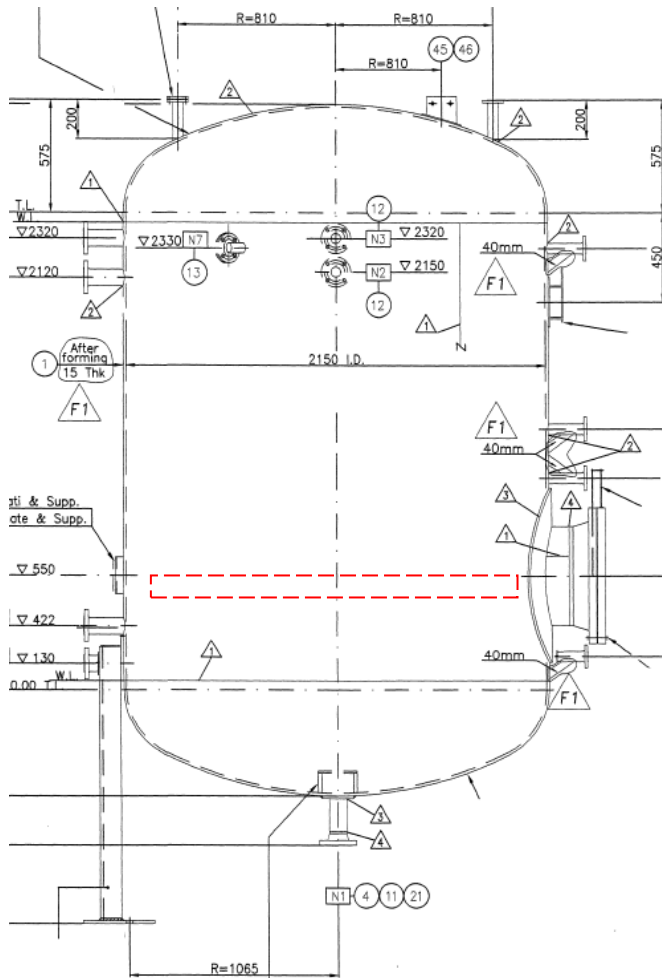
Figure 1. Vessel scheme.

As a result of all these facts, intensive degradation at the critical points, in this case circumferential welded joint, started immediately after putting the vessel into service, and during first inspection. After only 3 years in service, cracks have been observed on the mentioned joint between the shell and lower elliptical head. The location of cracks is indicated in Fig. 1. After internal inspection, numerous transverse cracks are found on the circumferential welded joint. Penetrant tests have been performed as one of the inspection methods. Discovered cracks were located in the welded face, as well as in the base metal (Fig. 2).

Except for the marked welded joint (Fig. 1), all other joints were in good condition and without any abnormalities like pitting corrosion, localized corrosion, erosion, etc. Internal surfaces were only subjected to light uniform corrosion, and according to the measurements, wall thicknesses were still according to design parameters.

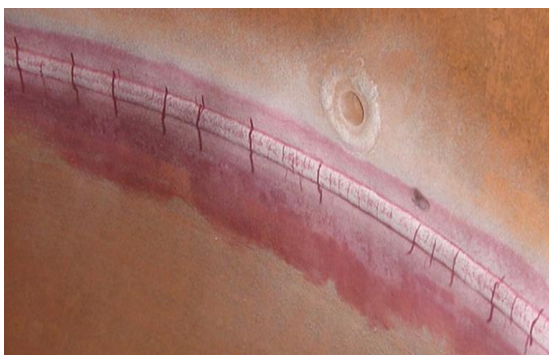
It should be emphasized that this type of corrosion as a result, typically has very narrow cracks filled with corrosion products, and for that reason it is very difficult to see them without the use of some non-destructive inspection methods, like penetrant, magnetic, or ultrasonic testing. These cracks could be so narrow that small leaks may occur even before cracks can be visually detected.

Figure 2. Transversal cracks in the circumferential welded joint.

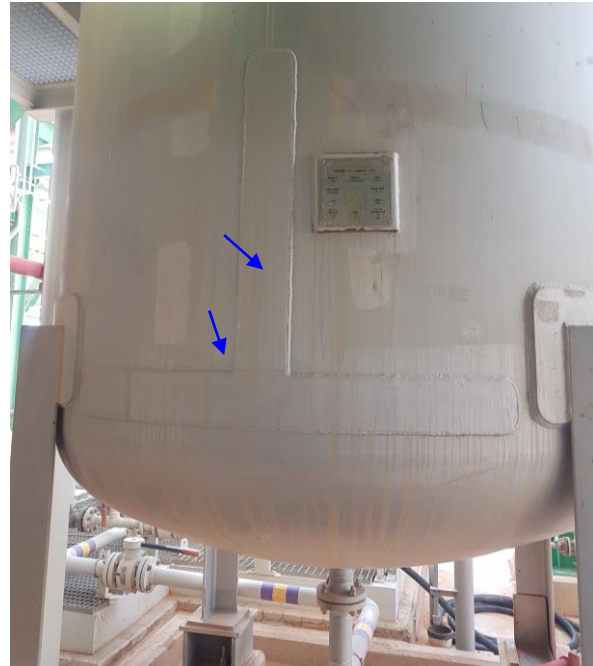
After discovering the cracks it was concluded that some kind of action should be performed in order to minimize any possibility of methanol leakage. Although design pressure is 12 bar, in fact operating pressure was much lower (less than 3 bar). This fact led to the wrong conclusion that it would be enough to install welded patches on the vessel to make it operational and safe enough for plant needs. This step was done without any deeper analysis of the problem, as shown in Fig. 3.

Figure 3. Installed welded patches.

A result of this unprofessional approach to problem solving in a very short period of time (just a few months) was the leaking noticed by operating personnel. After this event, internal inspection was performed in order to check the extent of damage.

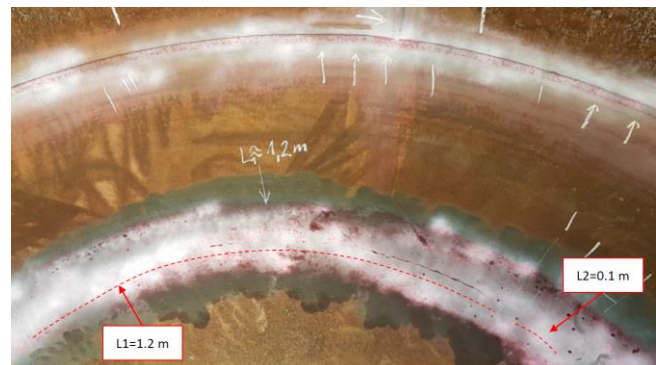
Intensive welding activities (without any heat treatment) resulted in additional increase of internal stress, and finally, in combination with aggressive influence of methanol had resulted in the creation of new cracks (Fig. 4). Cracks appeared on the knuckle region of the elliptical head where internal stress due to cold forming and additional stress due to welding activities, resulted with initiation of cracks.

Figure 4. Location of cracks in the elliptical head.

How large was the impact of additional stress can be concluded from the size of these new formed cracks. The length of the largest was 1.2 m. The remaining two had lengths of 0.1 and 0.3 metres. Among these, new cracks were formed on some nozzles near welded patches. Anyhow, they were not as large as the previous ones (Fig. 5).

The final result of these actions was a vessel that cannot be used anymore and has to be replaced with new one. In order to minimize the possibility for similar problems, heat treatment was strictly demanded for the new purchased vessel.

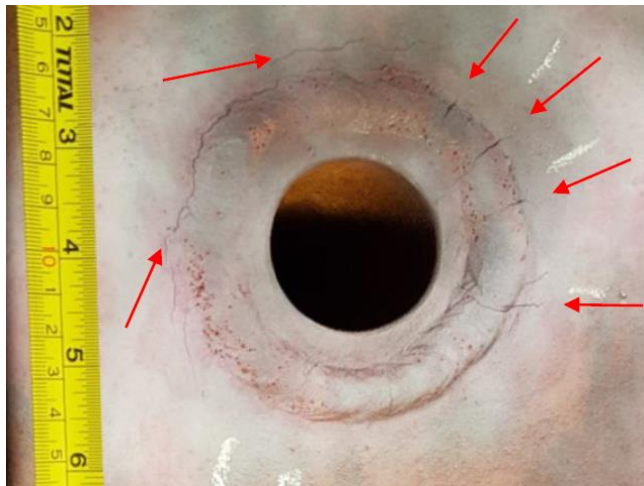
Figure 5. New cracks appeared on nozzles near the welding zone.

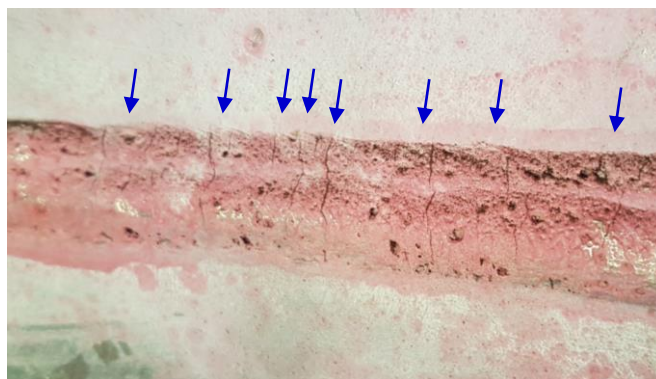
After the inspection of the second vessel it was found that the condition and damage mechanisms are almost the same as in the previous one. It means that only the circumferential joint between the shell and elliptical head is affected by methanol corrosion, as shown in Fig. 1.

The detected cracks were transverse to the welded joint and very narrow. Light pitting corrosion was also detected, Fig. 6.

Figure 6. Condition of the welded joint with tiny cracks, perpendicular to weld direction.

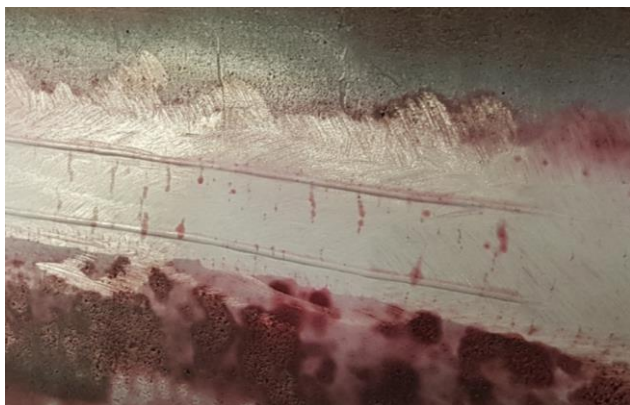
Figure 7. Condition of the circular joint during the grinding process and crack removal (traces of cracks can still be noticed).

According to the new repair procedure, the first step was to remove all detected. During grinding, from time to time, penetrant tests were performed in order to determine whether additional grinding is necessary, i.e. if all cracks have been removed or not (Fig. 7). Of course, at the end of the process all surfaces were made to be smooth in order to minimize stress concentration (Fig. 8). After grinding, thickness measurements were performed in order to confirm the remaining thickness of the material.

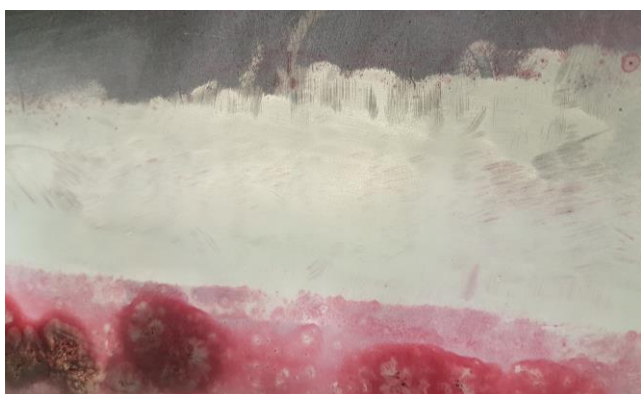
Figure 8. Condition of the circular welded joint after grinding and crack removal.

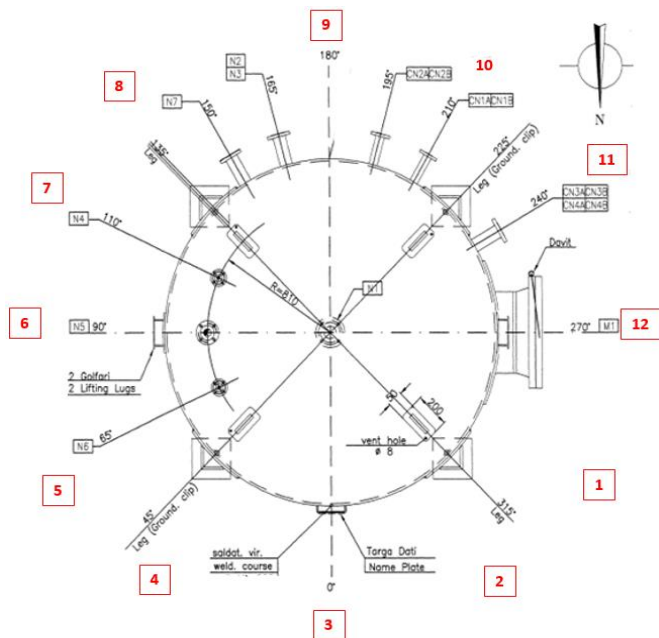
As shown in Table 1, all remaining thicknesses are still above design values, and it is concluded that the vessel can still be used after the methanol environment protection.

Figure 9. Location of UT scanning positions.

Location	1	2	3	4	5	6
Thickness (mm)	15.5	17.0	15.0	13.8	15.8	14.0
Location	7	8	9	10	11	12
Thickness (mm)	13.9	16.8	15.8	17.0	15.8	17.3
