## Second International Symposium on Risk Analysis and Safety of Complex Structures and Components (IRAS 2023)

# Review of failure analysis of coupling systems on trains

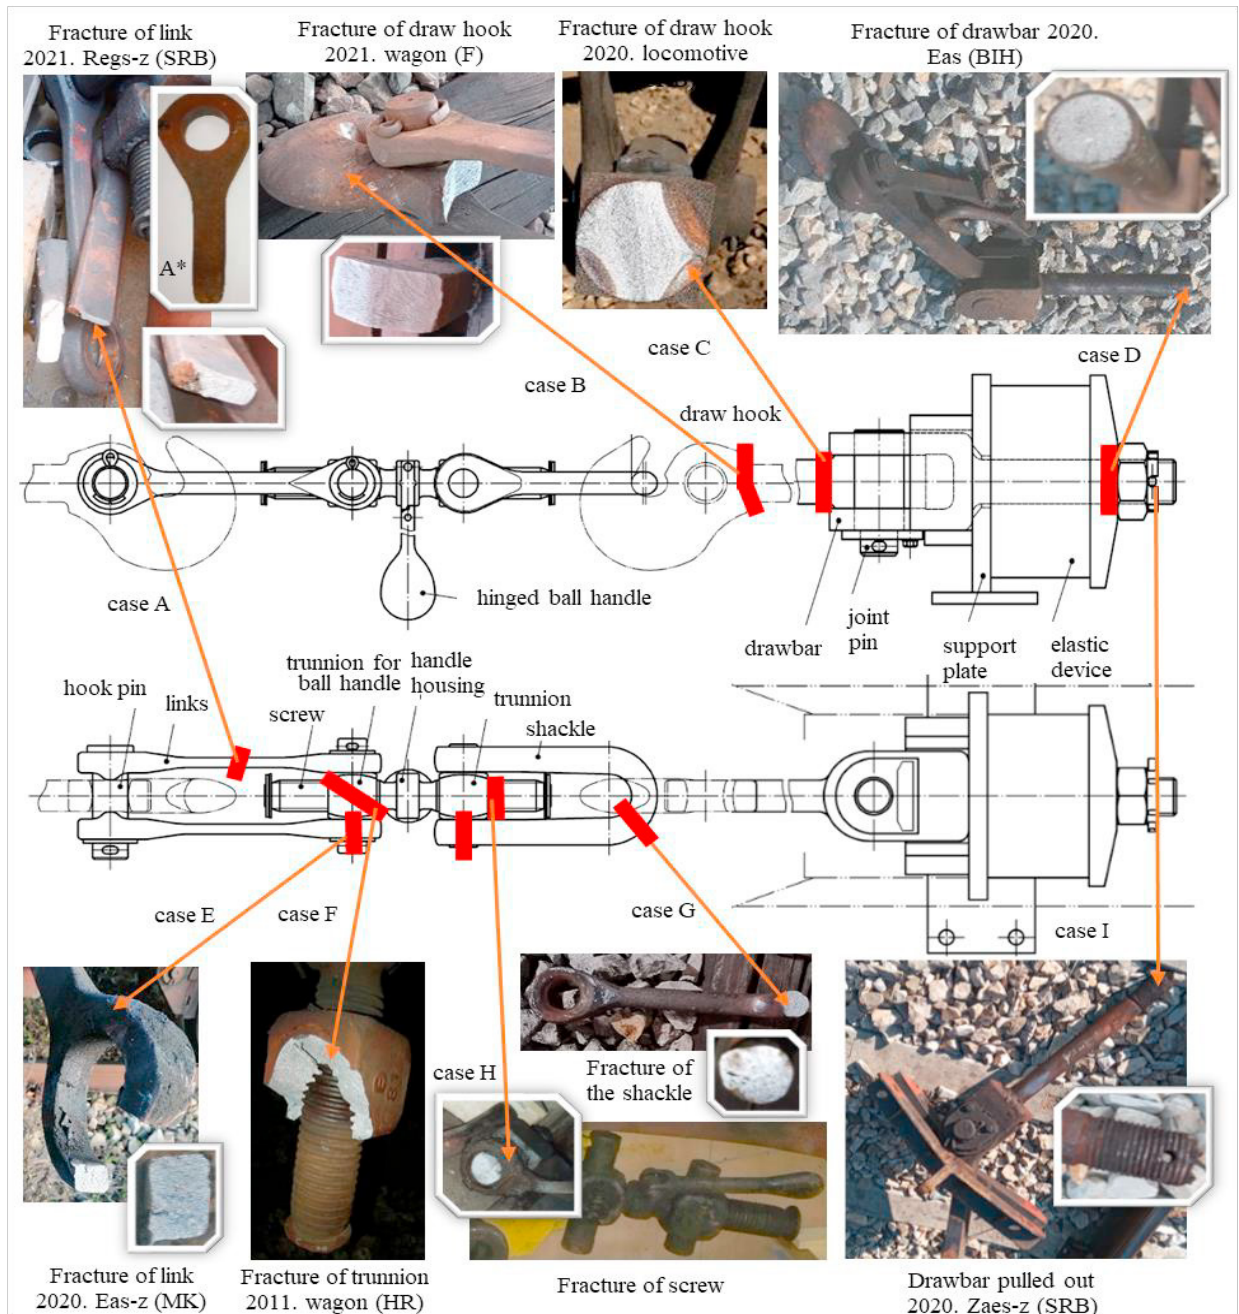
Fig. 2. Failures of coupling system with the appearance of fractures on Serbian railway

- Fractures of the drawbar, which typically transpire at the start of the thread, leading to the separation of draw gear components and causing damage to the guide and support plate on the wagon (Fig. 2, case D).

- Fracture of the drawbar or detachment of the nut resulting in the separation of draw gear elements and damage to the guide and support plate on the wagon (Fig. 2, case I).

- Fractures of the coupling link, commonly at the midpoint of its length (Fig. 2, case A) or at the eye of the hook pin or trunnion (Fig. 2, case E).
- Fractures of the draw hook at the change in cross-section (Fig. 2, case C), at the transition from neck to the head (Fig. 2, case B), or at the connection with the hook pin.

- Detachment of the hook pin or joint pin, caused by detachment or fracture of the split pin, resulting in separation of the draw hook.
- Fractures of the trunnion, screw or shackle (Fig. 2, case F and H), resulting in separation of the screw coupling.

- Fatigue fractures: These occur due to material failure at locations of stress concentration, with or without signs of corrosion. Examples include fractures at the cross-section change of the draw hook (Fig. 2, case C).

- Brittle fractures resulting from corrosion: In these cases, surface damage combined with corrosion and variable cyclic loads leads to the spread of corrosion across the cross-section, without apparent signs of stress concentration. An example is the breakage of the coupling link (Fig. 2, case A).

- Brittle fractures originating from initial cracks or surface damage: These fractures initiate from specific points and propagate along visible lines. Examples include fractures of the drawbar (Fig. 2, case D), the draw hook at the cross-section change (Fig. 2, case B), trunnion fractures (Fig. 2, case F), and coupling link fractures (Fig. 2, case E).

- Ductile fractures: In these cases, there is a clear narrowing of the cross-section before the fracture occurs. An example is the fracture of the coupling link (Fig. 2, case A\*).
