**DVANAESTO MEĐUNARODNO NAUČNO – STRUČNO  
SAVETOVANJE  
OCENA STANJA, ODRŽAVANJE I SANACIJA GRAĐEVINSKIH  
OBJEKATA**

**EFFECTS OF MAINTAINING A BUILDING CONSTRUCTED IN THE IMS  
SYSTEM (ŽEŽELJ) WITH AN APPROXIMATE ANALYSIS OF  
HYDRODYNAMICAL SHOCK AND THE ANALOGY WITH LATERAL SOIL  
EXPANSION WITH CAVERN EFFECTS DURING LIQUEFACTION**

**EFFEKTI ODRŽAVANJA OBJEKTA FORMIRANOG U IMS SISTEMU  
(ŽEŽELJ) SA PRIBLIŽNOM ANALIZOM HIDRIDINAMIČKOG UDARA I  
ANALOGIJOM UTICAJA KAVERNI SA BOČNIM ŠIRENJEM TLA KOD  
LIKVEFAKCIJE**

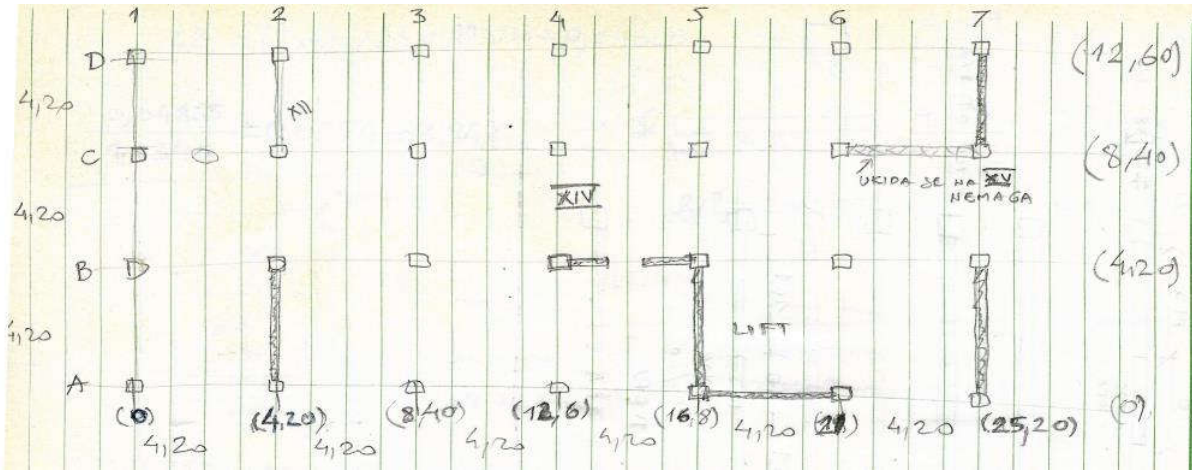
Figure 2. Ground floor plan (date design, April 1968). In reality, in the axis C/1-2 there is a bearing wall with an opening, but the working plan from the design does not have it, so it is not drawn here either.

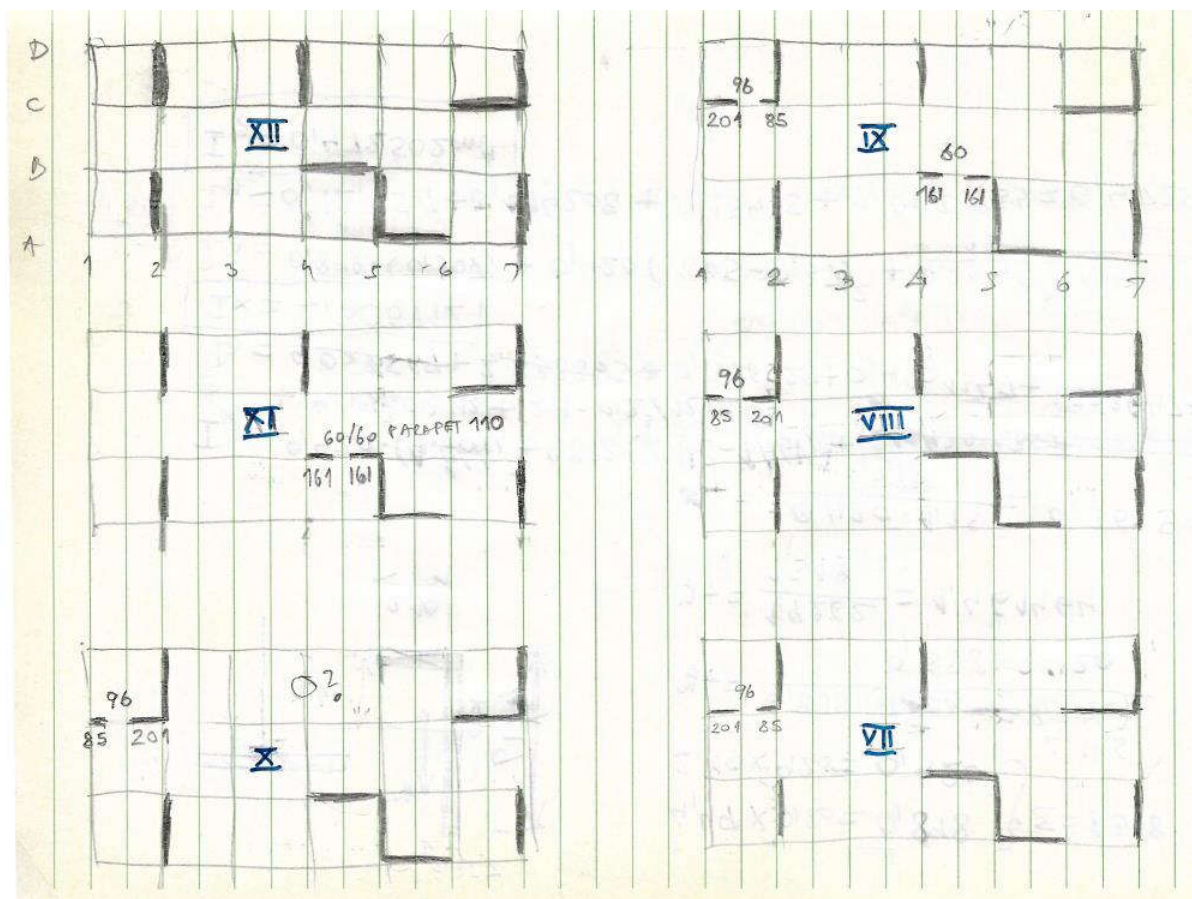
Figure 3. Floor plan from the 9<sup>th</sup> to the 12<sup>th</sup> floors (date design, April 1968). In reality, on the 10<sup>th</sup> floor, in the axis 4/C-D there is a bearing wall, but the working plan from the design does not have it, so it is not drawn here either.

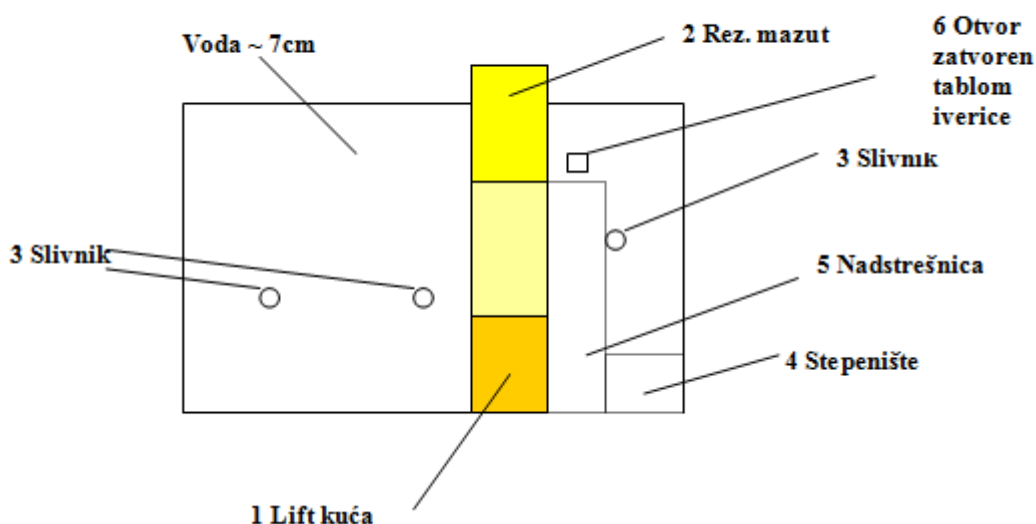
In July 2004 due to the heavy rains, and as a consequence of poor maintenance of the roof, because the property ownership rights were not clearly defined, the roof terrace became a shallow pool. For this reason, the water leaked through to the lower floors of the building and soaked the ceiling plasterboard panels.

Figure 4. Plan of the roof and roof terrace of the AV tower. 1 Elevator equipment room. 2 Heating oil tank. 3 Drain. 4 Staircase. 5 Overhang. 6 Opening covered with plywood panel. Average water depth cca 10-11cm. Smaller roof terrace is in the right hand side of the image. Drawing is not drawn to scale.

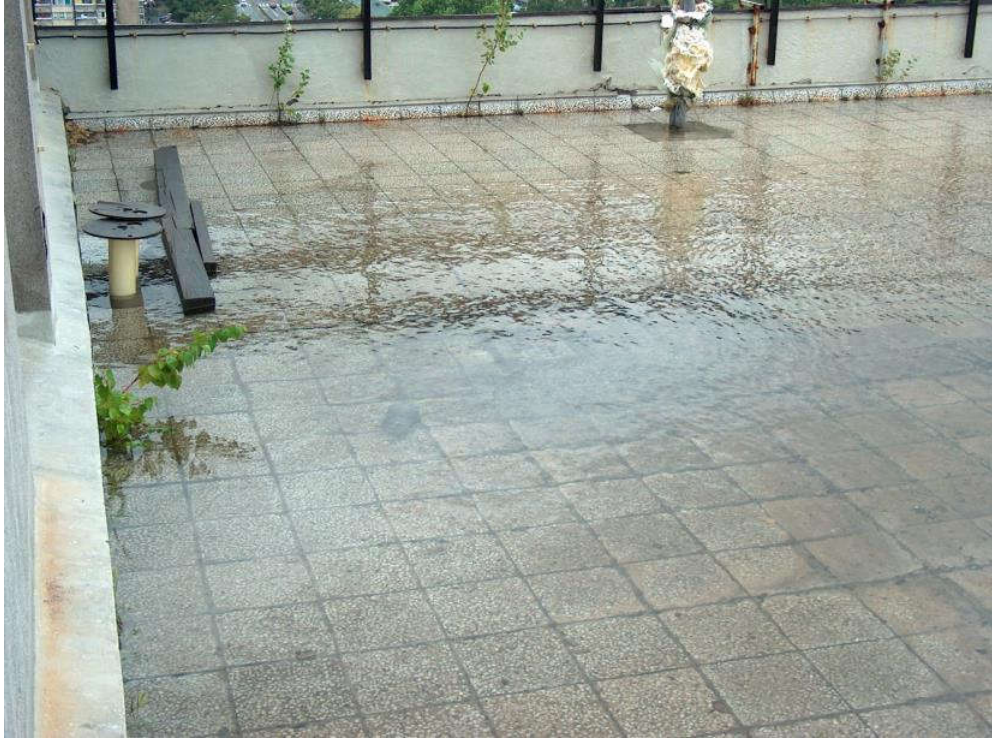
*Figure 5. A view of the flooded roof terrace and unplanned roof plants near the attics. July 2004.*

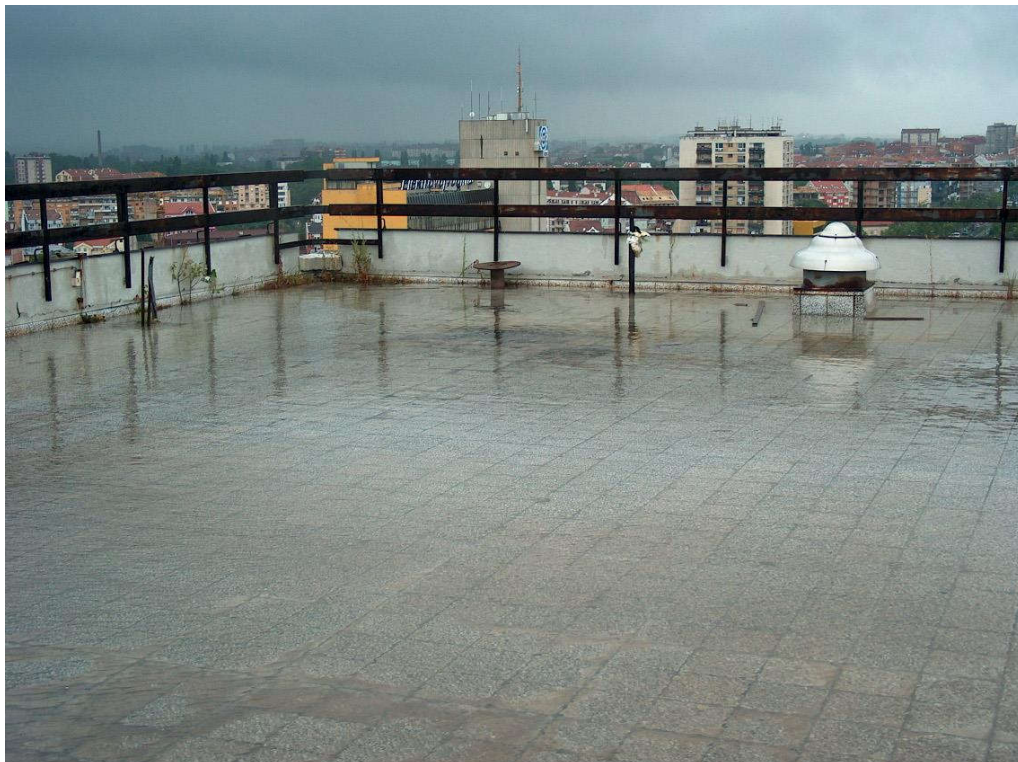
*Figure 6. A view of the flooded roof terrace and unplanned roof plants near the attics. July 2004.*

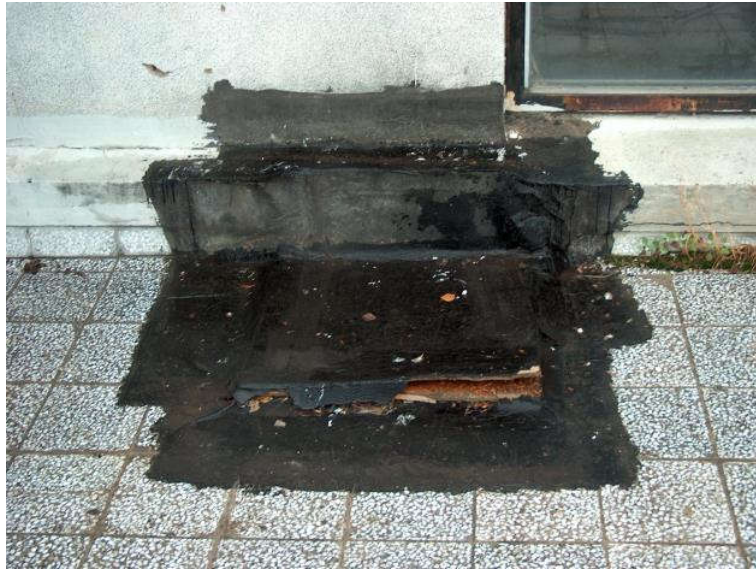
*Figure 7. Opening on the roof closed off with the plywood panel. Waterproofing damaged in one part. July 2004.*

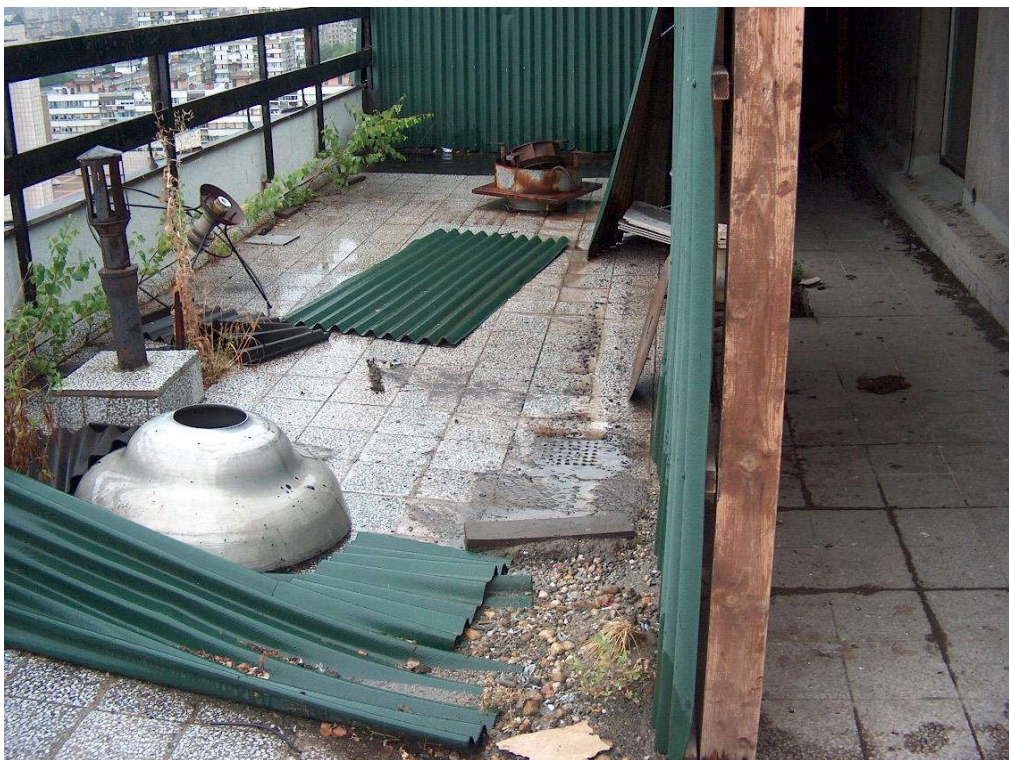
*Figure 8. A view of a smaller rooftop terrace and a drain. July 2004.*

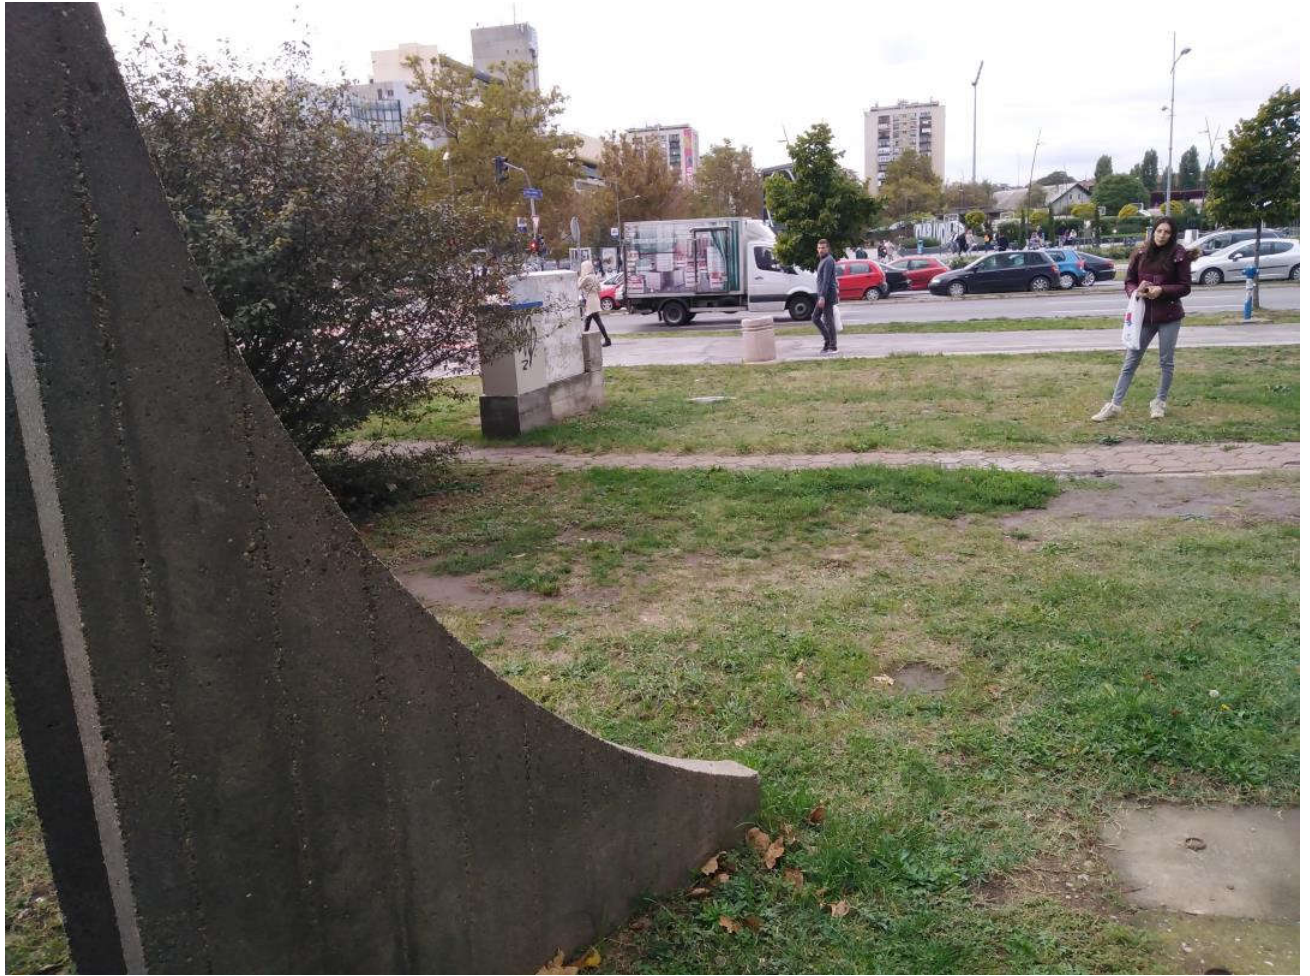
After the drain clogging was unblocked, water was not let out successively, but it was let out with no restrictions, abruptly, which caused the hydrodynamic shock, which shattered the drain shaft on the side of the Oslobođene Boulevard. It was visible as the soil settled on one side of the shaft for around 25cm. Figure 9, shows the current condition of this shaft. The metal cover was replaced with a RC slab.

*Figure 9. Lower right hand corner shows the shaft now covered with a RC slab. Photo taken in 2022.*

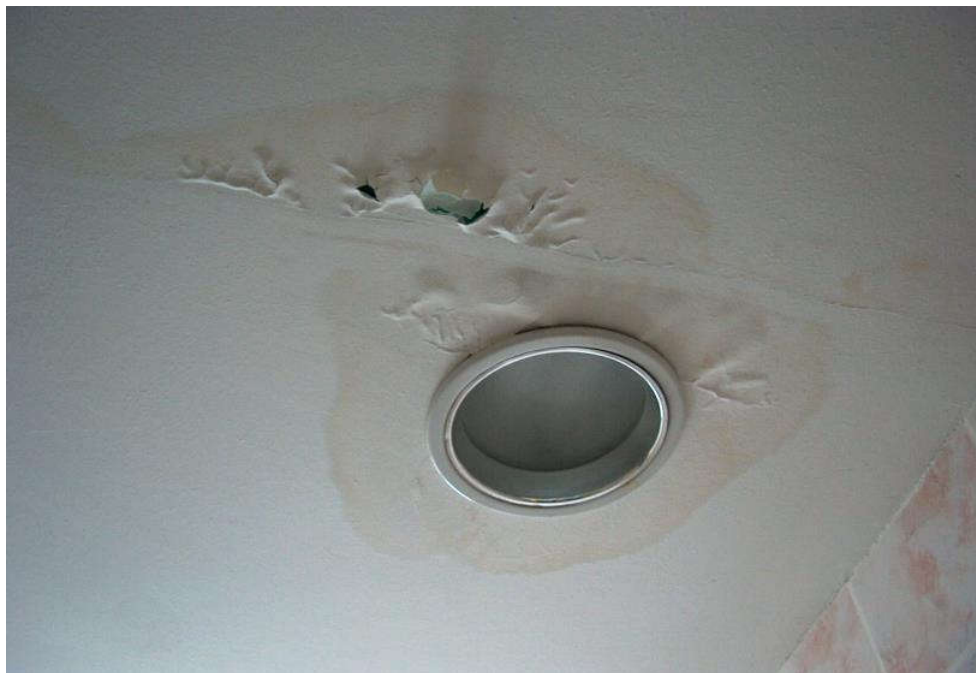
*Figure 10. Leaking of the ceiling around the lighting fixture. July 2004.*
