KLASIFIKACIJA EKSPLOATACIJSKIH OŠTEĆENJA ČELIČNIH UŽADI CLASSIFICATION OF IN-SERVICE DAMAGES OF STEEL WIRE ROPES

Stručni članak / Professional paper
UDK /UDC:
Rad primljen / Paper received: 26.11.2007.

Adresa autora / Author's address:
Institut za ispitivanje materijala IMS, Bulevar vojvode
Mišića 43, 11000 Beograd,

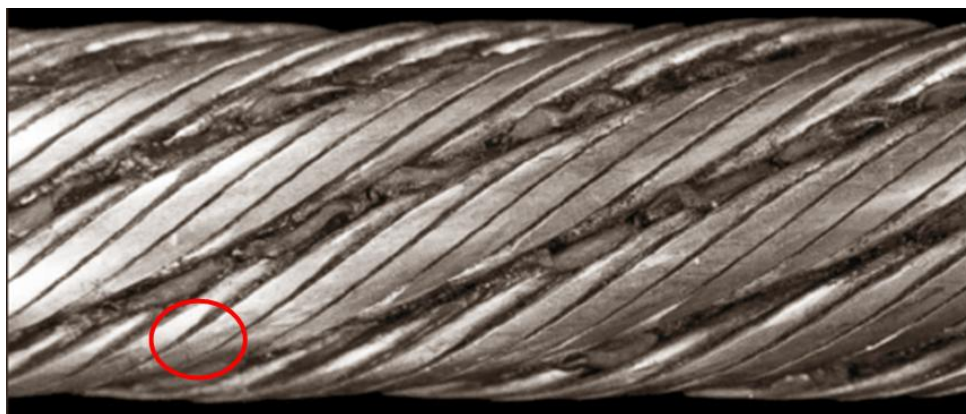
Slika 2. Ravnomerno jako mehaničko habanje spoljnjih strukova užeta bez pojave zamornih prsline na žicama

Figure 2. Uniform intensive mechanical wear of outer strands of steel rope without fatigue fracture of wire

As long as the rate of initial cross section reduction due to wear is higher than the fatigue crack propagation rate, fatigue fracture of rope wires will not develop (Fig. 2).

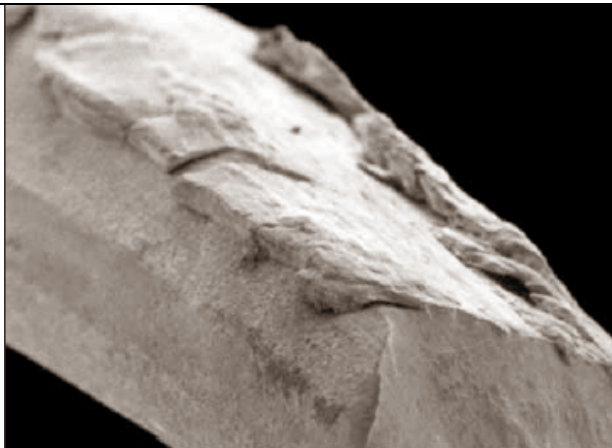
Mechanical wear must not be confound with plastic wear. Plastic wear is the intensive plastic deformation of material, without or with only little material loss. Figures 3 and 4 present examples of plastic wear.

Slika 3. Plastično habanje na površini žica spoljnjih strukova
Figure 3. Plastic wear on the surface of an outer wire of a strand

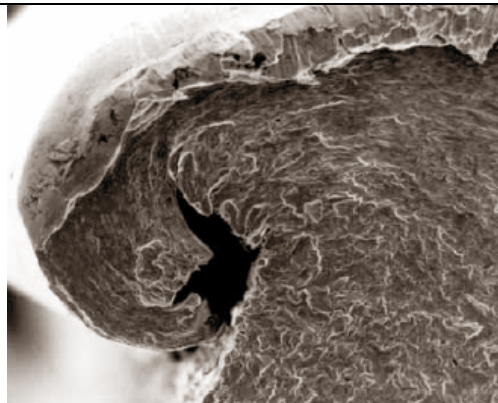
Slika 4. Smicanje materijala pri intenzivnom plastičnom habanju spoljnjih strukova
Figure 4. Material shearing at intensive plastic wear of outer strands

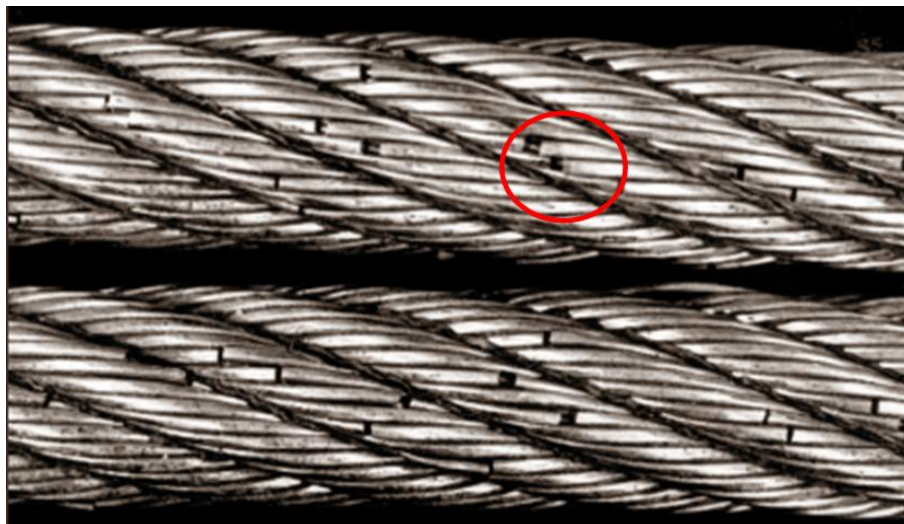
Fatigue cracks occur caused by rope flexion around guiding pulleys, in the contact points between the outer rope strands and drum, respectively sheave, or in the contact points between wires inside individual strand. Fatigue crack, which is perpendicular to wire longitudinal axis, initiates during operation with repeated flexion (Fig. 5 to 8).

Slika 5. Savojni zamorni lom užeta u spoljnjim strukovima. Raspodela prekinutih žica je najčešće slučajna
Figure 5. Flexion fatigue fracture of ropes in outer strands. The distribution of fractured wires is typically random

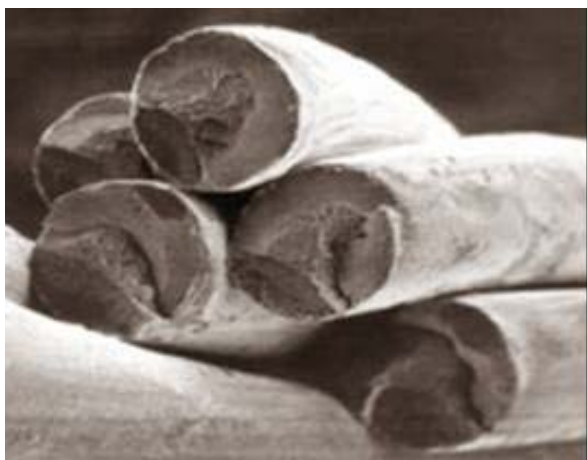
Slika 6. Zamorne prsline na mestu kontakta pojedinačnih žica. Inicirane prsline se vide nakon kidanja struka zatezanjem
Figure 6. Fatigue cracks at the contact points of individual wires. Initiated cracks are visible after fracture of strand in tensile test

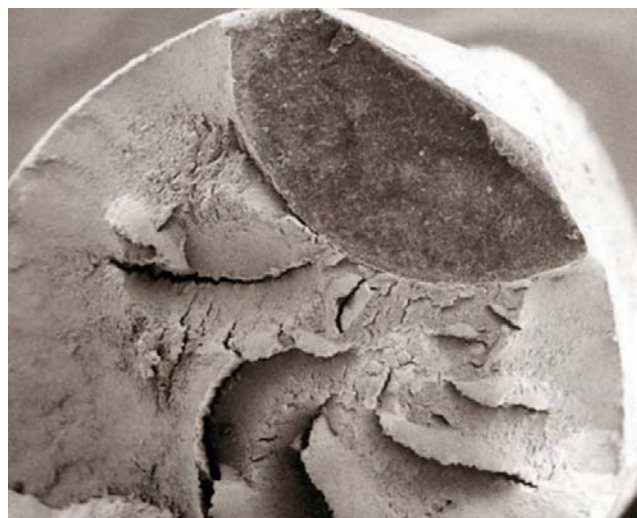
Slika 7. Zamorna prslina nastala na mestu dodira žice sa koturačom
Figure 7. Fatigue crack initiated at the contact point with a sheave

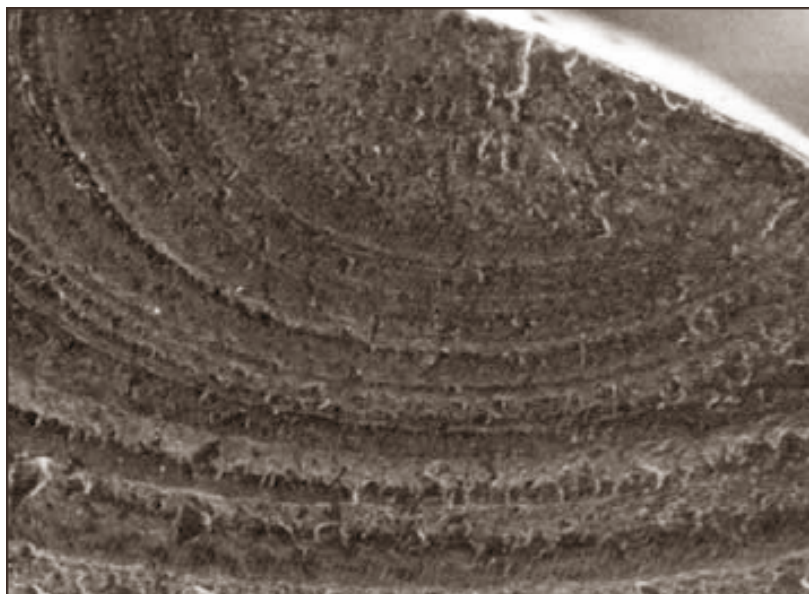
Slika 8. Linije zamora i odmora (strije) oko mesta iniciranja prsline, uvećani detalj sa slike 7

Figure 8. Fatigue and rest lines (striation) around position of crack initiation, magnified detail from Figure 7.

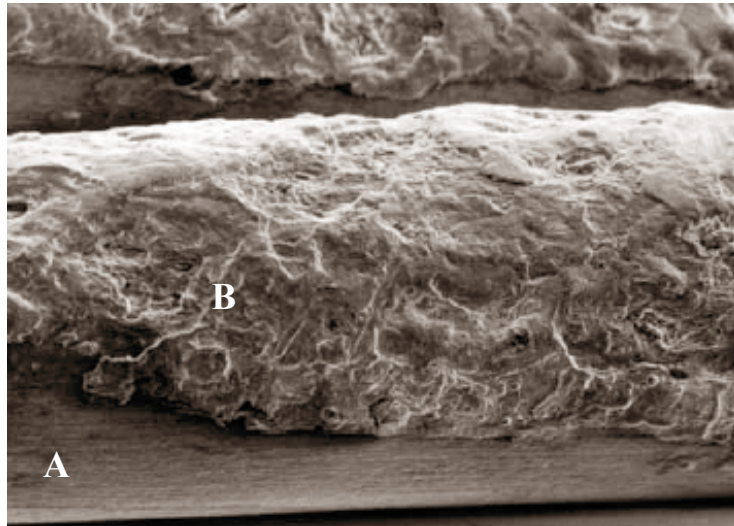
Corrosion is, usually, the reaction of metal with oxygen. In steel wire ropes one can distinguish atmospheric corrosion, producing uniform rust layer, Fig 9, and localized corrosion such as pitting, creating deep pits in the region where the protective coating is damaged or missing.

Slika 9. Atmosferska površinska korozija B na jednoj žici i deo žice neoštećen korozijom A, x100
Figure 9. Atmosphere surface corrosion.B on the single wire and undamaged part of the same wire A. x100

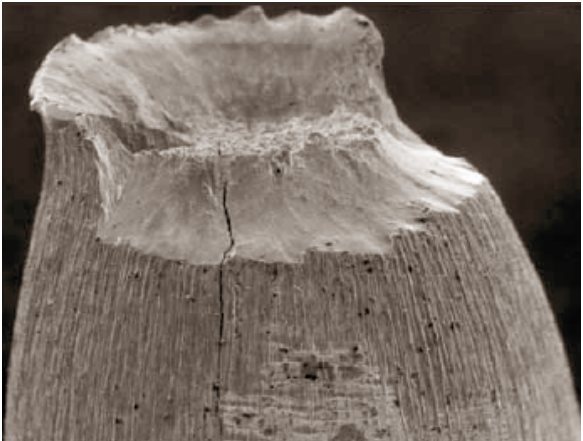
Rope failure will be experienced when wire ultimate tensile strength is overpassed by tensile overloading. The fracture is then ductile, with expressed necking and typical “cup and cone” ends of shear final fracture (Fig. 10).

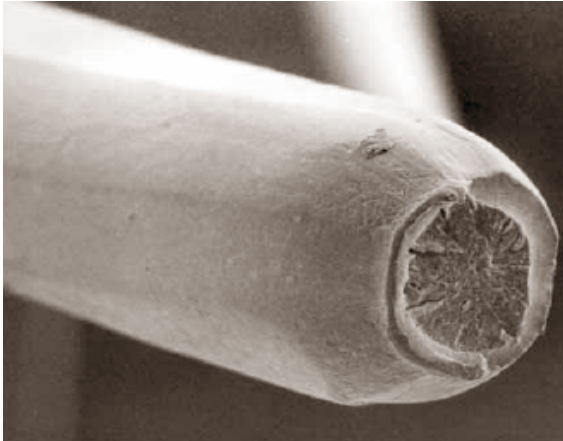
Figures 10 and 11 present typical examples of wire fracture due to tensile overloading.

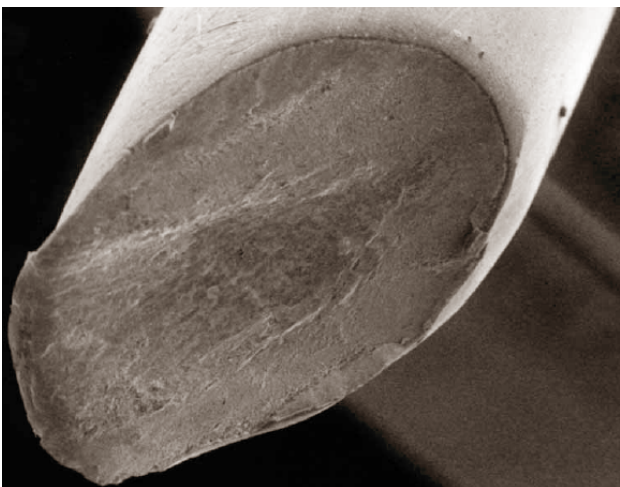
Fracture by shearing is most often experienced as combined tensile stress and simultaneous action of load perpendicular to strands. Fracture surface is exposed to the angle close to 45° relative to axial wire axis, in the direction of maximum shear stress, Fig. 12.

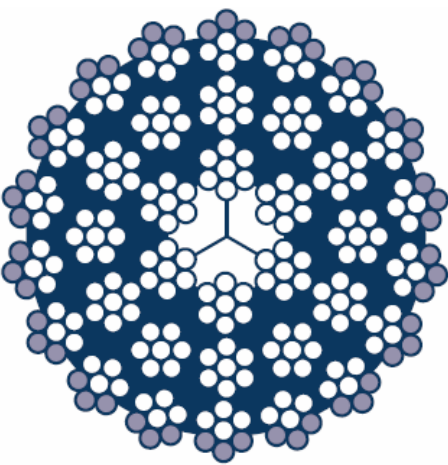
During a rope visual examination it is possible to assess only the condition of the outer wires visible parts. The metallic cross-section of the outer wires, however, presents only about 40% of total cross-section of a rope. Due to lay procedure only one half of the outer wires length is visible (Fig. 12). Based on that one can conclude that during a visual examination only about 20% of total metallic cross-section of rope wires is accessible. For the rest 80% of cross section only the evaluation of state is possible, and one can expect less damage being protected by position.

Quite often, however, the visible 20% of the cross-section seems to be well, while a great number of wire fractures are concealed in the inner of the rope. Wire ropes with internal wire fractures and no external sign of superficial strand damages present the case of extreme danger.
