Procedia Engineering 10 (2011) 2244-2249

# ICM11

# Failure Analysis of the Stacker Crawler Chain Link

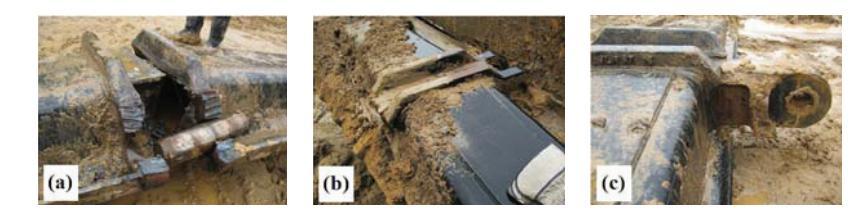
width and height. During the stacker's journey from the erection site to the open pit mine, three crawler chain links fractured, presenting an indication of the problems that were to occur during exploitation. In fact, after only 1000 working hours (about three months), 30 chain links sustained fractures, Fig. 2.

Fig. 2. Fractured (a) female lugs; (b) male lug; (c) chain link body

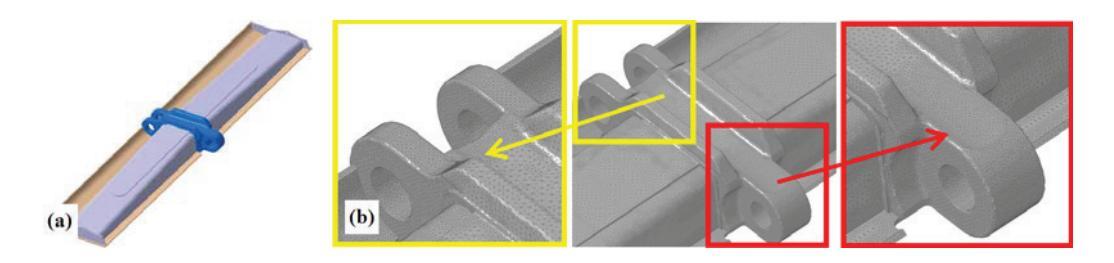
Fig. 4. (a) 3D model of the chain link; (b) detail of FE mesh in fracture zones

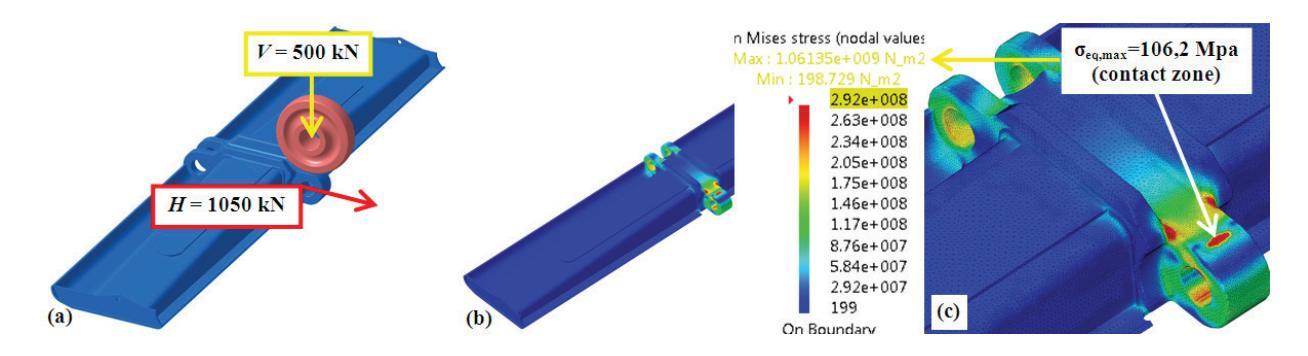
The analysis of the external load is performed in accordance with the referenced literature [12,13] and code [14]. Under the action of the relevant working load, Fig. 5(a), the maximum level of stresses in the critical zones does not compromise the integrity of the considered structure, Fig. 5(b,c).

Fig. 5. (a) Relevant working load of the chain link; (b) global distribution of von Misses stresses; (c) von Misses stresses in fracture zones

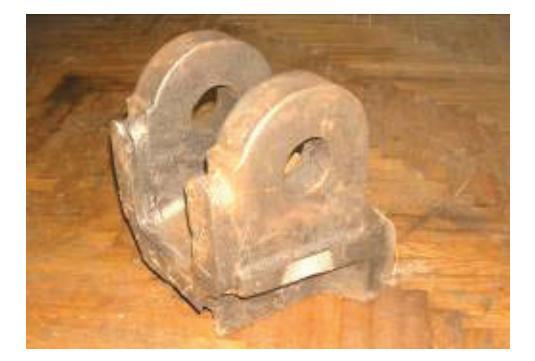
Experimental investigations were conducted on specimens made of the chain links' broken parts, Fig. 6.

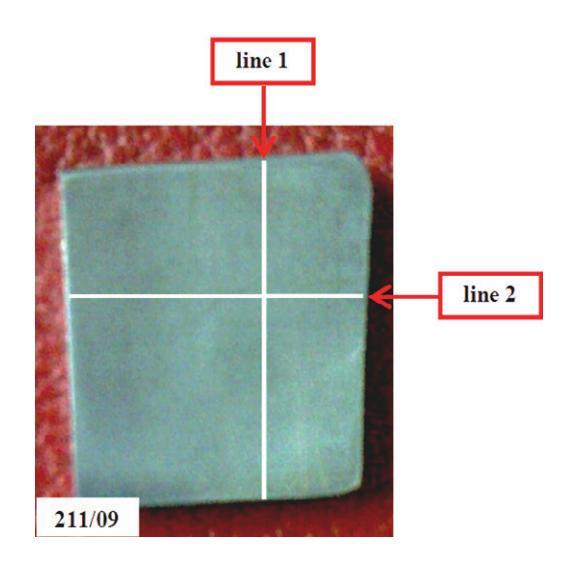
The Vickers hardness testing method is performed on the sample shown in Fig. 7. The measured values of macrohardness [17] showed irregular dispersion of results at the cross section, Table 6. Microhardness [17] of the surface layer is lower than the microhardness at greater depths, Table 7. Finally, the results of the hardness measurements indicate that the required depth of hardening - 10 mm, according to [18], is not achieved by induction hardening.

Fig. 7. Macro and microhardness measuring lines

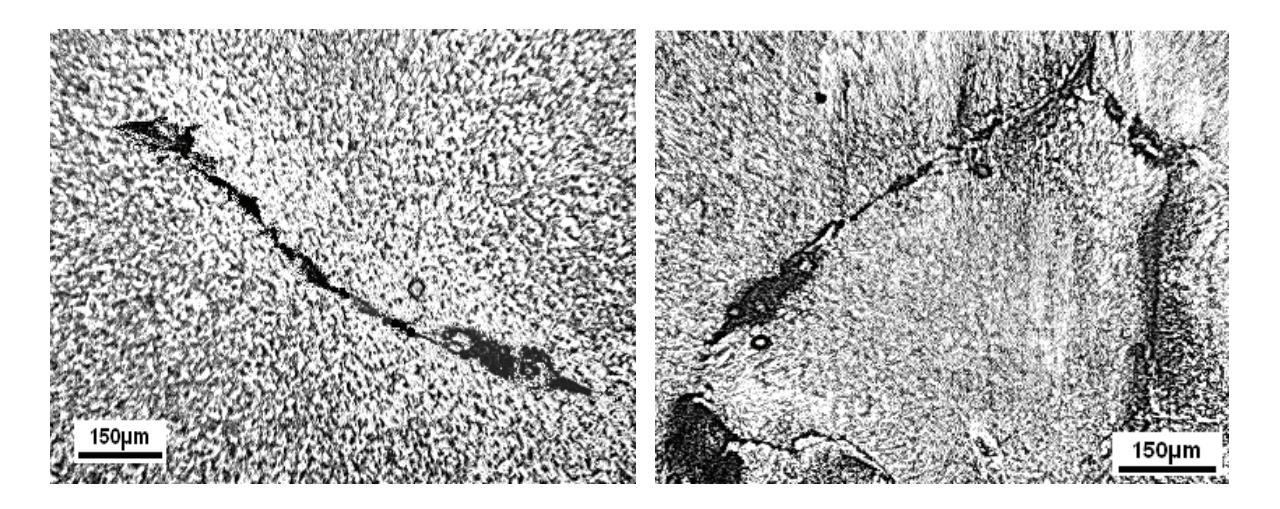
The microstructures shown in Fig. 8 are bainite - pearlite with carbide inclusions. Cracks of different lengths are observed as well.

Fig. 8. Bainitic-pearlitic microstructure with carbides and nonmetallic inclusions: (a) macrocrack length of about 0.9 mm; (b) macrocrack length of about 1.5 mm

- Substantial deviation of the mechanical properties of the material with respect to those prescribed by the standard;
- The existence of macro and microcracks in the material structure.

Therefore, the presented failure of the chain link belongs to the class of failures caused by the so-called 'manufacturing-in' defects [6,7].
