INSPECTION OF DAMAGE AND RISK ANALYSIS OF CONTAINERS IN A COAL DRYING FACILITY IN EXPLOITATION

Originalni naučni rad / Original scientific paper
UDK /UDC:

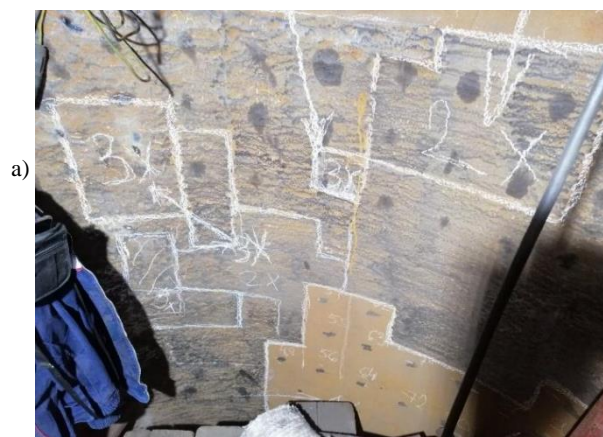
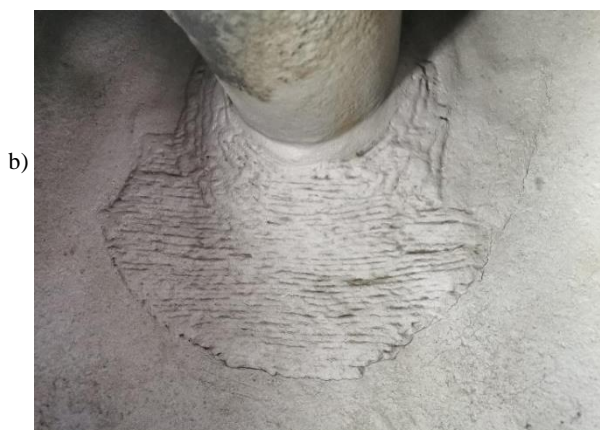
In order to assess the type and nature of damages that had occurred, extensive non-destructive tests /8-11/ were conducted for all containers, and it was concluded that the damage in question involved thinning of vessel walls in the upper lid and mantle zones, in the immediate vicinity of the lid. Wall thinning in certain regions was greater than 90 % of built-in thickness. Time period over which the damage occurred indicated significant flaws in the design solution for introducing of the condensate into the vessel, which resulted in erosion-corrosion action of the condensate on the impact surfaces of the vessel. The equipment supplier suggested reconstruction of the system for condensate intake and release, by introducing the condensate via 'hat' which ensues uniform draining of the condensate along the connecting vessel walls. Instead of replacing damaged vessels with newly designed ones, the existing vessels were reconstructed, along with the repair of damaged surfaces by replacing the upper lid and part of mantle. Reconstruction and repairs were entirely performed in accordance with the technical documentation provided by the equipment supplier, VOEST - ALPINE.

Aforementioned damages that occurred in the containers during exploitation were detected and monitored using modern non-destructive test methods. Some of the most commonly encountered types of damage are shown in Fig. 1, wherein one of the most critical damage types, which will be considered by the risk analysis shown here – the vessel mantle wall thinning, can be clearly seen.

Figure 1. Most common damages in containers: a) wall thinning in the upper mantle and lid; b) cracks in the shower connector areas.

The established procedure for the removal of defects shown above involves repair welding / surface welding which will not be considered here in detail, but its application is shown in Fig. 2.

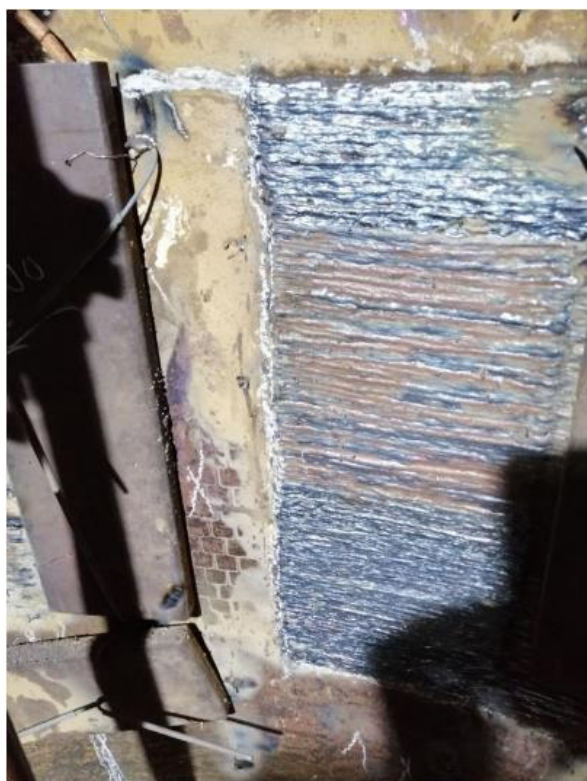
Figure 2. Repair welding of connecting vessel mantle thinned walls.
