A. Sedmak¹, K. Čolić², Z. Burzić³, S. Tadić²

STRUCTURAL INTEGRITY ASSESSMENT OF HIP IMPLANT MADE OF COBALT-CHROMIUM MULTIPHASE ALLOY

Originalni naučni rad / Original scientific paper
UDK /UDC: 669.295, 615.46:616.314
Rad primljen / Paper received: 02.07.2010

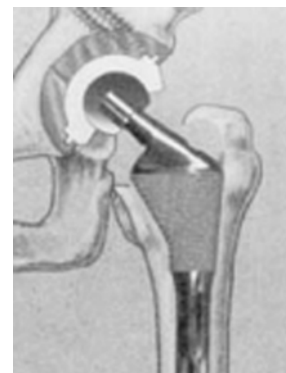
Figure 1. The shape of the artificial hip.
Slika 1. Oblik veštačkog kuka.

Total hip replacement (THR), is a surgical procedure in which parts of the hip joint are removed and replaced with artificial parts, known as the prosthesis, Fig. 1. Metallic alloys and composite materials are used for prosthesis. As for the total hip joint, its femoral head prosthesis is often made of cobalt-chromium alloy, while the stem component is made of titanium alloy, Fig. 2.

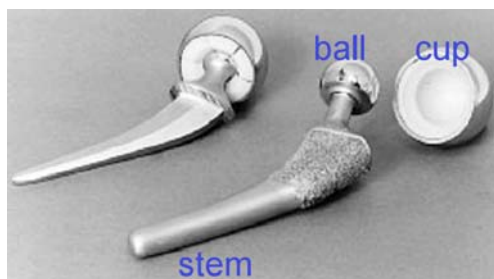
Figure 2. Components of the artificial hip implant.
Slika 2. Komponente implanta veštačkog kuka

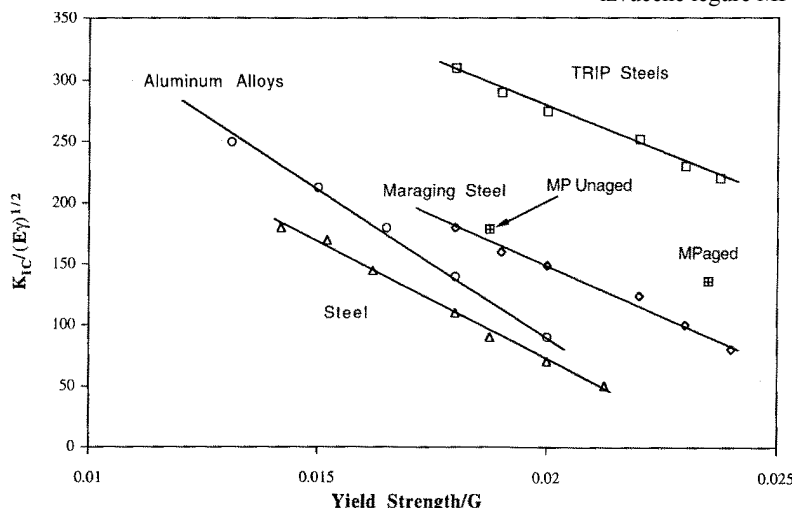
E = Young Modulus, G = Shear Modulus and γ = Surface energy.

Figure 6. Normalized strength-toughness curves of MP35N vs. other materials, /9/.
