## EXPERIMENTAL AND NUMERICAL CROSS-CORRELATED MODAL ANALYSIS OF THE FLOOR STRUCTURE DYNAMICS IN A THERMAL POWER PLANT

*This article presents search methodology after the cause of excessive floor vibrations in a thermal power plant control room. The floor structure is a composition of a steel grillage and concrete slabs at 12 m level above soil. It was detected that floor vibration severity exceeds the threshold of the permitted rate. After full scale measurements are conducted on site, the results are arranged versus time and frequency domain. In parallel to site measurements a 3D modal analysis is performed in ANSYS. The outcome is a set of modal frequencies and modal shapes. Cross-correlated analytical and experimental analysis formed a true picture of the excitation, response and their mutual interaction. The obtained results and appropriate conclusions had profiled a remedy strategy to mitigate the severity of the floor vibration.*

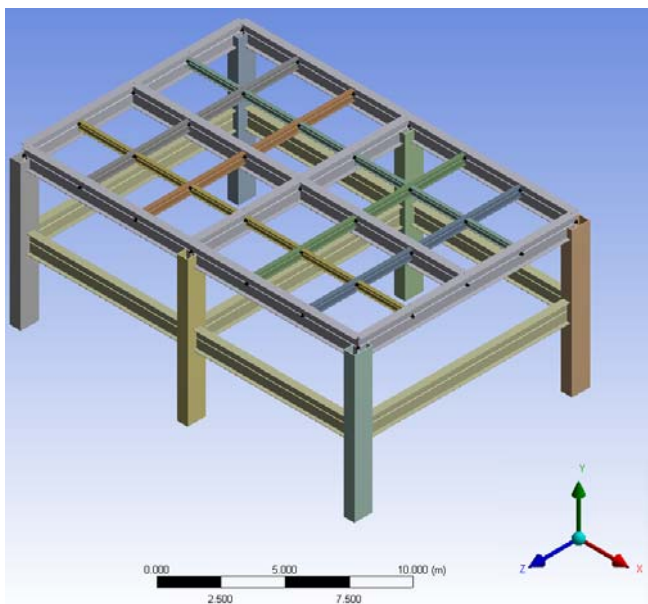
The control room floor is a rebar concrete plate on a grillage steel structure. Welded steel bars (cross section I 400), form a grill at 12 m high steel columns (rectangular cross section, 50 mm wall thickness, shown in Fig. 1).

Figure 1. 3D model of the grillage structure.

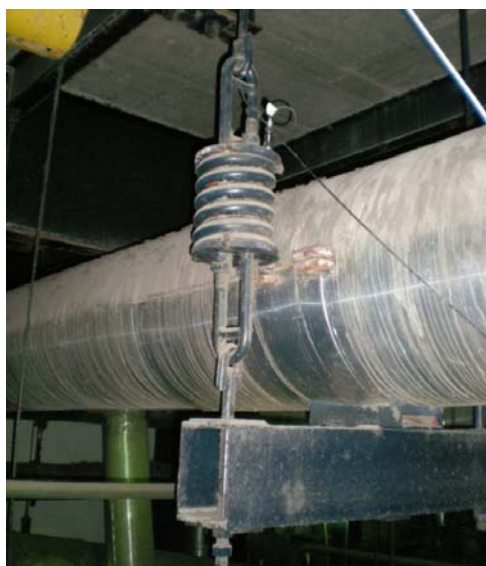
The bundle of steam pipelines is suspended to the under-structure of the control room steel grillage, shown in Fig. 2.

Figure 2. Suspended pipelines.

The steam lines were focused as the measurement sites. Mostly, they differ in size, ranging within 200-800 mm in diameter. Steam flow pressure varies significantly in each pipeline. Pipelines are suspended to the underside of the floor structure, either directly or via dampers. Vibrations on the pipelines are mostly caused by the swirling steam flow or the pulsating operation of related machinery. In order to find the clue to solving excessive vibrations, two spectral images are established: image of the pipeline excitation and

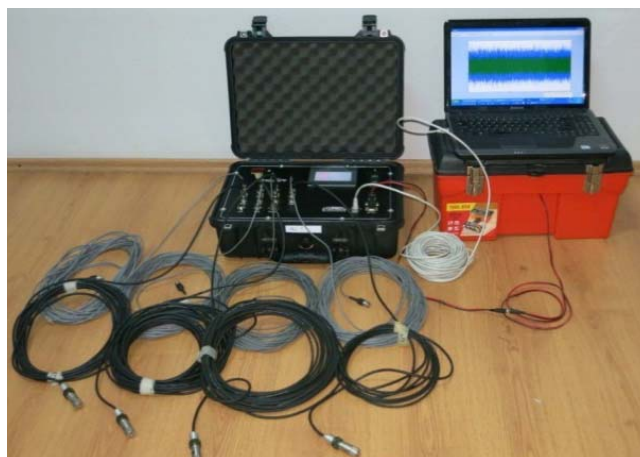
collector. Figure 3 shows the schematic chart. Sensors, cables, the acquisition device, data logger and battery are shown in Fig. 4.

Figure 4. Measurement equipment.

Measurement on site was carried out by Wilcoxon Instruments 780A piezoelectric accelerometers. Temperature rating (-50 to +120°C) suits the temperature in the zone of measurement (50°C). Sensor sensitivity 100 mV/g is well adjusted for the intended measurements as well its natural frequency, around 25 kHz. According to the outcome of the FE modal analysis, the floor structure natural frequency is around 13 Hz, and the highest spectral component on the pipeline is around 750 Hz. This frequency is far enough from the accelerometer natural frequency.

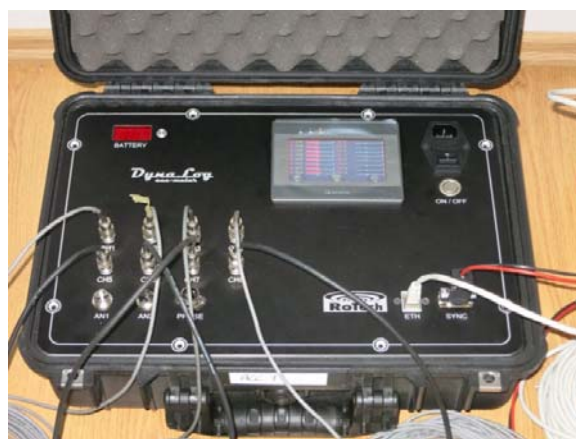
Figure 5. Acquisition device

The analogue signal from an accelerometer is conducted to the data acquisition device, shown in Fig. 5. The first level amplification is performed at that stage. Gain factor is selected and applied by the program, in the range  $\times 1$  to  $\times 100$ . From that point, the signal is transferred to the A/D

converter (LTC 1864, 16-bit). The conversion process and the characteristics of the A/D converter are explained in detail, /14/. Modbus RTU binary protocol is deployed for data transfer from acquisition box to the PC “logger”. The ‘master’ role is dedicated to the PC, while the acquisition device is the ‘slave’.

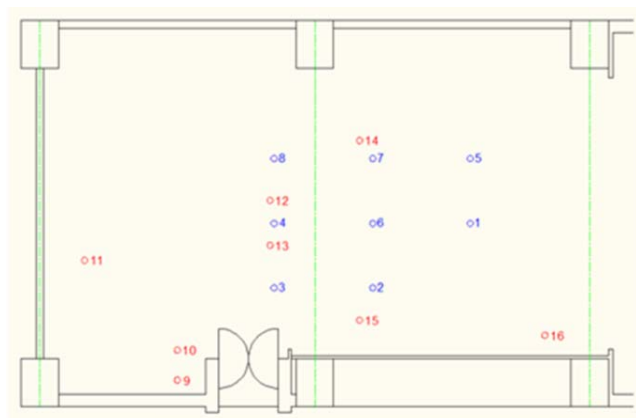
An arrangement of 16 measuring points is established, adequate to the capacity of the acquisition system. Eight measuring points are located on the top side of the floor and another eight below the concrete slab. Top side accelerometer disposition is an equally spaced rectangle, while the under-floor disposition is dispersed towards prominent hanging points. Layout of the measuring point network is shown in Fig. 6. Channels 1-8 are at the top of the floor, while channels 9-16 are below.

Figure 6. Disposition of the measurement points.

The sensors are gathered to the central position in the room because the highest response is expected there.

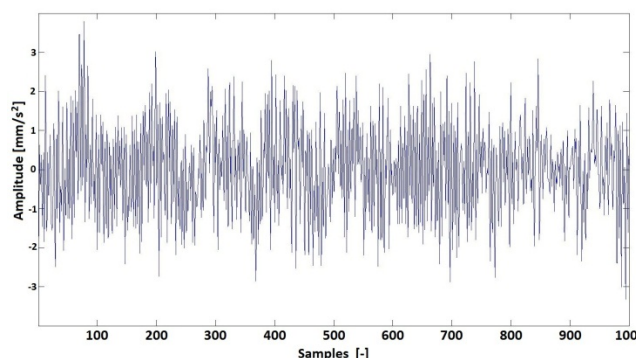
Data sets are collected synchronously with sixteen accelerometers at a sample rate of 1800 samples per second. In total, 1,458,792 data samples are collected per channel. A presentation in the time domain is shown in Fig. 7.

Figure 7. Collected data in the time domain.

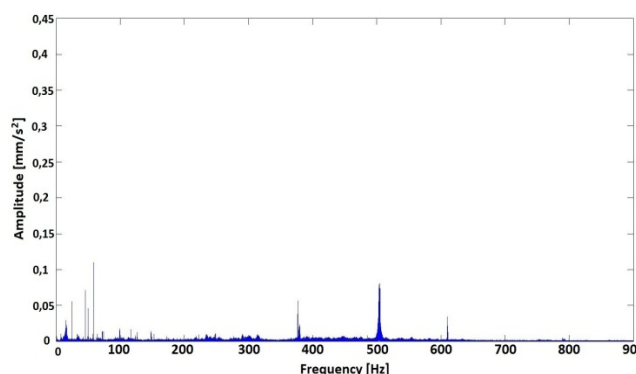
Figure 8. Collected data in frequency domain (CH1).

Response peaks are at 58 Hz (CH1), 58 Hz (CH2), 610 Hz (CH2), 375 Hz (CH2), 58 Hz (CH3), 610 Hz (CH3), 375 Hz (CH3), 375 Hz (CH6), 610 Hz (CH6),

The results of FFT are shown in Figs. 8-15.

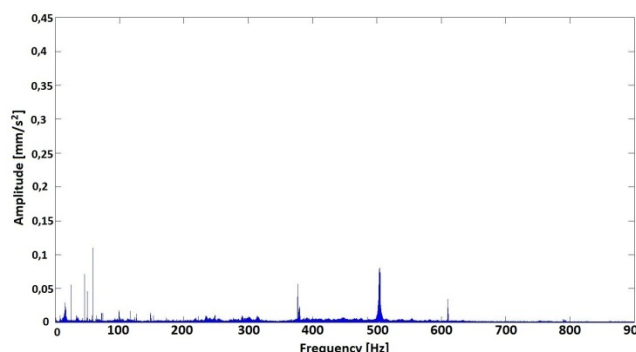
Figure 9. Collected data in frequency domain (CH2).

Measurement results show the presence of vibrations at 58 Hz, which is very close to one of the natural frequencies of the structure (63 Hz). The difference is approximately 10 %. It is reasonable to conclude that it is not a resonance, but a simple transfer of excitation vibrations. The same frequency component (58 Hz) exists on channel CH12. If it were the resonant frequency of the concrete slab, a component of 58 Hz would have been dominant at all response measurement points, which has not been the case. It is dominant only at measurement point CH2 that is physically close to the attaching point of the excitation sling CH12.

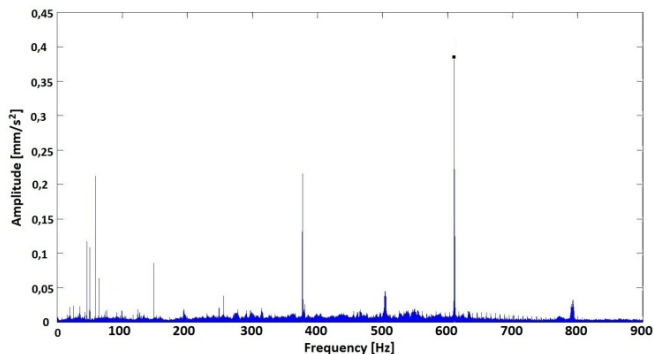
Figure 10. Collected data in frequency domain (CH3).

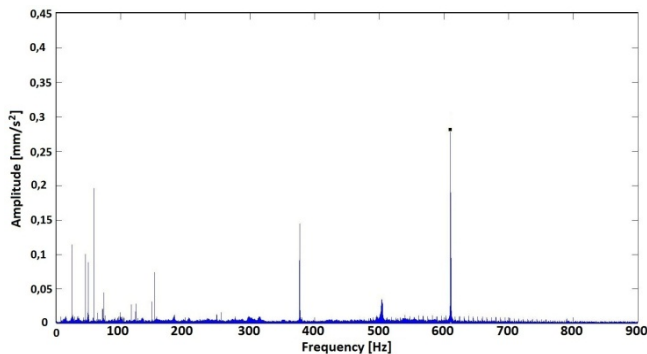
Figure 14. Collected data in frequency domain (CH7).

58 Hz (CH6), 610 Hz (CH7), 58 Hz (CH7), 375 Hz (CH7), 375 Hz (CH8), 58 Hz (CH8), 610 Hz (CH8).

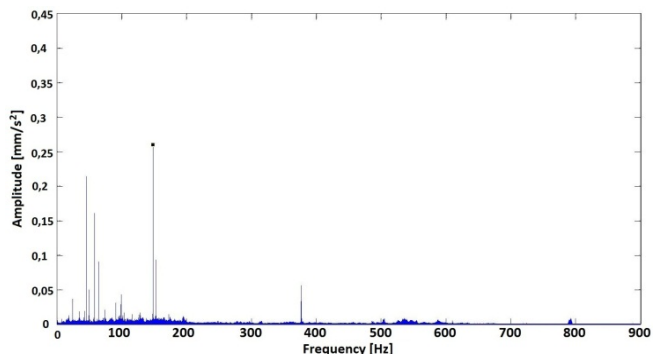
Figure 11. Collected data in frequency domain (CH4).

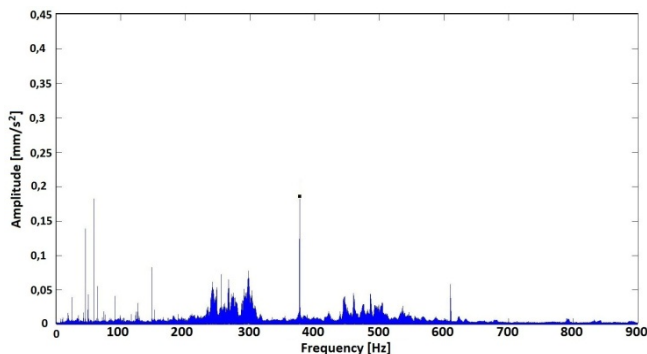
Figure 15. Collected data in frequency domain (CH8).

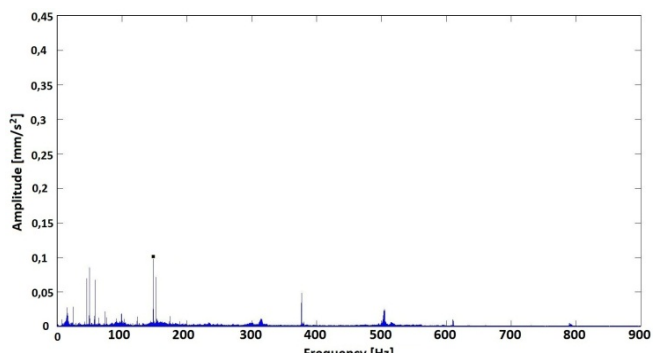
Figure 12. Collected data in frequency domain (CH5).

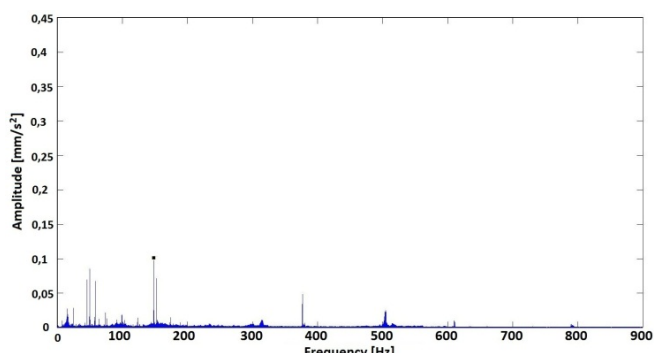
Figure 13. Collected data in frequency domain (CH6).

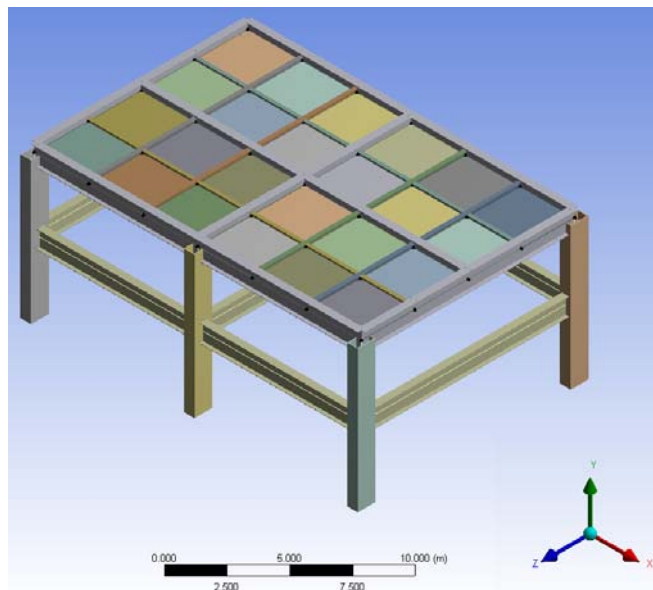
model. After that an appropriate cross-section form is assigned to linear elements. First, a rectangular box-profile to main vertical columns is defined and assigned (Fig. 17). The same approach is applied for other steel beams, Fig. 18. The concrete slab is modelled as a planar element, whose borders are transverse and longitudinal line elements. The appearance of the 3D test model at the end of the modelling process is shown in Fig. 19.

Figure 19. Complete 3D model.

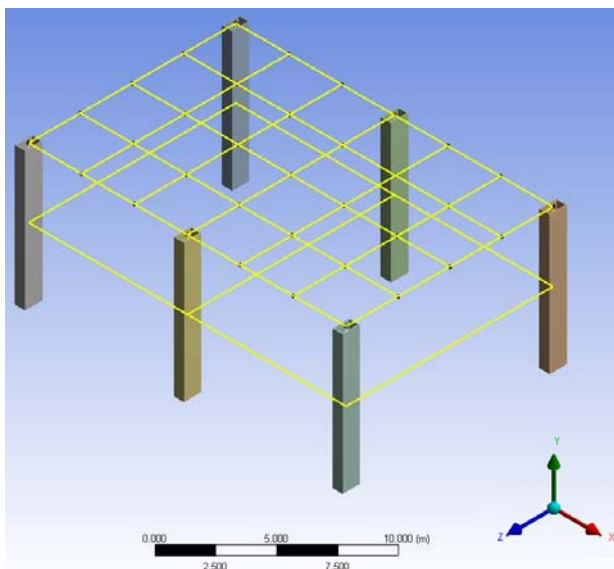
Figure 17. Linear model with assigned cross section to vertical columns.

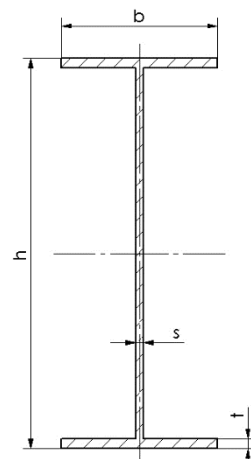
Figure 21. Cross section of the grillage structure.

$h$ (mm)	$b$ (mm)	$t$ (mm)	$s$ (mm)
$I_{1000}$	1000	400	25	20
$I_{500}$	500	220	17	12
$I_{400}$	400	180	13.5	8.6

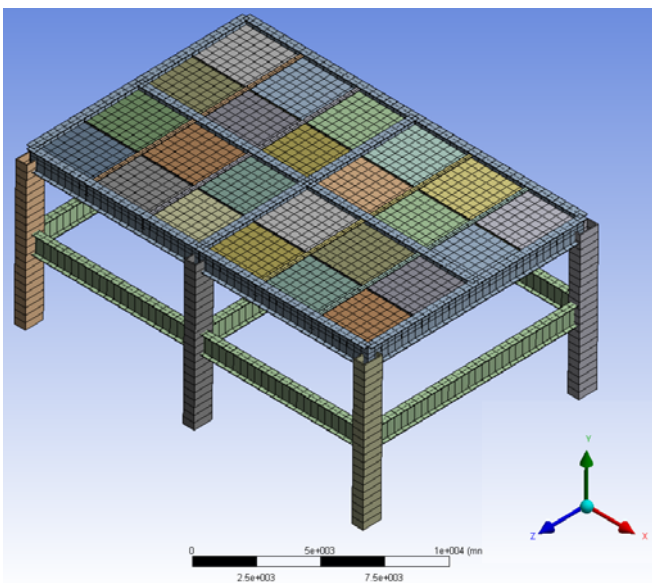
Subsequent to forming the 3D model, the finite element mesh is defined. Simplicity of the 3D model composed of linear elements, enabled use of the ‘sweep’ methodology, exclusively applicable for elements of constant cross-section throughout the whole length.

The ‘sweep’ method is very strict about fulfilling the conditions for its application, but on the other hand the generated finite element mesh is easy for further processing. Beneficial advantage of this methodology over others is the creation of rectangular, instead of tetrahedral elements. A reduced number of finite elements means reduced calculation and less memory required. The resulting finite element mesh is shown in Fig. 22. This mesh has 2722 FE, with 2324 nodes, having extremely moderate complexity compared to structure size (18.4 m × 12 m × 8 m).

Figure 22. Sweep mesh method on a 3D model.

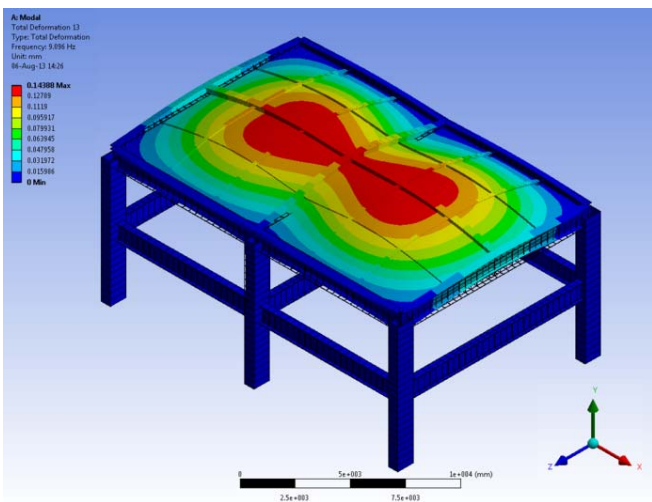
Before the search of natural frequencies it was necessary to define the model support type. In this case, the feet of the vertical columns are modelled as built-in support (in ANSYS it is called Fixed support). Mode shapes of the first three modes are shown in Figs. 23-25. Subsequent harmonic response analysis for the defined FE model is also conducted. Frequency range for this analysis is 0-900 Hz, with a step of 0.25 Hz. Analysis result is shown in Fig. 26.

Figure 23. Mode shape of the first natural frequency.

FEM analysis shows that there are three basic flexion modes of the floor integrated slab at 13, 30 and 63 Hz. At these frequencies there are no actually detected responses in

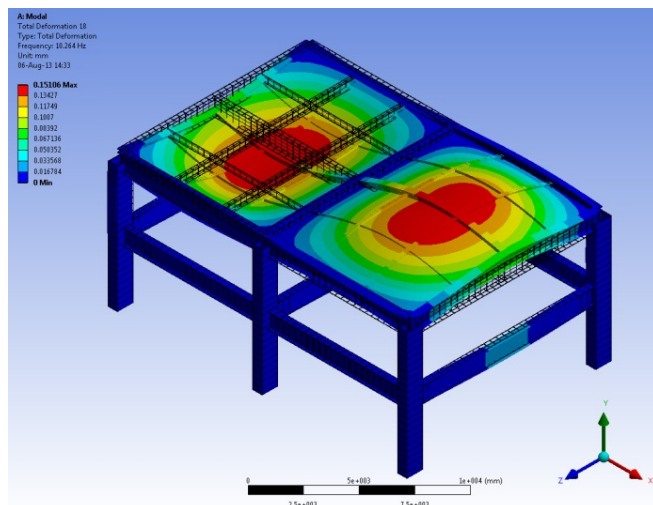
Figure 24. Mode shape of the second natural frequency.

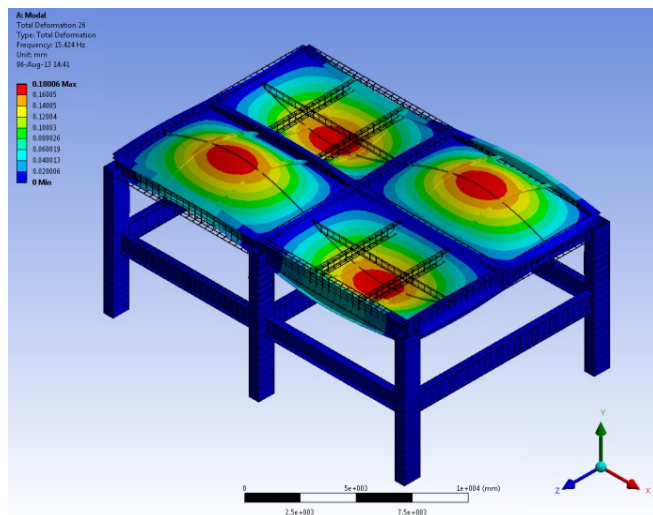
Figure 25. Mode shape of the third natural frequency.

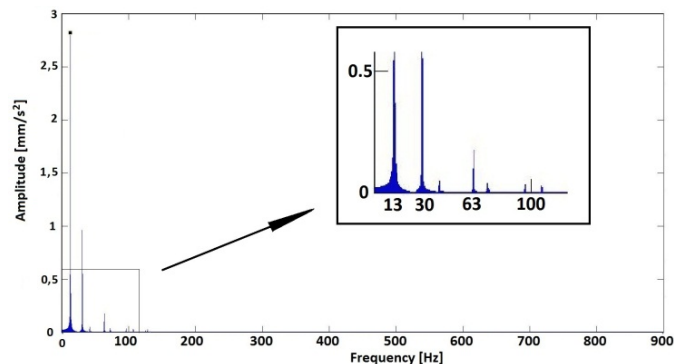
Figure 26. Result of ANSYS harmonic response analysis.

the structure. Just one frequency component (58 Hz) is close to the third calculated natural frequency (63 Hz).
