## CAVITATION RESISTANCE OF TURBINE RUNNER BLADES AT THE HYDROPOWER PLANT 'DJERDAP'

Originalni naučni rad / Original scientific paper

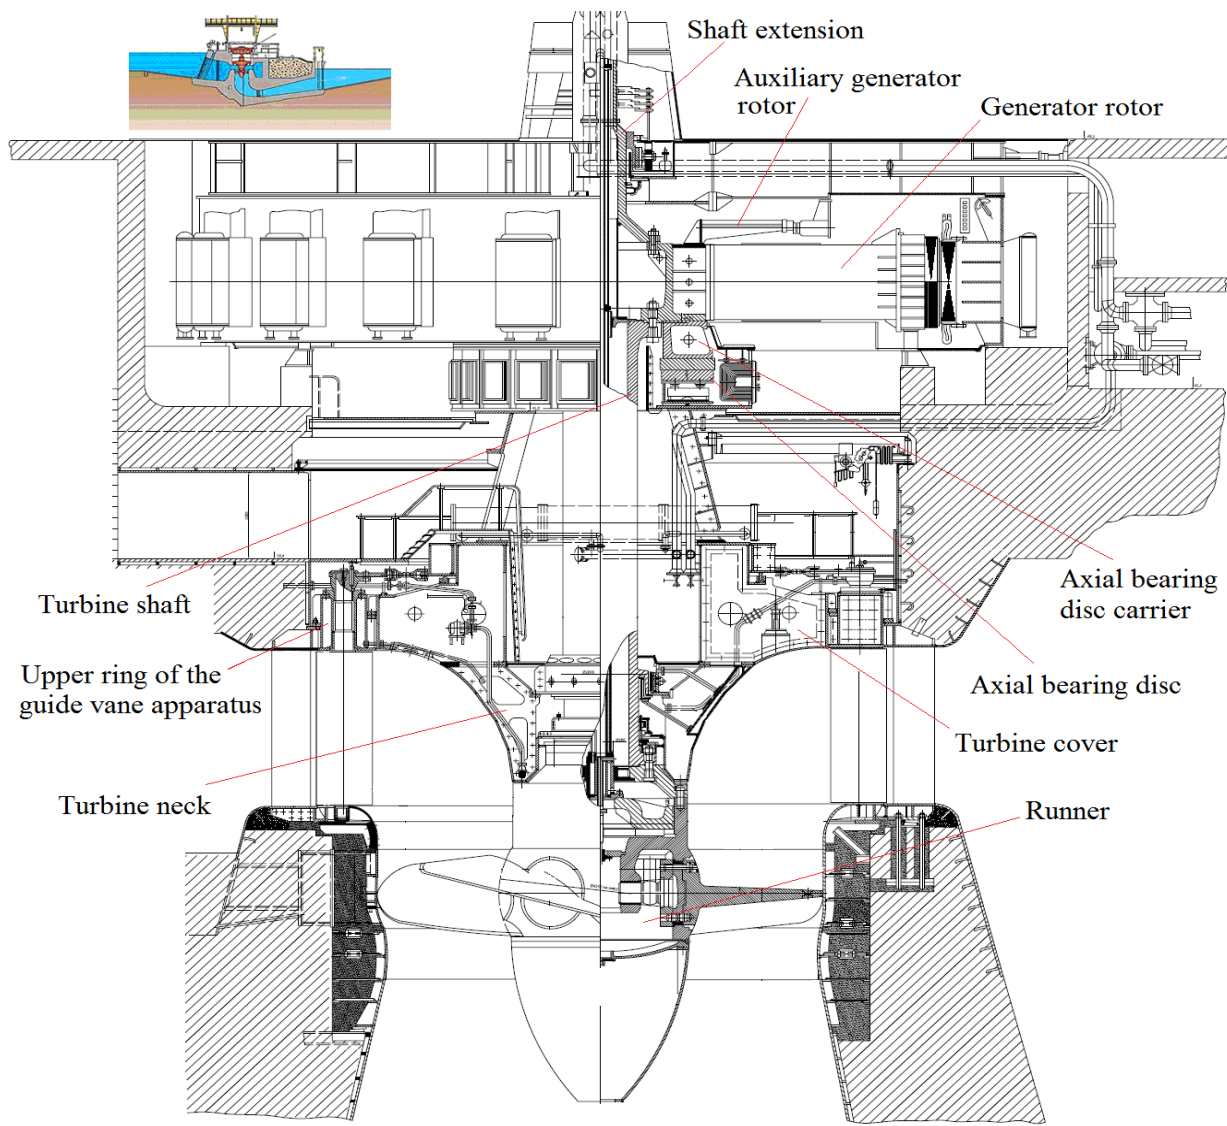
Figure 1. The vertical Kaplan turbine, nominal power 200 MW.

Vertical Kaplan turbines, manufactured in Russia, with nominal power of 200 MW, have been installed in 6 hydroelectric generating units at 'Djerdap 1', /1/, Fig. 1. Various non-destructive and destructive tests were performed on the parent material and welded joints for state analysis and assessment of the level of damage and degradation, as well as for the determination of causes for damage occurrence during the refurbishment of hydroelectric generating sets A4, A5, A6 and A1.

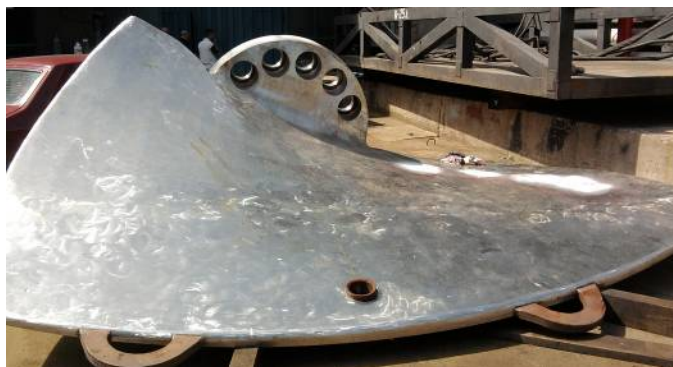
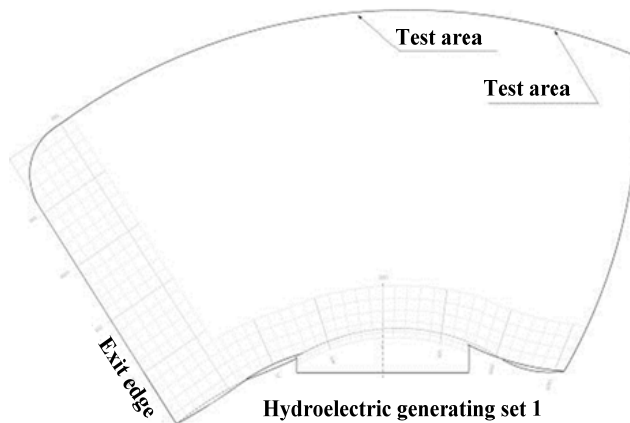
a) turbine runner blade

b) areas of the blade where damages occur the most

Figure 2. A turbine runner blade and areas where cavitation damages occur the most.

blade with areas where cavitation damages occur the most, is shown in Fig. 2. Figure 3 shows the area where cavitation damage has occurred before and after repair welding. The microstructure of the sample taken from one of the blades is presented in Fig. 4.

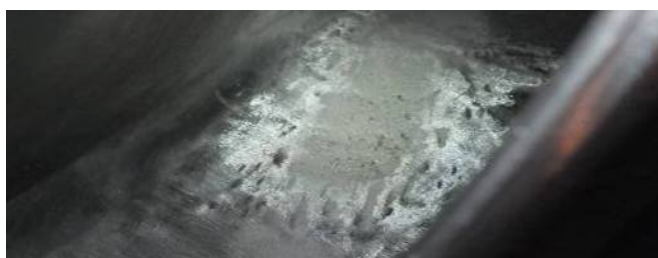
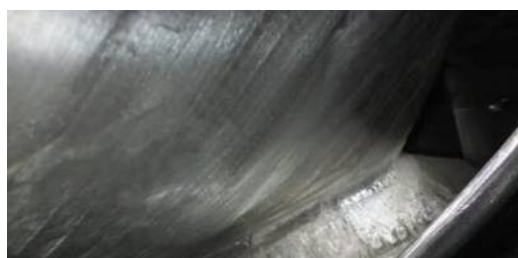
a) cavitation damage on a runner blade

b) runner blade area after repair

Figure 3. The area where cavitation damage has occurred before and after the repair.

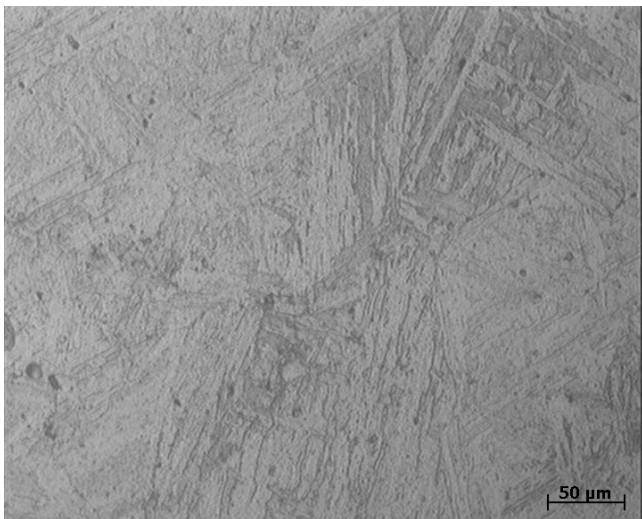
Figure 4. Microstructure of a sample taken from a blade, (martensite ferrite microstructure).

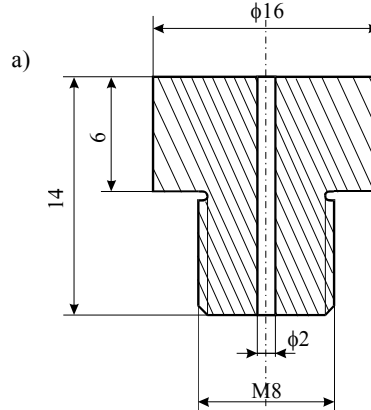
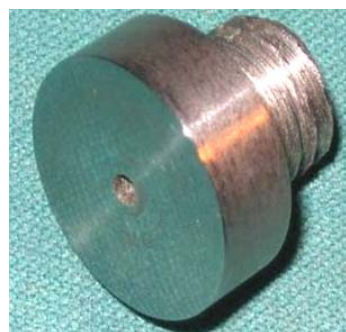
Figure 5. The test sample: a) basic dimension; b) photo, /7/.

The ultrasonic vibration test method is used for testing the resistance to cavitation of the cast steel sample, taken from a runner blade. In Fig. 5, a test sample with basic dimensions is shown, while Fig. 6 shows a device on which the tests were performed, /7/.

The sample is 16 mm diameter, 6 mm thick with an aperture at the centre of 2 mm diameter, and is coupled to the test rig by a screwed spigot 8 mm long. After machining, the test specimens are rubbed down on successively finer grades of emery paper, until 2400 grit is applied. Then, the specimens are polished with 6, 3, and  $1 \mu\text{m}$  diamond paste, to remove any work hardened layer formed during the manufacture of specimens. Mass loss of test specimens is measured with an analytical balance, accuracy of 0.1 mg,

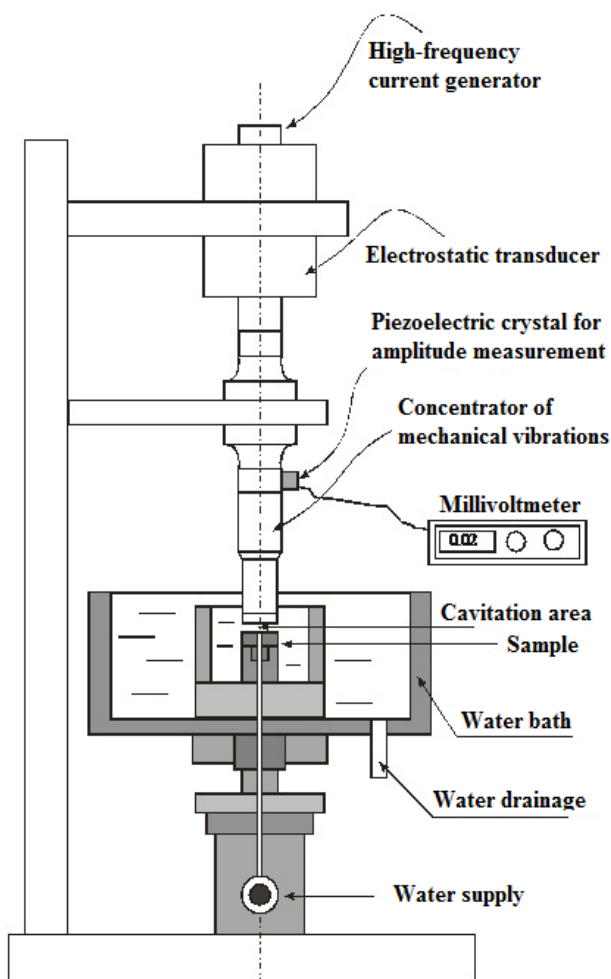
Figure 6. Schematic overview of cavitation test setup, /7/.

The vibration frequency and peak-to-peak displacement amplitude of the horn are  $20 \pm 0.5$  kHz and  $50 \mu\text{m}$ , in respect, with separation of 0.5 mm between the sample and horn tip. The cavitation area is formed below the frontal area of the horn and sample. The test is carried out in water at  $25 \pm 0.5$  °C. The water is brought to the water bath through an opening in the sample by means of a pump, and it cools the sample. At the same time, the water with its constant flow creates a pressure field which instigates the implosion of cavitation bubbles at the surface of sample.

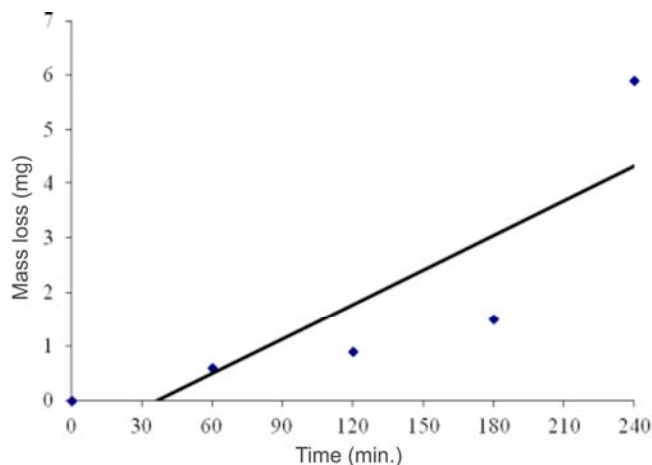
Results of mass loss measurement during the test period are shown in Fig. 7. The diagram shows the relation between mass loss and testing time. The curve is drawn by least-square method and data can be represented with straight lines. The slope of the line represents the cavitation rate. The intersection point of that direction and the abscissa defines the incubation period, the period of time during which no mass loss or destruction of material occurs due to cavitation, but only due to deformation (deformation strengthening). Figure 7 shows that the incubation period of the sample is about 40 min. as well as a significant mass loss starts to occur after 180 min. of cavitation action. The calculated value of cavitation rate of the sample is 0.025 mg/min. The value of cavitation rate and incubation period of the cast steel 08X15H4DMJI sample indicates a high resistance of the tested sample to cavitation.

Figure 7. Mass loss of sample during testing time.

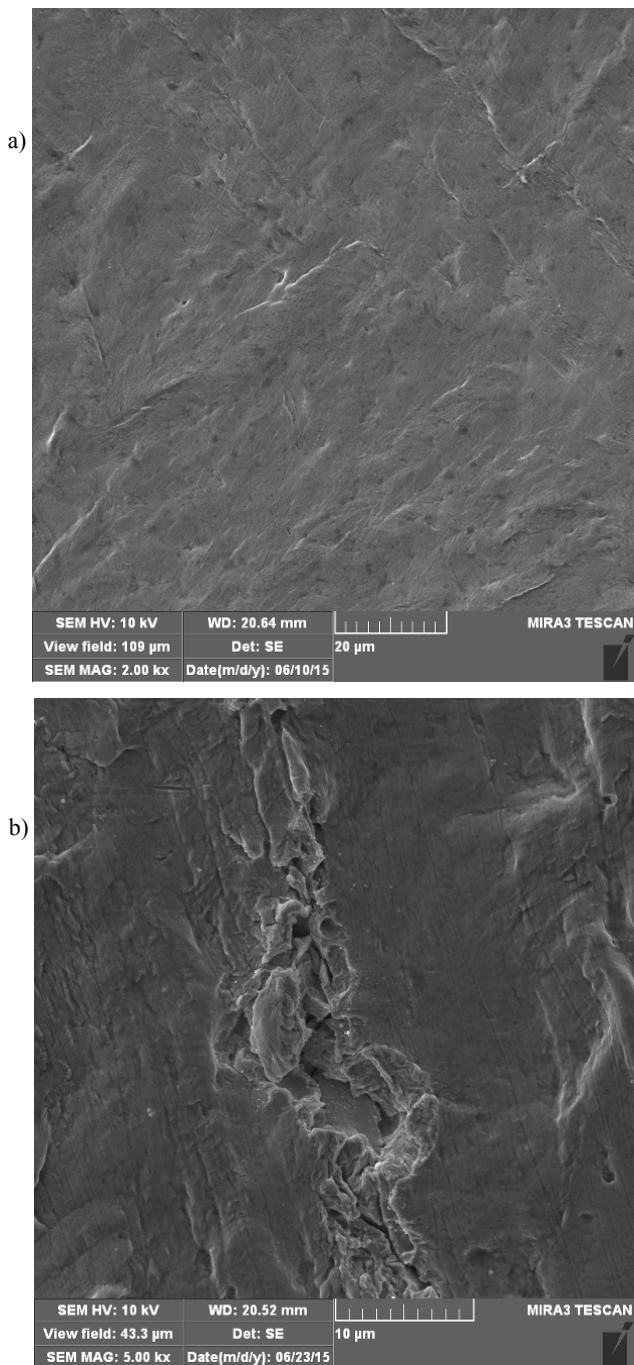
Figure 8. SEM micrographs of sample surface after: a) 60 min., and b) 120 min. of cavitation action.

Figures 8 and 9 show the morphology of the damaged surface of the test sample after each test interval.

Microscopic analysis of the surface of cast steel 08X15 H4DMJI sample after 60 minutes of cavitation action at SEM (Fig. 8a) shows that the surface layer starts to deform due to cavitation. Surface undulations of the sample show that plastic deformation of the surface layer occurs due to dislocation movement (incubation period lasts around 40 min., Fig. 8). Nevertheless, inclusions at grain boundaries block further dislocation movement, and therefore, cavitation action causes the weakening of bonds between the metal grains and the occurrence of initial pits along the grain boundaries. These pits in the surface layer cause the focusing of shock wave energy that occurs due to implosion of cavitation bubbles which intensifies the effect of cavitation action. At this stadium of testing, mass loss is initiated and localized only at specific locations of sample surface.

After 120 min. of testing, the surface morphology is characterized by distinctive plastic deformation (Fig. 8b). Also, at specific surface locations, the damaging of ferrite due to the initiation of microcracks occurs. In steels of martensite-ferrite microstructure, cracks mostly occur in the ferrite phase which is soft, while hard martensite phase acts as a barrier to crack propagation. The efficiency of this barrier depends on the volumetric share of martensite and the geometric distribution of phases. The morphology of the sample surface after 180 min. of cavitation action (Fig. 9a) shows that during this period the surface roughness increases, or in other words, the damaging of the marten-

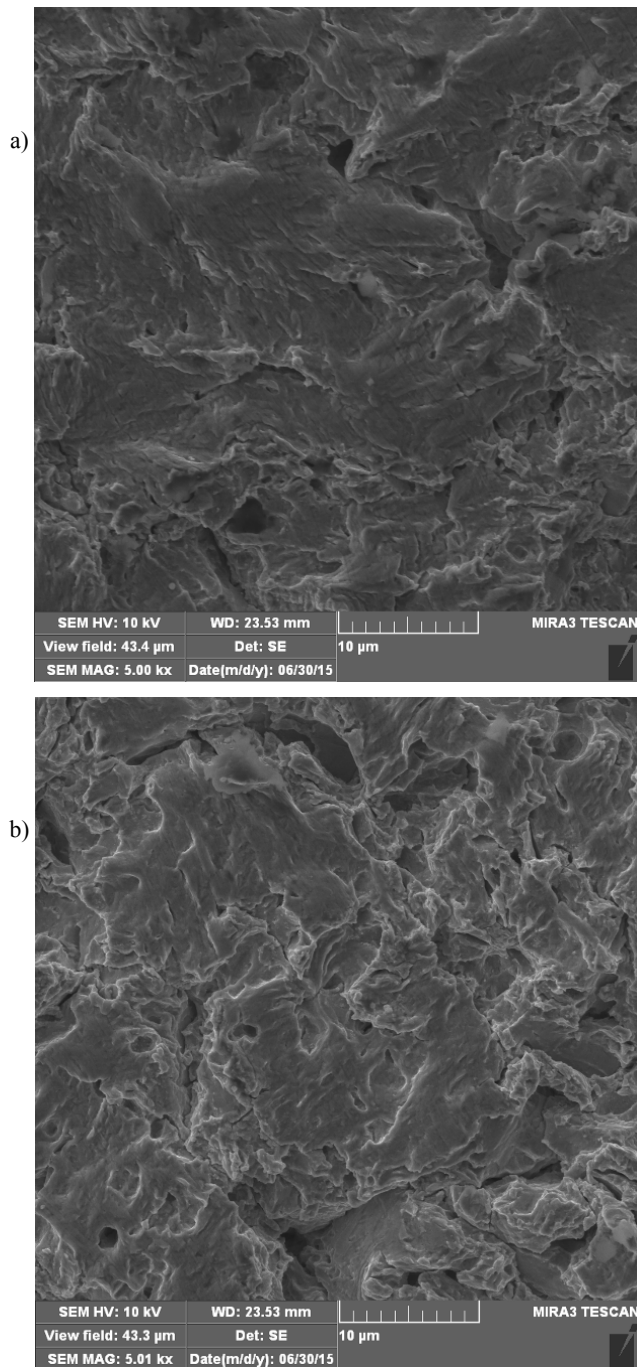
Figure 9. SEM micrographs of sample surface after: a) 180 min., and b) 240 min. of cavitation action.

sitic phase has started as well. The removal of material starts at boundary surfaces of martensite slats, in a form of small pits. At the damaged surface of the sample, a net of microcracks forms, as well as local micro pits. When shock waves and micro jets, that occur due to the implosion of cavitation bubbles, continue to act on the surface during further action of cavitation, the degradation rate of the material increases. The morphology of the surface after 240 min. of testing proves that fatigue is the main degradation mechanism (Fig. 9b), because there are many pits and grooves with distinctive plastic deformation at the damaged surface of the sample.
