APPROACHES IN FORENSIC ENGINEERING OF EXCAVATING UNITS OPERATING ON OPEN PIT MINES OF SERBIA

Abstract: *Bucket wheel excavators (BWEs) are a backbone of any power industry that heavily relies on surface exploitation. As such, any failure, breakdown or collapse of the machine or its subsystems poses a serious drawback in the efficiency of an entire mining system, and is strongly reflected on costs in labour, finances, material and downtime, and is also a potential risk to the safety of workers. This, combined with lengthy lifetime of the machines operating in open cast mines of Serbia (measured in decades), places immense value on the avoidance of potentially hazardous problems during all stages of their lifespan, namely the design, manufacture and exploitation phases. Over the past decades, demand for the ever-increasing capacity and efficiency of BWEs has led to failures which may indicate a need for the reassessment of the calculation methods and guides. This paper presents few such cases, along with the discussion about causes, and suggests an approach to dynamic behaviour analysis based on reduced spatial dynamic models of BWEs which enable modal analysis and the analysis of a

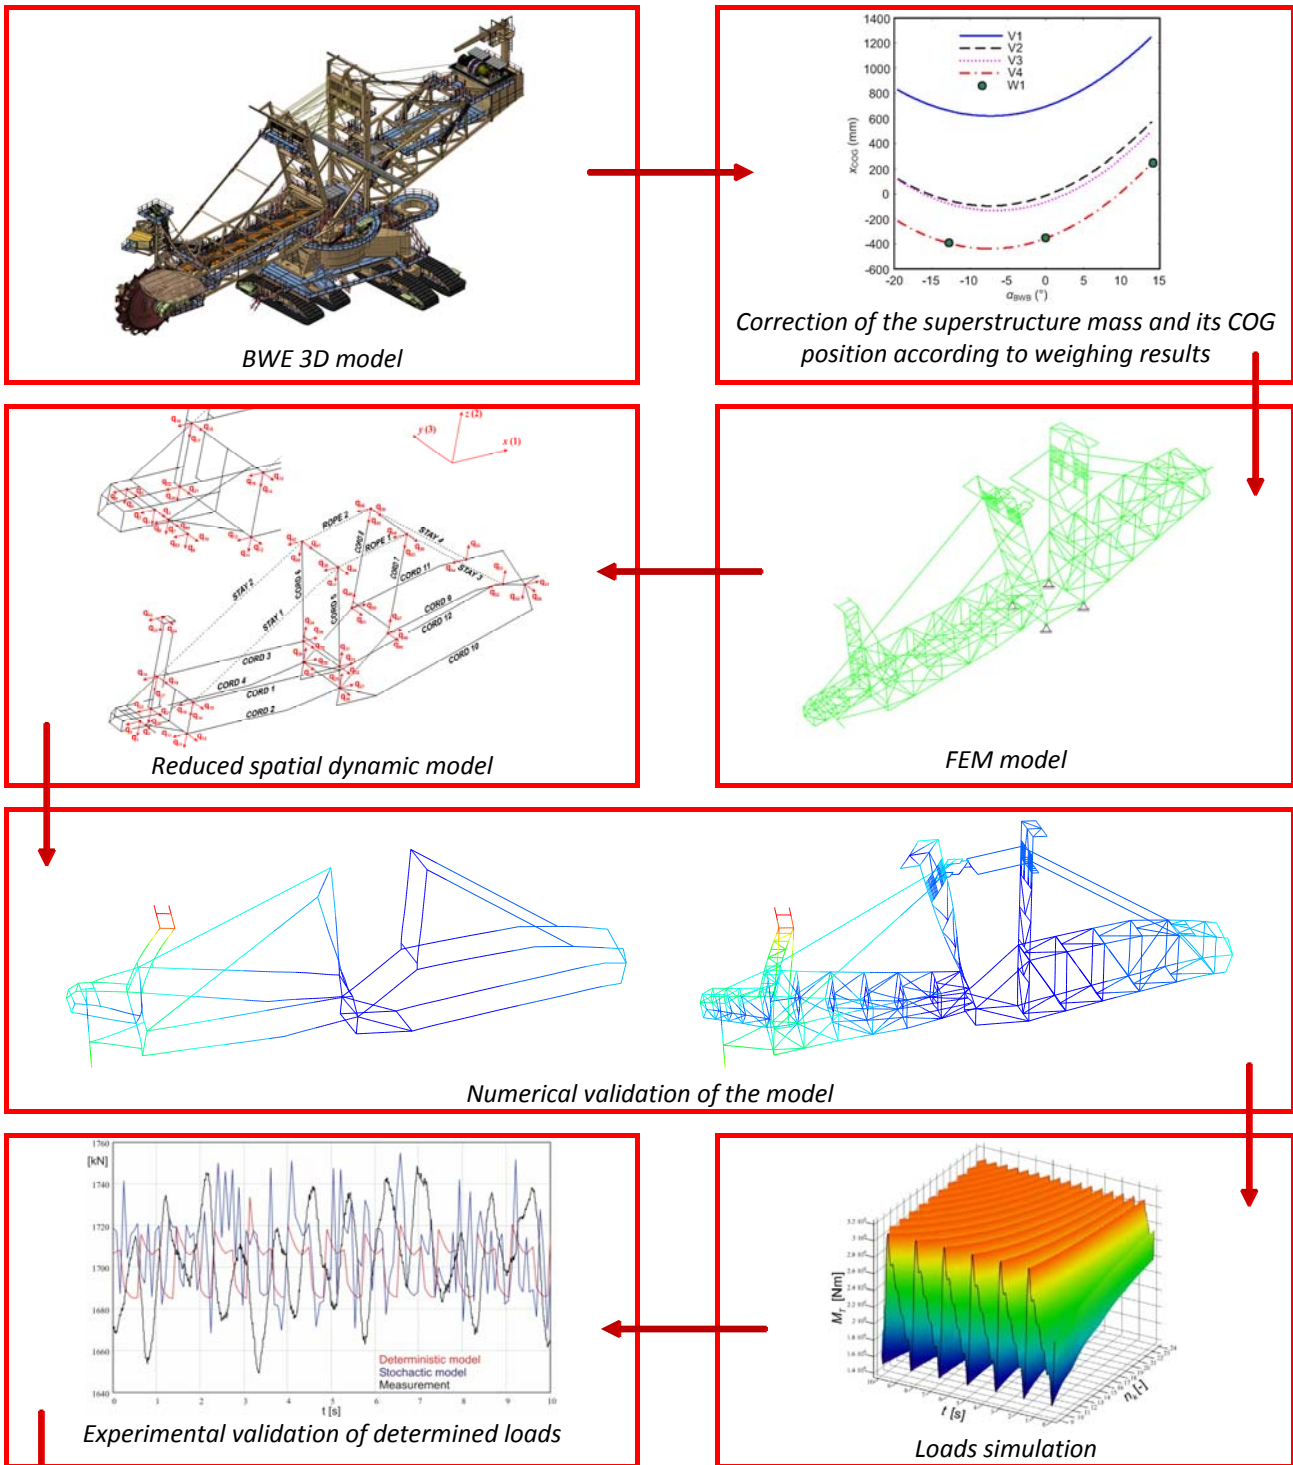
Picture 1. – Identification of the dynamic response

Key stages of the identification procedure of BWEs response to dynamic impacts, realized based on reduced spatial dynamic model approach, which enables modal analysis as well as analysis of the dynamic response in the continuous domain of constructional parameters variation, are presented in picture 1.

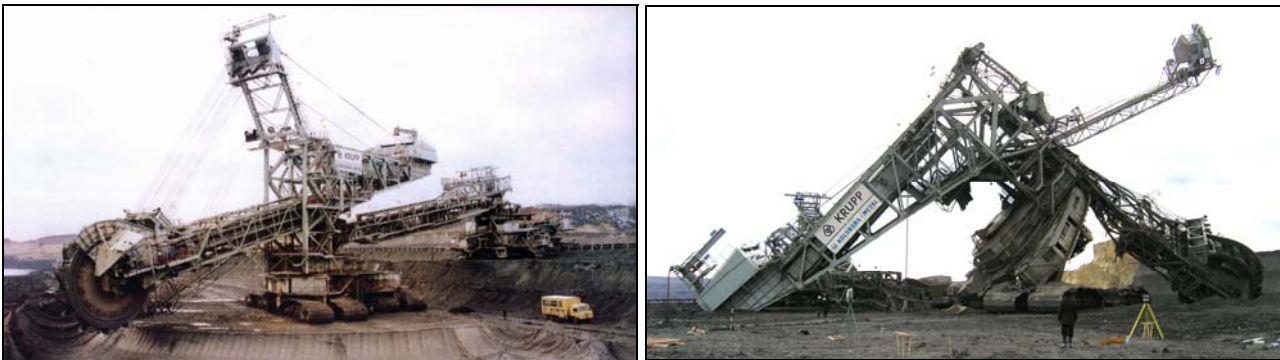
After a mere sixteen years of exploitation, a heavy accident caused a total collapse of the BWE SchRs 1760, picture 2, a machine with the highest theoretical capacity at that time (6100 m³/h), operating on the overburden excavation on open pit mine “Kolubara”. Revitalization process, which included the dismantling of the complete BWE structure, its transport to the erection site, repair and manufacturing of almost every part of the superstructure and putting it back to service, lasted for almost five years. Direct expenses in terms of material and labour were estimated to be around fifteen million Euros [13]. However, indirect losses, caused by the BWE’s downtime substantially exceed revitalization costs.

Picture 2. – BWE SchRs 1760 before and after the collapse [14]

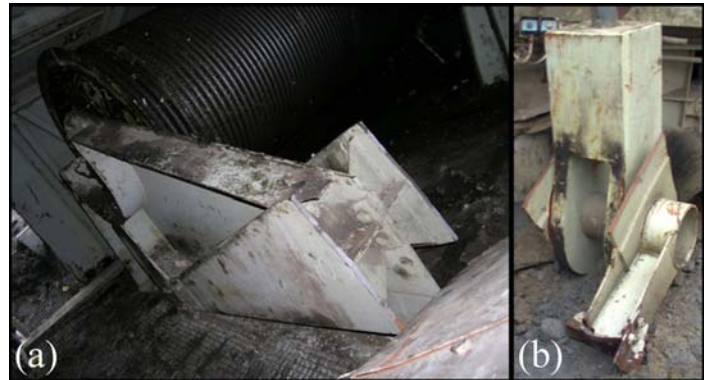
Damage diagnostics concluded that the straightforward cause of the BWE collapse was the failure of the end eye connection of the support of the right portal tie-rod, picture 3.

Picture 3. – 3D model and the broken-down support of the right portal tie-rod [13]

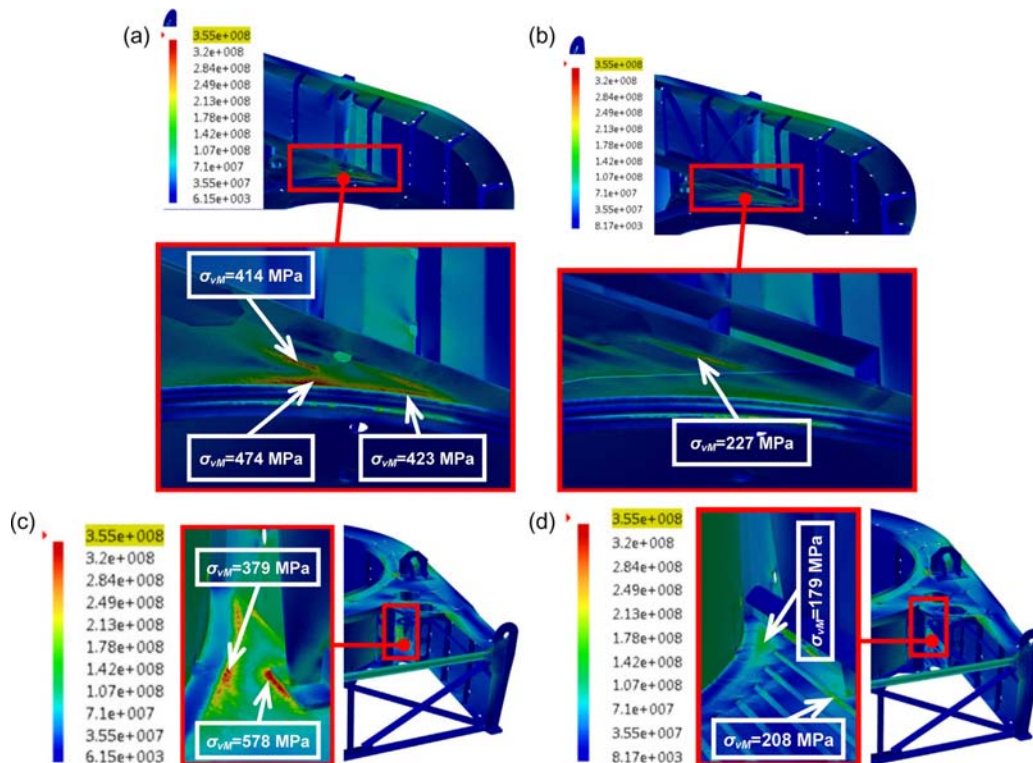
Comparative stress analysis, conducted for the referent load case (in which the maximum value of the von Mises stress in the bottom plate of the original slewing platform is considerably higher than the permissible stress value in zones where cracks occurred during perennial exploitation) of both the original and redesigned solution revealed the following facts: (a) the maximum von Mises stress value on the bottom surface of the bottom plate is 2.1 times lower in the redesigned structure; (b) the maximum von Mises stress value on the upper surface of the bottom plate is 2.8 times lower in the redesigned structure, picture 9.

Picture 9. – Von Mises stress fields in critical zones of the slewing platform: (a and c) original structure design; (b and d) redesigned structure) [16]
