Repair Methodology for the Carrying Structure of the Rejecting Drum of the Bucket-Wheel Reclaimer Stacker Conveyor at Coal Landfill

Damaging of the carrying steel structure and embedding of the rejecting drum of the stacker conveyor occurred during the exploitation of the bucket-wheel reclaimer with the belonging stacker. The analysis of the cause and level of damaging led to the conclusion that damaged parts should be replaced by new ones and that methodology of repair should be based on the application of a suitable welding technology. This paper presents the methodology of repair welding performed during the replacement of the damaged carrying structure and embedding of the rejecting drum of the stacker conveyor which consist of steel sheets and profiles that's based on the conceptual solution for damage repair through the use of program package 'Catia' – V5 that enabled the creation of models and graphic documentation of structural parts that should be replaced by new ones. It should also be noted that geodetic survey of the lower belt of the stacker structure was performed after the substitution of damaged parts of the structure.

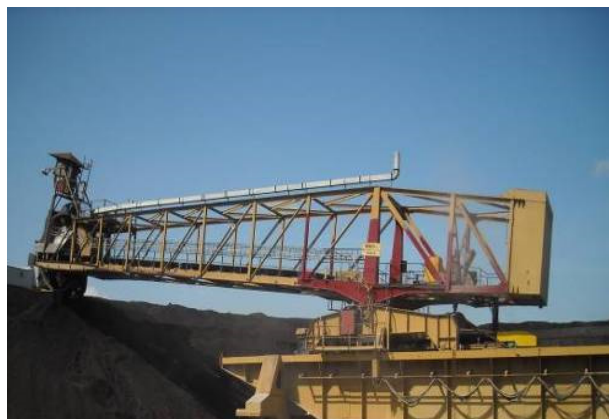
a) Bucket-wheel reclaimer (DU1);

Figure 1. Appearance of the bucket-wheel reclaimer with internal designation DU1 and of the boom of the belonging stacker at the coal landfill.

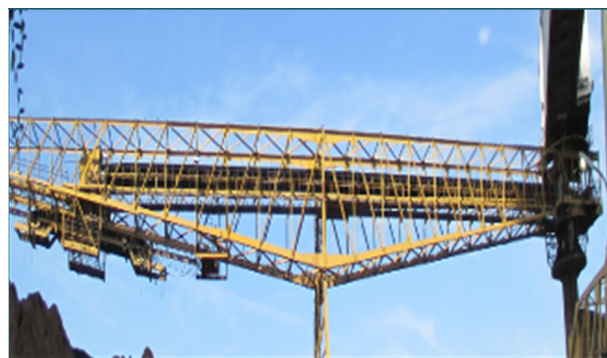
b) Appearance of the bucket-wheel reclaimer (view from the side);

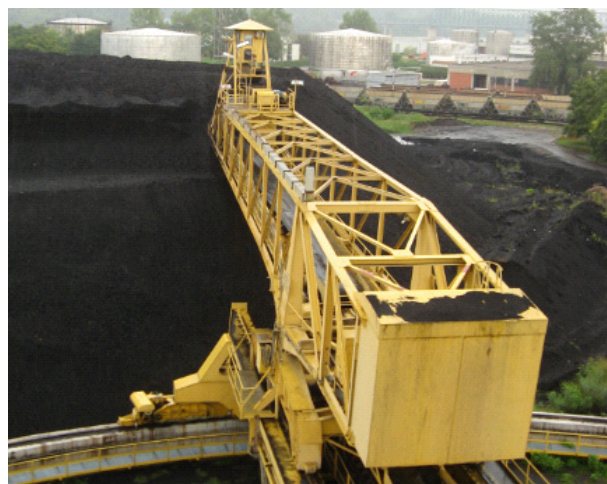
c) Appearance of the bucket-wheel reclaimer (view from behind)

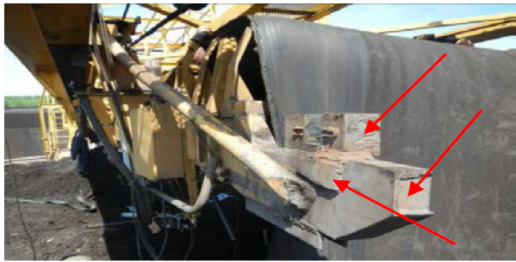
a) Damage that occurred on the carrying structure of the drum (right side);

Figure 2. Appearance of damages that occurred at the carrying structure and embedding of the stacker conveyor rejecting drum.

Through the analysis of damages and executed temporary repair of the support steel structure and embedding of the rejecting drum of the bucket-wheel reclaimer stacker conveyor, shown in figures 2 and 3, it can be concluded that temporary repair has not been successful, because figure 3 clearly shows that welded joints have not been executed properly, as well as that

geodesic deviation between the carrying steel structure and embedding of the rejecting drum of the stacker conveyor occurred. Only by replacing the complete section of the damaged structure its integrity and service life could be maintained.

After the determination of the cause and amount of damage that occurred at the steel structure of the rejecting drum of the bucket-wheel reclaimer stacker conveyor during service it was concluded that repair methodology should be based on the application of adequate welding technology.

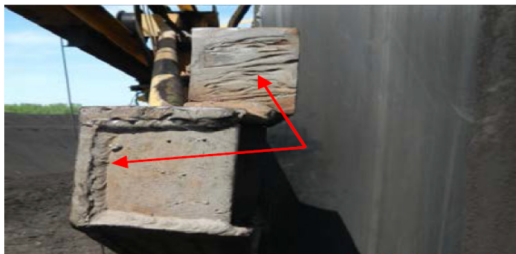
c) Detail that indicates the cause of geodesic deviation of parent material during the repair of carrying structure;

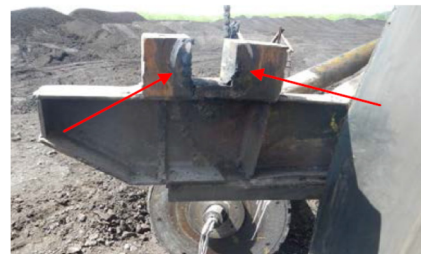
d) Damage at the structure of an embedding of the stacker conveyor rejecting drum – detail;

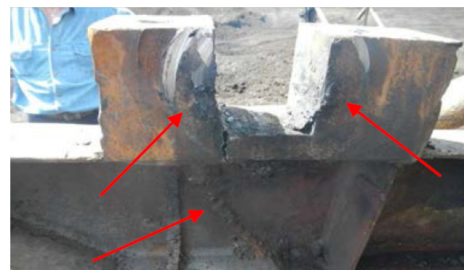
f) Damage and a crack at the carrying structure of an embedding of the stacker conveyor rejecting drum

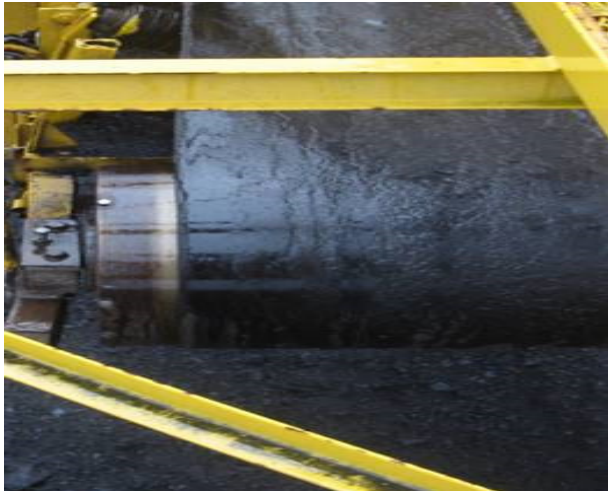
Figure 6. Appearance of the rejecting drum after the installation of new components at the carrying structure

During and after welding testing of welded joints by non-destructive methods was carried out (visual testing [5], magnetic particle testing [6], penetrant testing [7] and ultrasonic testing [8]). Geodetic survey was also performed in order to determine if the carrying steel structure and embedding of the rejecting drum were brought to an adequate position and therefore restored functionality.

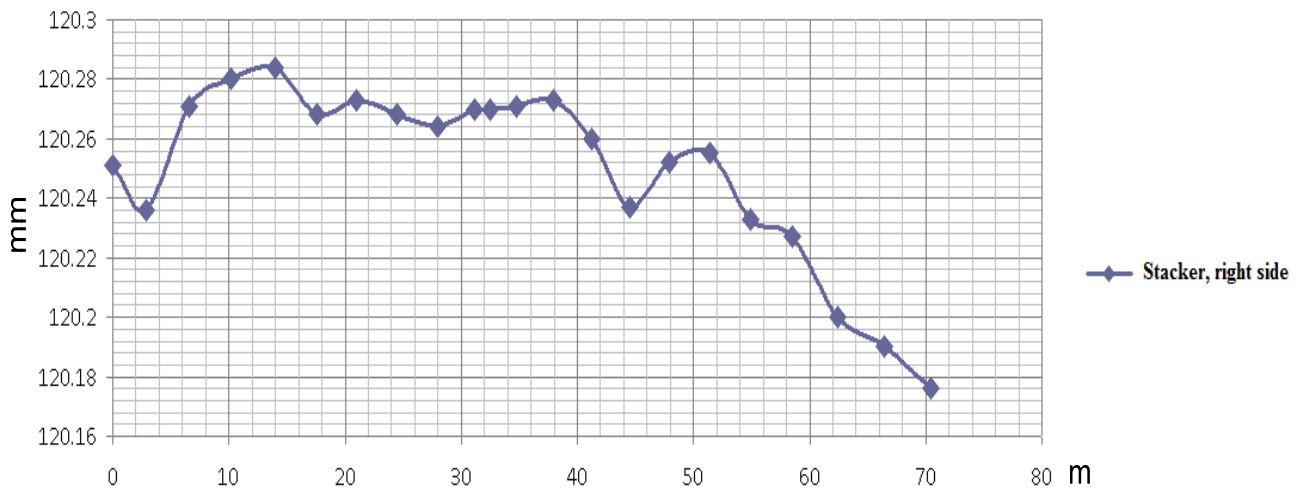
Results of the geodetic survey carried out in order to establish the condition of the lower belt of the welded lattice structure of the stacker boom after the repair of the carrying structure and embeddings of the rejecting drum show that there is no significant deviation from predetermined geodetic values.

Figure 7. Appearance of results of geodetic survey that refer to the right side of the lower belt of the stacker structure

Results of the geodetic survey of the condition of the welded carrying structure and embedding of the rejecting drum after the repair are presented in figures 7 and 8, as well as in tables 1 and 2.
