# EXPERIMENTAL AND NUMERICAL ANALYSIS OF FLAT CARS CONNECTIONS BETWEEN PIVOTING STANCHIONS AND MAIN LONGITUDINAL BEAMS

***Abstract** – This paper presents experimental and numerical strength analysis of some existing designs of connections between pivoting stanchions and main longitudinal beams of flat cars, pointing out the problem of possible appearance of high contact stresses at some contact surfaces, that might cause some local deformations within plasticity range. Criterion set in the applicable standard requires that two side stanchions fitted to the wagon and positioned opposite each other, shall be able to withstand, without residual deformation, a force of 35 kN acting at 500 mm from the bearing centre of the stanchions in a horizontal direction towards the outside of the wagon. Meeting this criterion and staying inside the limited available space, leaves only minor changes of dimensions of moving parts in a contact as a possible solution of this problem.*

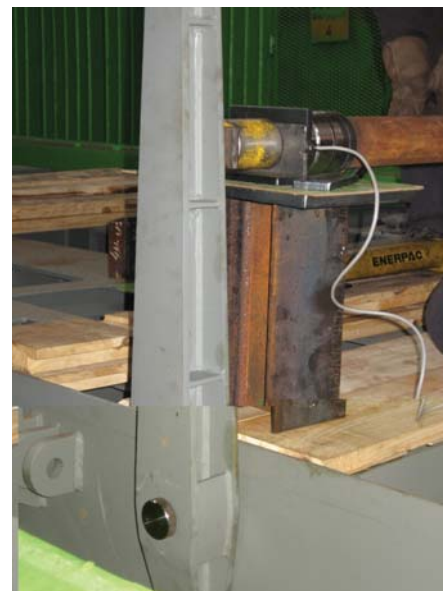
*Fig.1. Side stanchion*

In Figure 1 is presented existing design of the connection between pivoting stanchions and main longitudinal beam on the flat car [1]. Pivoting stanchion is made of steel grade S355. Connection is provided using a bearing pin (figure 2, pos. 1) and U-shaped securing element with cotter pin (figure 2, pos. 2 and 4). In such a way is enabled easy assembling and dismantling of the stanchion in service. Motion stops placed on the outer side of the main longitudinal beam are using as prevention of rotation about bearing pin in locked position.

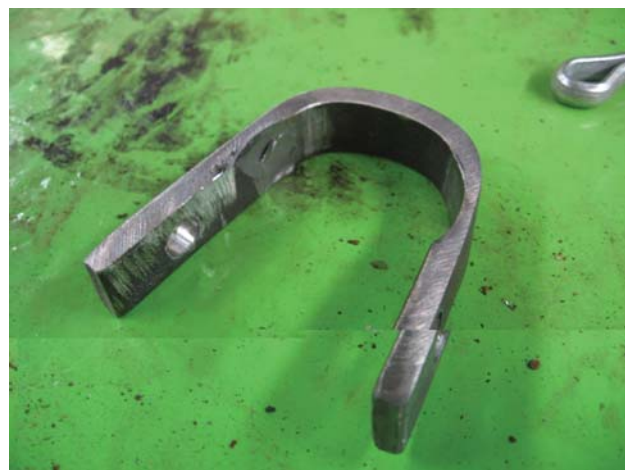
Fig.3. Deformed U-shaped securing element

During testing of the side stanchion appeared a problem with U-shaped securing element (figure 2, position 2) which suffered deformation in the plasticity range, jeopardizing safety of the connection (figure 3).

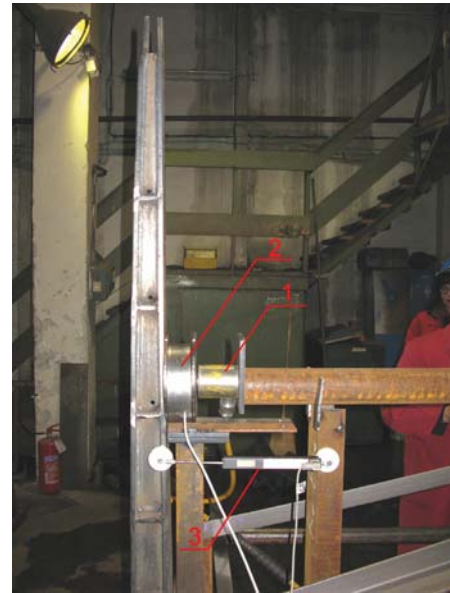
*Fig.8. Measurement equipment*

Test was performed according to requirements defined in [2] by applying pressure force between the two opposite stanchions at 500 mm above pivoting centre (figure 8). Force equal at least 35 kN was produced using hydraulic cylinder (position 1) placed in series with force transducer (position 2). Pressure in the cylinder was achieved using hand hydraulic pump and permanent deformations of the stanchions were measured using displacement transducer (position 3).

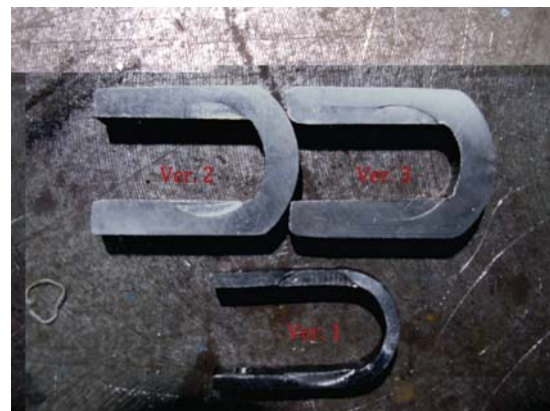
*Fig.9. U shaped securing elements after testing*

Version No. 2 with increased thickness of the securing element showed relatively lower surface damage, while version No. 3 with improved U-shaped securing element and replaced bearing pin with the aim of increasing of the contact surfaces between bearing pin and securing element showed minor surface settlement of all contact surfaces. It should be mentioned that surface damage of the version No. 3 in figure 9 and 10 is a result of a force equal to 50 kN and not under required 35 kN. The reason for that was to check additional safety margin of the connection design. Version No. 2 and No. 3, besides minor surface damage did not suffer other damage which may jeopardize function of the connection between the pivoting stanchion and the main longitudinal beam. Measured deformations of the stanchions using displacement transducer for all three versions of design (if appropriately fastened) were within accuracy range and were less than 1 mm, measured at the point of application of the required load equal to 35 kN.
