8th International Scientific Conference on Defensive Technologies

PROBLEMS AND ACQUIRED EXPERIENCE IN THE DEVELOPMENT OF DOMESTIC HIGH-PRESSURE PUMPS

Abstract: *The paper presents the applied methods of testing, observations, problems and experiences gained during the development of a domestic high pressure pump at the Military Technical Institute, which can be of interest and benefit to the wider professional public. The pumps are intended and specially designed for diesel engines, with the nominal power of up to 1000 hp, and are produced in many varieties, in our country and abroad, in large number. The development of this pump proved to be very important, as the foreign business partner cancelled the contracted cooperation in the production and delivery of serial engines high-pressure pumps. Problems got even more complicated when the domestic manufacturer, after the ownership transformation, gave up the further cooperation on the almost agreed production of the domestic pump. In the last five years, efforts have been made to enable a domestic manufacturer to produce the pumps. Although it is a company that has never previously dealt with the development and production of such

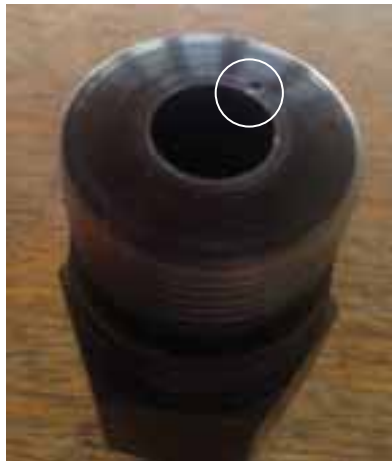
Figure 7. A recess of approximately 1.5 mm in diameter on the front surface of the release valve assembly

8) On the front of the release valve assembly, on which the reservoir body is located, in the 9th element of the P505 pump, a recess with the diameter of approximately 1.5 mm (see Figure 7) is noticed. This circuit was replaced with a set produced in IPM.
