IDENTIFICATION OF ERGONOMIC HAZARDS AND RISK ASSESSMENT FOR THE WORKPLACE OF OPERATOR OF A BUCKET-WHEEL EXCAVATOR - CASE STUDY

Aleksandar Zunjic^{1, a}, Igor Cosic^{2, b}

¹University of Belgrade, Faculty of Mechanical Engineering, Belgrade, Serbia

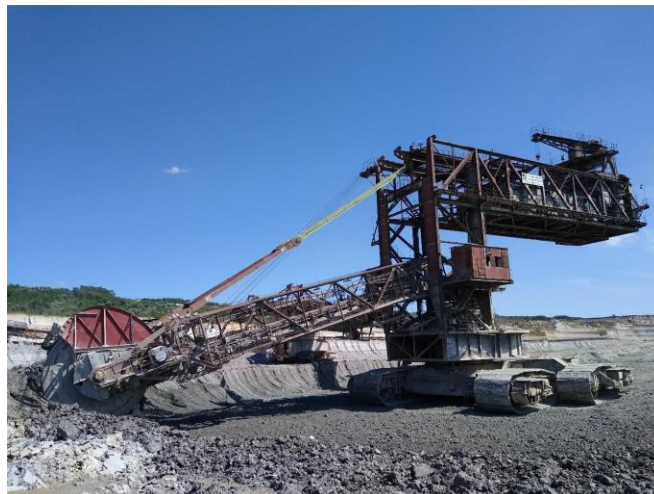
Figure 1. Bucket-wheel excavator SRs 1200x24/4.

The results obtained on the basis of the application of the observation method will be presented here. Figure 1 shows the bucket-wheel excavator that is the subject of this study.

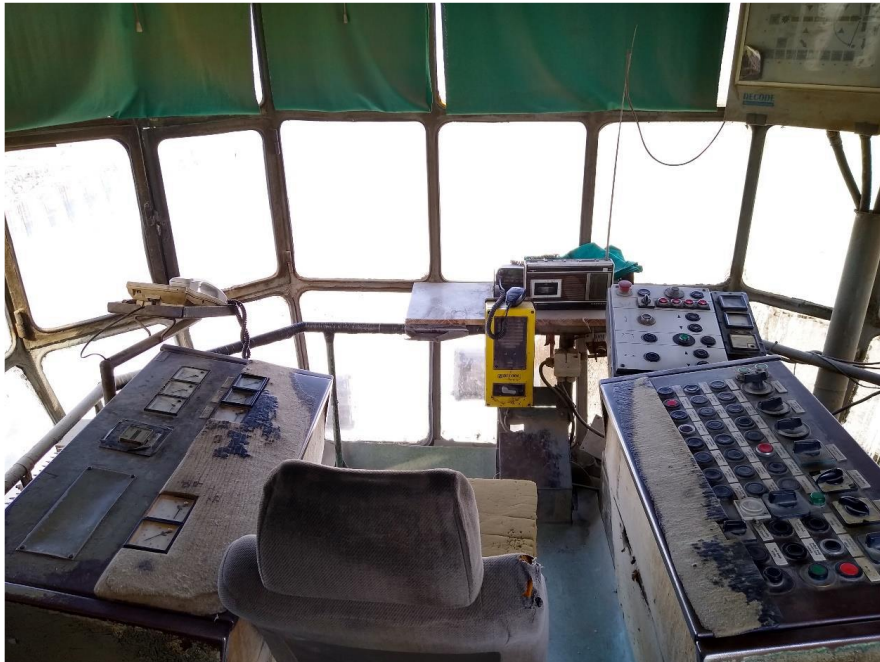
Figure 2. Control cabin of SRs 1200x24 /4 bucket-wheel excavator.

Figure 2 shows the cabin of the operator who operates the bucket-wheel excavator for excavating tailings in surface coal mining.

In Figure 2, on the right side of the control panel, the control organs are arranged, by means of which the operator assigns control actions to the bucket-wheel excavator. On the left side there is a control panel, on which there are displays, which serve to monitor the vital parameters for the operation of the machine. Among others, there is a display that shows the state of overload of the bucket-wheel excavator. In the front center part of the cab, there is an operator's chair that cannot be rotated.

A table with hazards grouped by hazard types was used to identify hazards [1]. Since the subject of consideration is the operator's cabin, the emphasis is on the identification of ergonomic hazards. The first danger that can be noticed in Figures 2 and 3 is the inadequate placement of controls and indicators. The design of the controls and indicators is inappropriate, as the controls and indicators are placed laterally in relation to the operator, at an angle of 90^0 degrees or more in relation to the line of sight of the operator. Some of the controls and displays are out of visual angle, so it is necessary for the operator to turn itself in the chair to activate a command or read a value from a display. In this way, the operator is forced to spend most of his working time in an inadequate body position, which can lead to acute problems in the musculoskeletal system (for example, sciatica). In addition, due to many years of the incorrect position of the torso, neck, shoulder girdle and arms, chronic (tendonitis) and even irreversible changes in the musculoskeletal system (for example scoliosis) can develop.

Figures 2 and 3 show another hazard, which arises from the installation of ordinary glass in the cabin. This glass cannot filter sunlight, and can often penetrate directly into the operator's field of vision. The effect of sunlight on the visual system of the operator is most pronounced early in the morning or in the evening when the sun is low on the horizon. Given this, not only that the operator may be unable to complete the operation and that he can experience an execution error as a result of this, but such a situation may also impair the operator's vision. Blurred vision, sensitivity to light, excessive tearing, blindness are some of the effects of short-term and long-term exposure of the eyes to the action of the sun's rays.

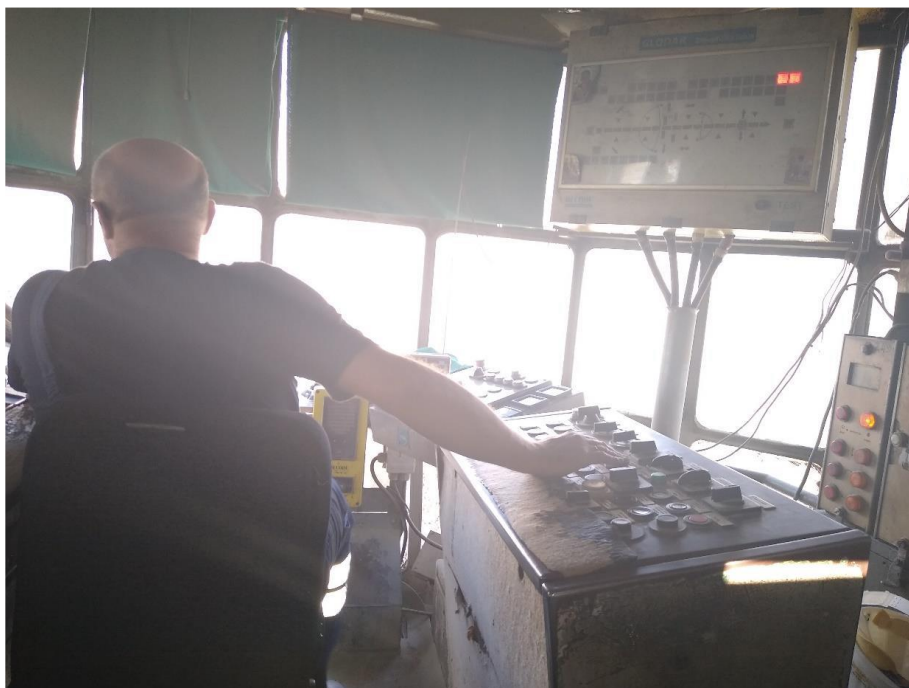
Figure 3. Usual working position of the bucket wheel excavator operator.

Figure 3 shows the usual body position of the operator during the operation of the bucket-wheel excavator.

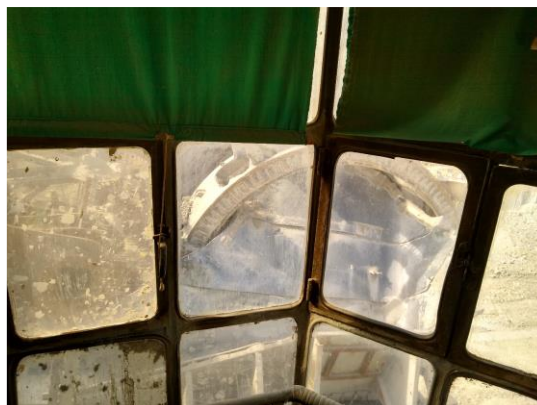
The next hazard is also the consequence of an inadequate design solution for the windows in the excavator cabin. Outdoor weather conditions, such as rain, snow and dust, can lead to reduced visibility and soiling of the cab glass. However, the cabin is not equipped with wipers that could reduce this harmful effect. The cabin has only one small window (Figure 4), which can eventually be used to occasionally wipe dust or falling snow from the glass surfaces of the cabin.

Figure 4. The exterior glass surfaces of the operator's cab are not equipped with wipers to clean them.

Although impaired visual interaction of the operator cannot cause damage directly to the operator, it can jeopardize the execution of the work task and cause an unsafe situation where the material is unloaded to a location that is not intended for that. Also, in this way, in conditions when the operator is not able to clearly see the details in the external environment, in very rare unfortunate circumstances, a natural person outside the excavator can be injured by part of the excavator or the material being transported.

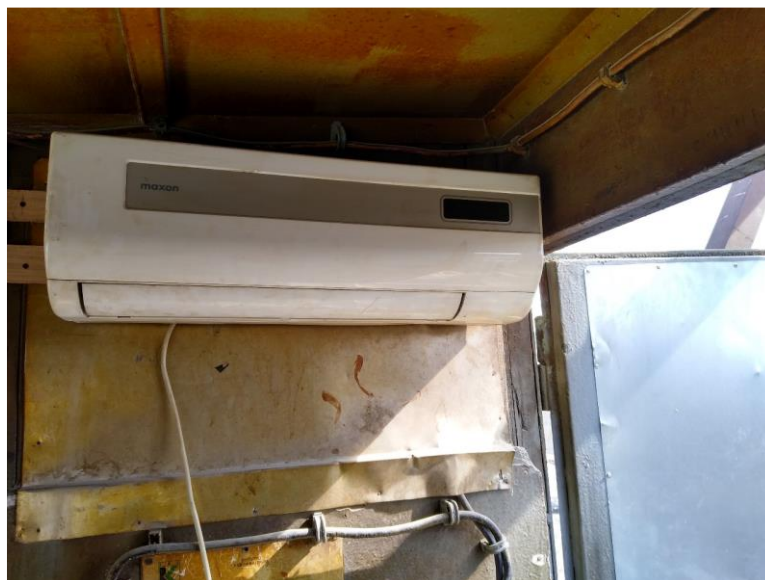
Figure 5. Air circulation based on the use of air conditioning in the excavator cabin.

As already mentioned, the cabin has only one window that can be opened. However, even when opened, a large amount of dust enters the cabin. For this reason, the operator relies on the operation of the air conditioner installed in the cabin as shown in Figure 5.

The problem, however, is that the air conditioning filter is cleaned only once a year, usually before the start of the summer season. Given that, in the bucket-wheel excavator cabin, we identify a new danger, inadequate air quality with a large amount of carbon dust. These carbon dust particles can have short-term and long-term, serious effects on the health of operators.
