SIGNIFICANCE AND APPLICABILITY OF STRUCTURAL INTEGRITY ASSESSMENT ZNAČAJ I PRIMENLJIVOST OCENE INTEGRITETA KONSTRUKCIJA

Pregledni rad / Review paper

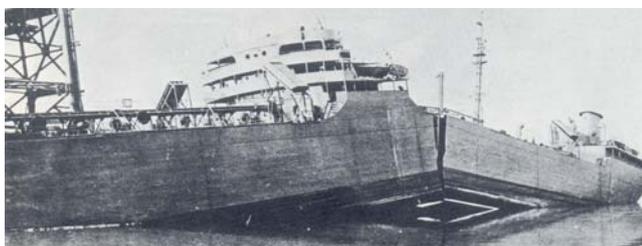
Figure 1. The "Schenectady" fractured amidships (1943), /2/.
Slika 1. Lom broda „Skenektedi“ po sredini (1943), /2/

In many cases experienced failure of objects is not explicable at the time of occurrence, requiring detailed and extended investigation, research and experimental analysis, /1/. It was also performed after successive serious failures of ships (Fig. 1) during the Second World War, /2/. It is revealed that the fracture of ships initiated from a crack, negligibly small compared to the size of the structure. These fractures had been simultaneously treated for several years in many institutes worldwide, whereas the problem was complex and required cooperation of scientists from all involved countries. The performed investigation can be considered as an initial step in the development of fracture mechanics.

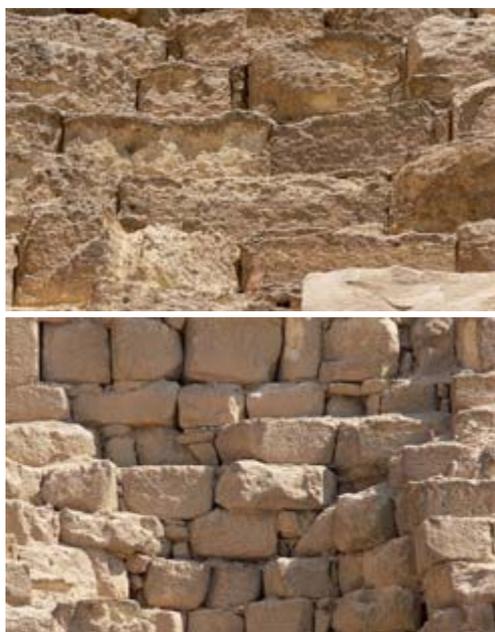
Figure 3. Blocks that appear to have been cast (top); blocks most likely not cast (bottom).

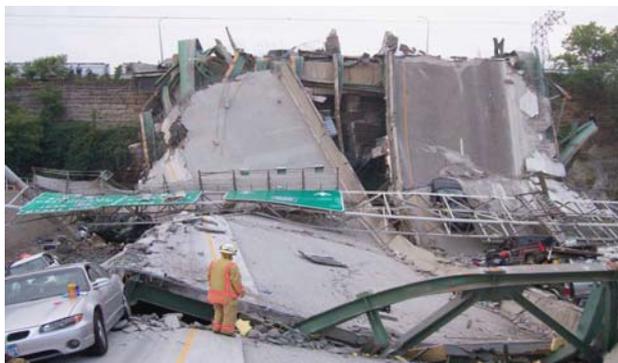
Figure 7b. The collapsed bridge, 1st August 2007, /10/
Slika 7b. Srušen most, 1. avgusta 2007, /10/

during the evening rush hour, it suddenly collapsed, killing 13 people and injuring 145. The bridge, carrying 140 000 vehicles daily, was Minnesota's fifth busiest. The National Transportation Safety Board (NTSB) cited a design flaw as the likely cause of the collapse, and asserted that additional weight on the bridge at the time of collapse contributed to catastrophic failure (Fig. 7b).

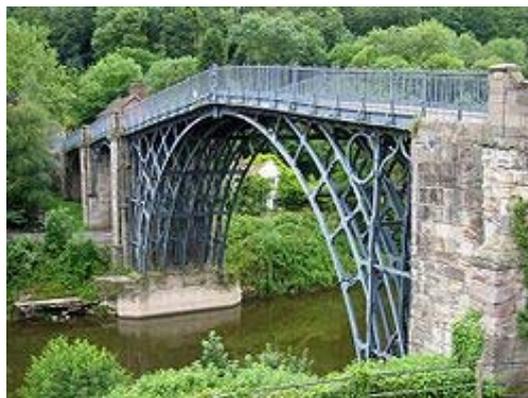
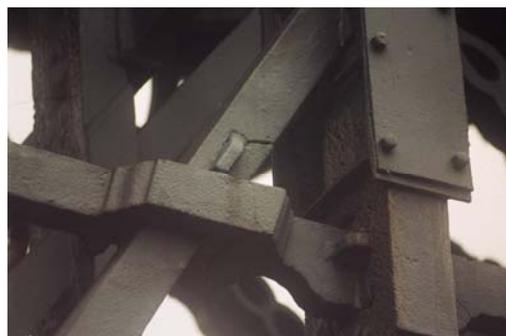
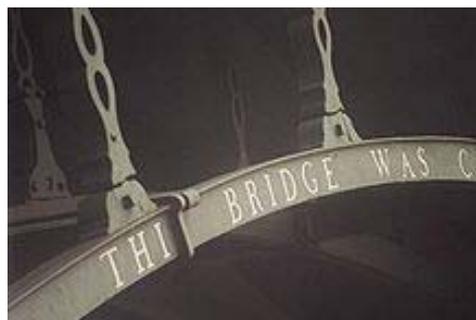
Figure 8. The Iron Bridge (top), crack and repairs in bridge (centre) and cracked supports (bottom).
Slika 8. Gvozdeni most (gore), popravka prsline na mostu (sredina) i oslonci sa prslinom (dole)

Just a few years after the construction of the bridge, cracks appeared in the masonry abutments, caused by ground movement. Some of the present-day cracks in the cast iron may date from this time, although others are probably casting cracks. Some were pinned with wrought iron straps, but others have been left free. By 1802, the

southern stone abutment had to be demolished, and replaced with temporary wooden arches, before eventually being replaced by iron arches. Many of the cracks visible today in the bridge have been left untouched, however. The bridge was over-designed, and subsequent bridges built by Thomas Telford, used much less cast iron. His cast iron arch bridge at Buildwas used less than half the weight for a greater span (39.6 m). However, it suffered similar problems of abutment movement and was replaced in 1902. The cast iron bridge at Coalport, built in 1818, is even more impressive because of its lean, streamlined design, and it still carries vehicular traffic. It has about half the weight of cast iron and is longer than the earlier iron bridge structure. It was renovated in 2004.

In 1972 a programme of major repairs took place on the foundations. It involved creating a ferro-concrete counter-arch under the river. In 1999-2000, the Iron Bridge was renovated again, with replacement of cast iron road plates with steel plates, and a lightweight top surface. While the smaller parts were cast using wooden patterns, the large ribs were cast freely in excavated moulds in casting sand.

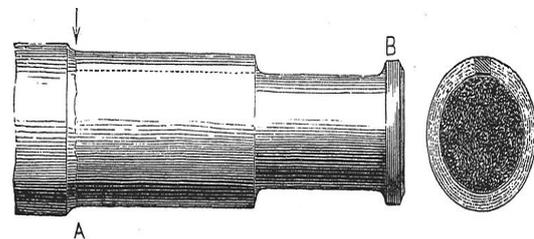
Figure 12. Drawing of a fatigue failure in an axle (1843).
Slika 12. Crtež preloma zamornog loma osovine (1843)

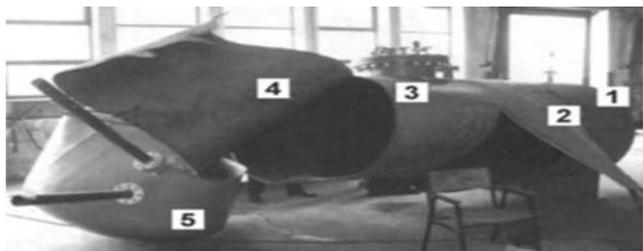
Figure 13. Brittle fracture of the underground storage tank (I), /21/
Slika 13. Krti lom podzemnog rezervoara (I), /21/

Here, two typical cases of storage tank failures are presented /21/, just to indicate some basic problems which can be met in fracture analysis. Similar problems are also important in structural integrity assessment. The cases are pretty simple since only the vessels were damaged. In the first case (I) fracture is brittle (Fig. 13), in the second (II) it ended by plastic collapse (Fig. 14). The fracture mode is quite different, although used steels were of the same class, 8 mm thick, the fracture mode was different due to different loading conditions.

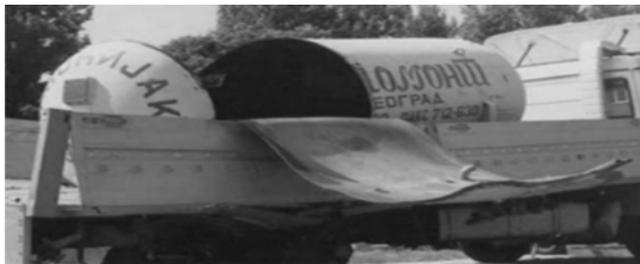
Figure 14. Plastic collapse of transportable storage tank (II), /21/
Slika 14. Plastični lom transportne cisterne (II), /21/

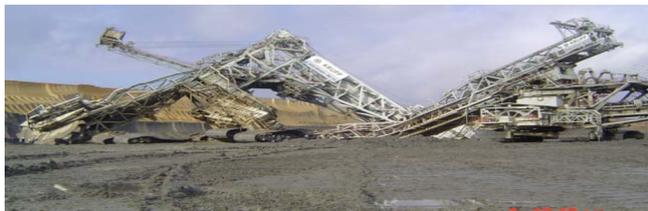
Figure 15. Collapse of bucket wheel excavator, /1/.
Slika 15. Kolaps rotacionog bagera, /1/

Collapse of bucket wheel excavator (Fig. 15) in an open surface coal mine was caused by the fracture of lugs on the counterweight holder (Fig. 16).

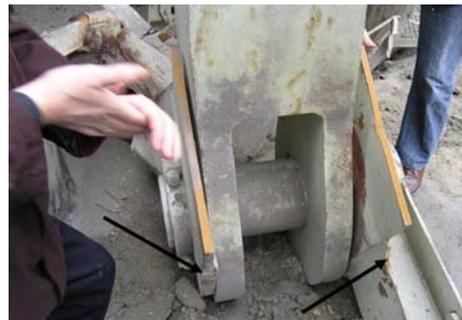
Figure 16. Fracture of two lugs on the counterweight holder caused the collapse of rotor excavator, /1/.
Slika 16. Lom dve uške držača protivtega izazvao je kolaps rotacionog bagera, /1/

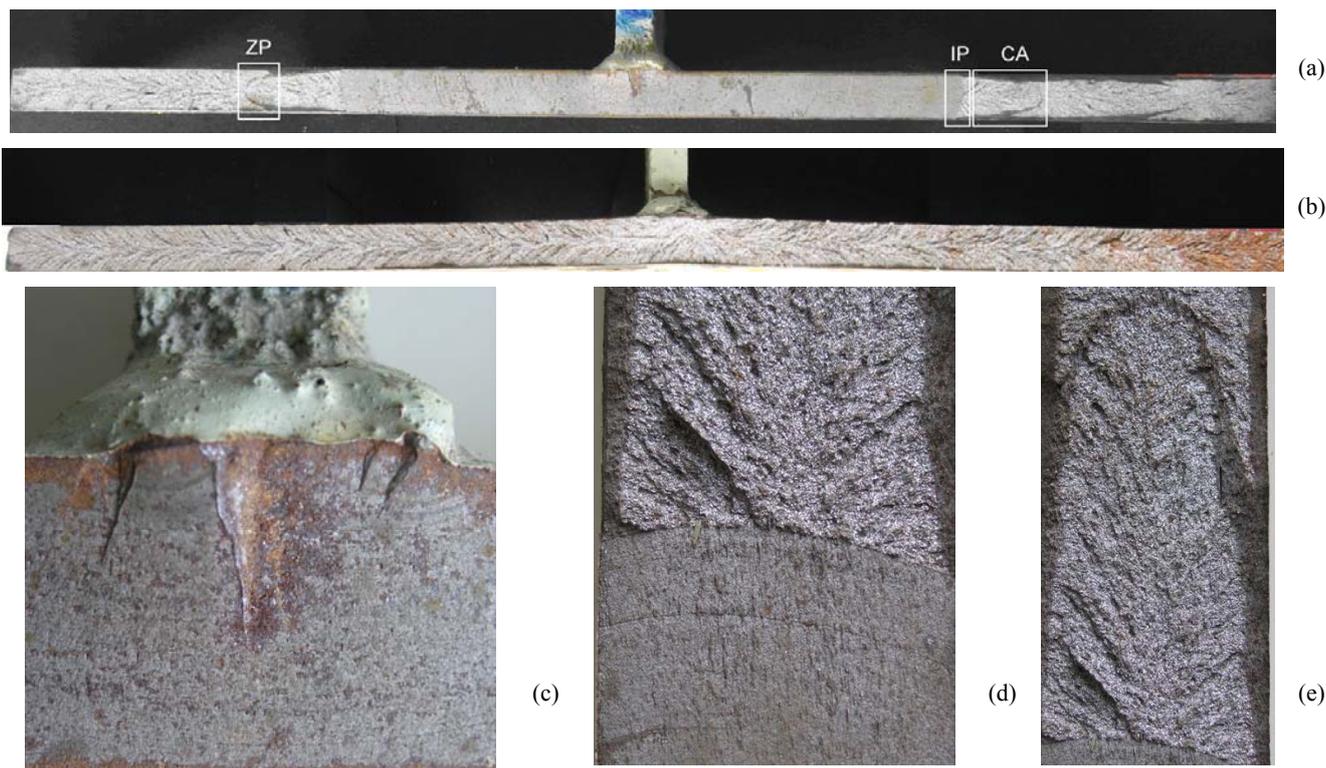
Figure 17. (a) Combined fracture (fatigue, stable crack growth with shear lips and final failure) of lug upper part
(b) Brittle fracture of lug lower part, indicating single initiating points from both sites

(c) Enlarged view of T welded joint – marked development of initial (1) and final fatigue cracks (2)

Some details of combined fracture are given in Fig. 17.

Cracks that initiated from defects in T welded joint, between the lug and web (a, c), had grown by variable loading as fatigue cracks on both sites of front lug plate. On the back side, fracture was only brittle (b). At the end of the fatigue crack, stable crack growth in plane stress condition started after blunting of the fatigue crack tip and reached the final stretch zone (d). On one side the final stretch zone in position ZP (a) developed before final brittle fracture. On the other side, position CA, (a, c), the stretch zone partly developed after crack blunting, and after stress redistribution, the crack continued to grow again in a stable manner (e) up to the final stretch zone (a), followed by fast fracture. When the cross section area of lug plate was reduced to one third, the excavator collapsed.

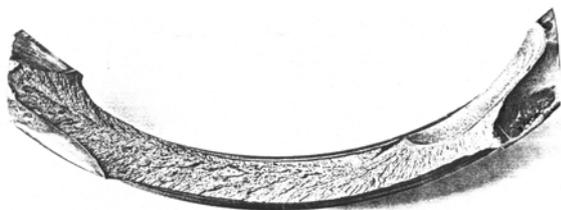
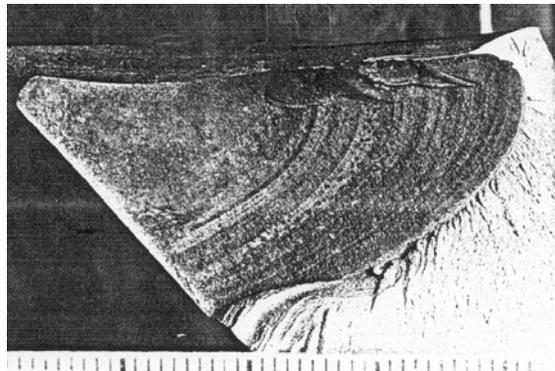
Figure 18. Blade fracture from fatigue crack in upper corner (top) with visible striations (bottom), /27/.

The steam-turbine rotors are subjected to cracking by a variety of failure mechanisms, sometimes with catastrophic result by complete destruction, as was the case here. Therefore, special attention should be given to rotor and blade upgrading and repairing techniques.

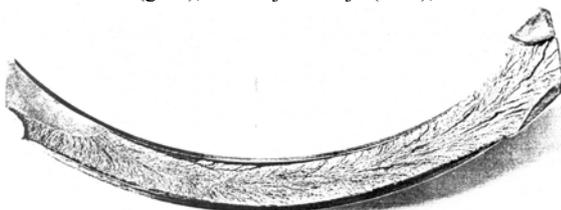
Figure 19. Second blade fracture started from a fatigue crack, /27/.

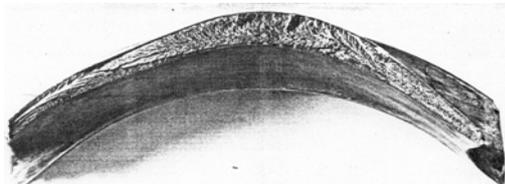
Figure 20. Brutal fracture of blade due to overloading, /27/.

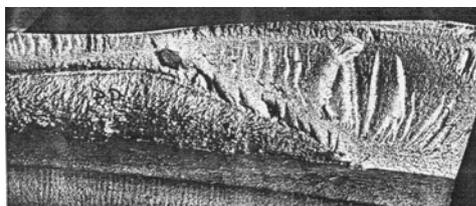
Figure 21. View of developed crack surface from Fig. 21 (top) and normal cross-section (bottom), /27/.

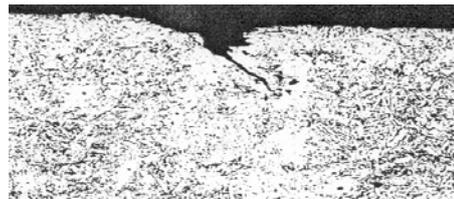
Figure 22. Corrosion attack at blade surface, /27/.

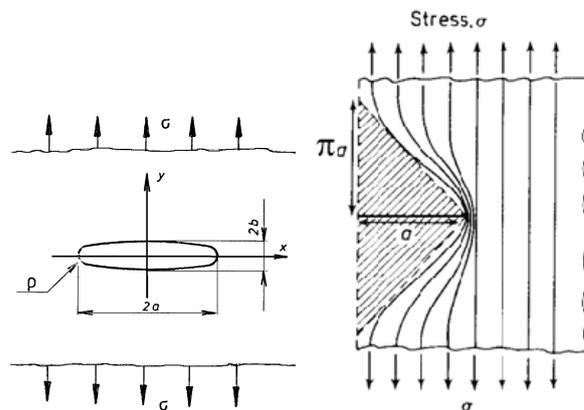
Figure 26. Griffith's crack: geometrical configuration (left) and simplified presentation (right), /34/.

In the analysis of fracture strength, Griffith /38/ recognised that it is possible to derive a thermodynamic criterion for fracture by considering the change of total energy of a cracked body with increased crack length. Only if the total energy should decrease, would the crack extend spontaneously under applied stress. Applying the energetic approach to the body as a whole, it is possible to neglect local stress concentration around the crack tip (Fig. 26) and after complicated calculus derive a useful expression for fracturing stress. New surfaces of the growing crack are created, and since stresses and displacements ahead of the infinitesimally extended and the initial crack tip are almost identical, the energy increase during crack extension is simply the unit “work to fracture,” 2γ , multiplied by the area of new produced crack surfaces. Griffith proposed that the driving force for crack extension is the difference between the energy released for crack extension and that needed to create new crack surfaces. The calculation applied by Griffith is complicated, but the same result is obtained by simplified calculation, /37/, used here to present an approach to modelling.

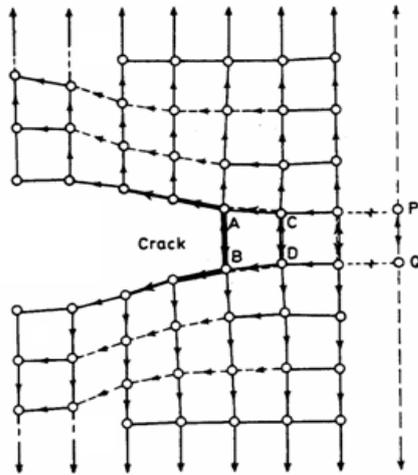
Figure 27. Development of a crack in an atomic model.
Slika 27. Razvoj prsline u atomskom modelu

Obtained results combine the energy U , remote applied stress σ , and involve the crack length, a , for the first time in calculation. It is not possible to directly analyze crack effect [37], hence the crack is modelled in an ideal crystalline body by increased interatomic distance at the tip under applied remote stress σ (Fig. 27), considering the change in crack driving force F with crack extension at the atomic level.

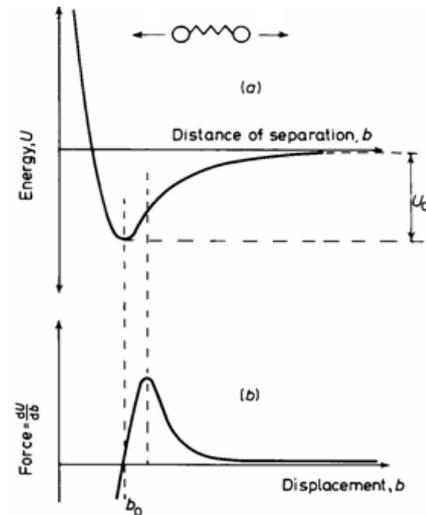
Figure 28. (a) Bonding energy as a function of atomic distance at separation, (b) Force–displacement curve.
Slika 28. (a) Energija privlačenja atoma u zavisnosti od rastojanja atoma pri razdvajanju, (b) Kriva sila–pomeranje

A fracture stress value the order of $E/10$ may be estimated from Eq.(5), using the value of γ the order of $0.01Eb_0$, applicable to many metals. Strengths of crystals and glasses in practice tend to be lower than this value by two orders of magnitude. Ideal fracture stress can be attained locally, but macroscopically, the homogeneous sample might contain small defects, causing discrepancy between predicted and actual values, as Griffith had suggested, [38].

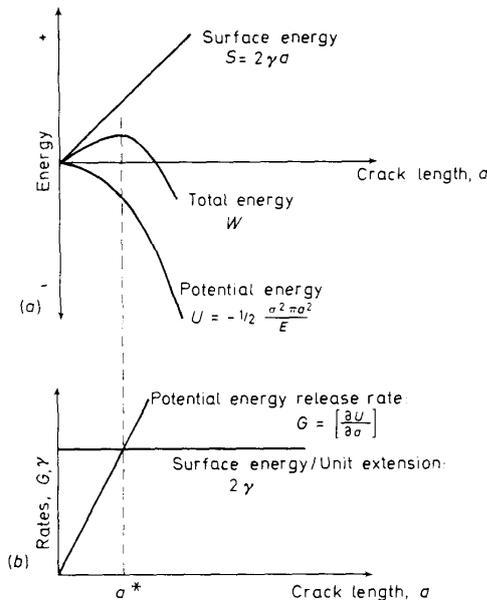
Figure 29. (a) Variation of energy with crack length. (b) Variation of energy release rates with crack length. (a^* is the critical value).

$$W = U + S = -\frac{1}{2} \frac{\sigma^2 \pi a^2}{E} + 2\gamma a \quad (9)$$

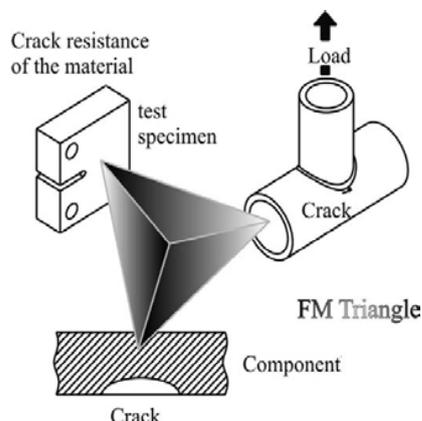
Figure 30. Fracture mechanics application in design.
Slika 30. Primena mehanike loma u projektovanju

In the fracture mechanics-based approach, the material should withstand maximal applied load when a crack-like flaw exists, see Eq.(12). This approach is shown in Fig. 30.

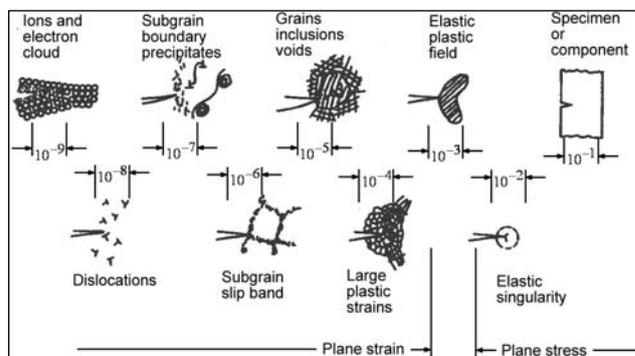
Figure 31. The sizes of phenomena in metals – a classical picture, presented in centimetres, /34/.

The range in which continuum mechanics theories are applied is very narrow. All material properties differ when they are averaged over different regions within each grain that can be traced to crystal lattices. When load is applied, the morphology of present defects and imperfections can be changed, complicating the analyses. At reduced scale size the changes may occur continuously, such that equilibrium cannot be reached and the process is in non-equilibrium. When the use of an ordinary continuum mechanics theory that assumes equilibrium and material homogeneity fails, one preferable assumption is not applicable. This situation needs modelling and simulation, since experiments and calculations are not possible yet at this level.

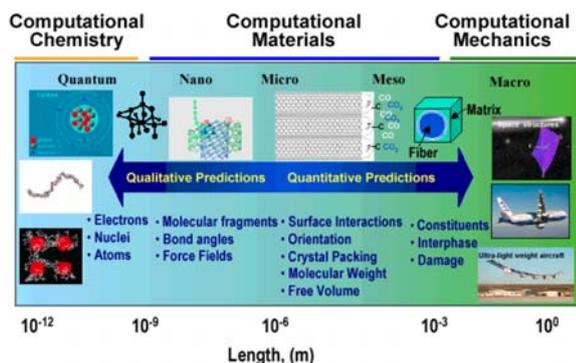
Figure 32. Length and time scales in material modelling, /44/.

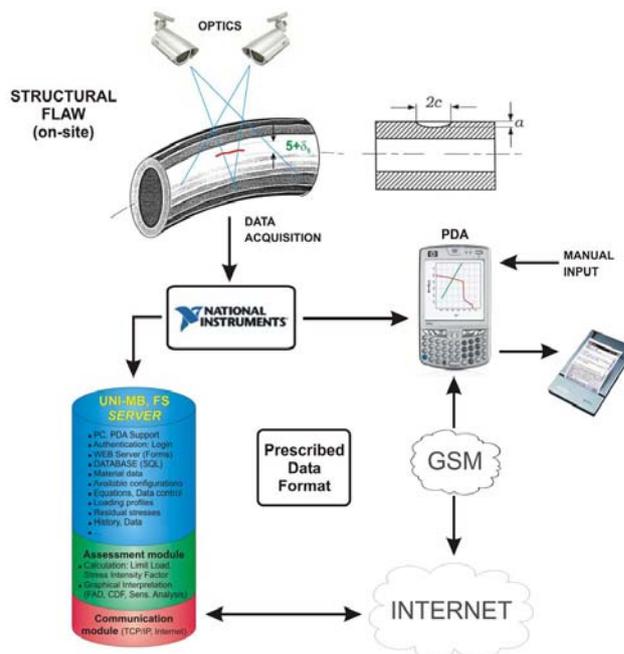
Figure 34. System for continuous monitoring of strain and damage on structure, data acquisition and fitness-for-service evaluation, /52/
Slika 34. Sistem za kontinualno praćenje deformacija i oštećenja, sakupljanje podataka i ocenu podobnosti za upotrebu

Ten years ago, about 187 000 bridges are classified as deficient in USA. The Federal Highway Administration (FHWA) has introduced a mandatory bridge management system and 10 000 bridges had been constructed or retrofitted per year. Non-destructive tests (NDT) by digital devices and non-destructive evaluation (NDE) by applying the modern database with test results are involved, /53/.

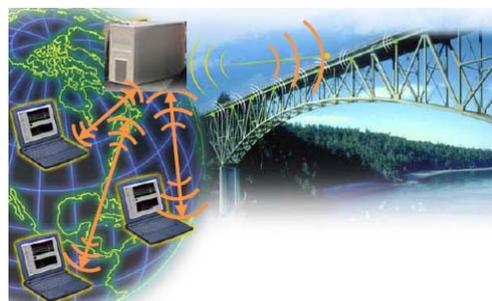
Figure 35. System for continuous monitoring of bridges, /53/
Slika 35. Sistem za kontinualno praćenje stanja mostova, /53/

This fraction of steel bridges is important. According to FHWA data, in USA it is above 50%. The choice of NDT and non-destructive evaluation (NDE) methods depends on bridge type and materials used. Quantitative NDE and NDT data on bridge condition are necessary and can be wirelessly transmitted to an Independent Film Channel (IFC) server (Fig. 35).

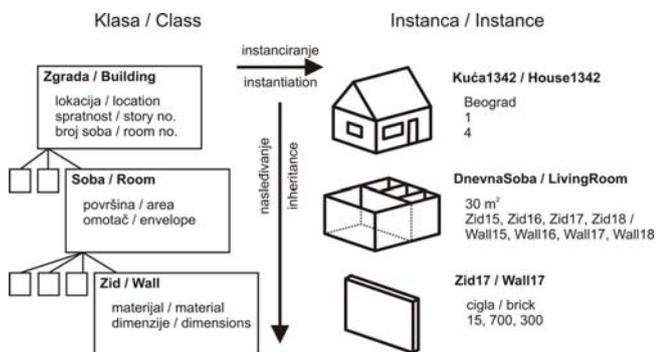
Figure 36. Object oriented modelling concepts for the Building Information Model (BIM), /54/.

Object oriented modelling enables rapid and reliable development of complex systems for Building Information Model (BIM), (Fig. 36). It is standard in the software industry, for modelling all pursuits of information technologies in all branches of human life, /54, 55/. The basis of the electronic building model development interoperability are data models as the extensible markup language (XML) and Industry Foundation Classes (IFC), Fig. 37. Similarly, the IFC Bridge model is intended to manage the entire lifecycle of the bridge construction, /53/.

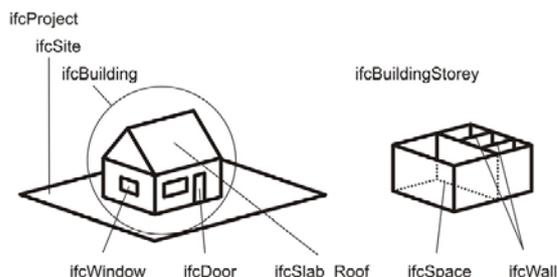
Figure 37. Example of Industry Foundation Classes (IFC).

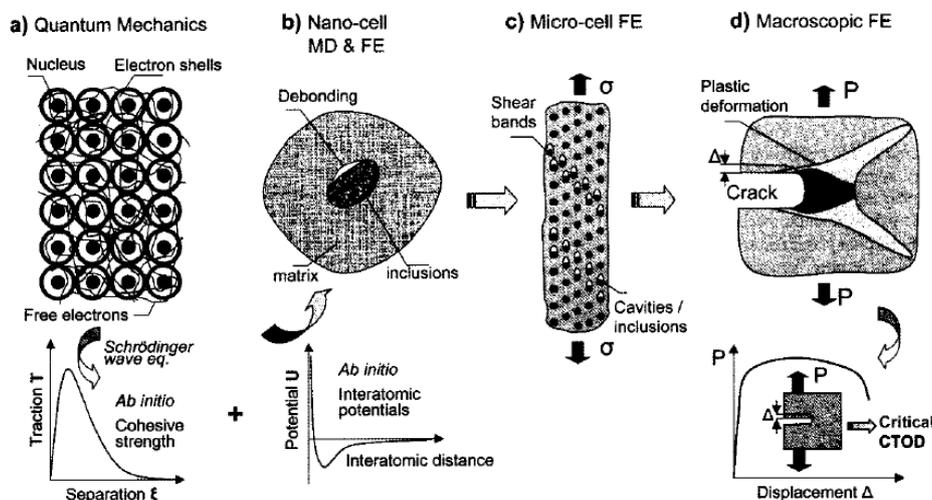
Figure 38. Hierarchical modelling: (a) quantum mechanics simulation; (b) molecular dynamics and finite elements models; (c) macro-cell and nano-cell; (d) macroscopic finite elements model for critical crack opening displacement assessment, /42/. MD–Molecular dynamic, FE–Finite element, CTOD–Crack tip opening displacement.

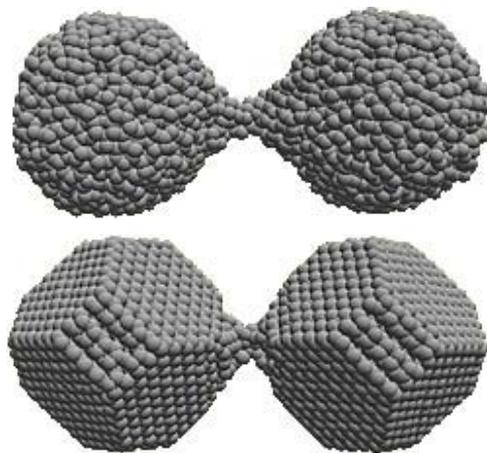
Figure 40. NIST researchers have shown that silica that are brittle in bulk, exhibit ductile behaviour at the nanoscale. Computer simulations demonstrate material extension and necking that occurs during the separation of amorphous (top) and crystalline (bottom) silica nanoparticles, /59/.
