Inspection and Repair Quality Plan of Regeneration Gas Heater

In this paper, the regeneration gas heater is inspected using nondestructive testing methods, and repair quality plan is presented.

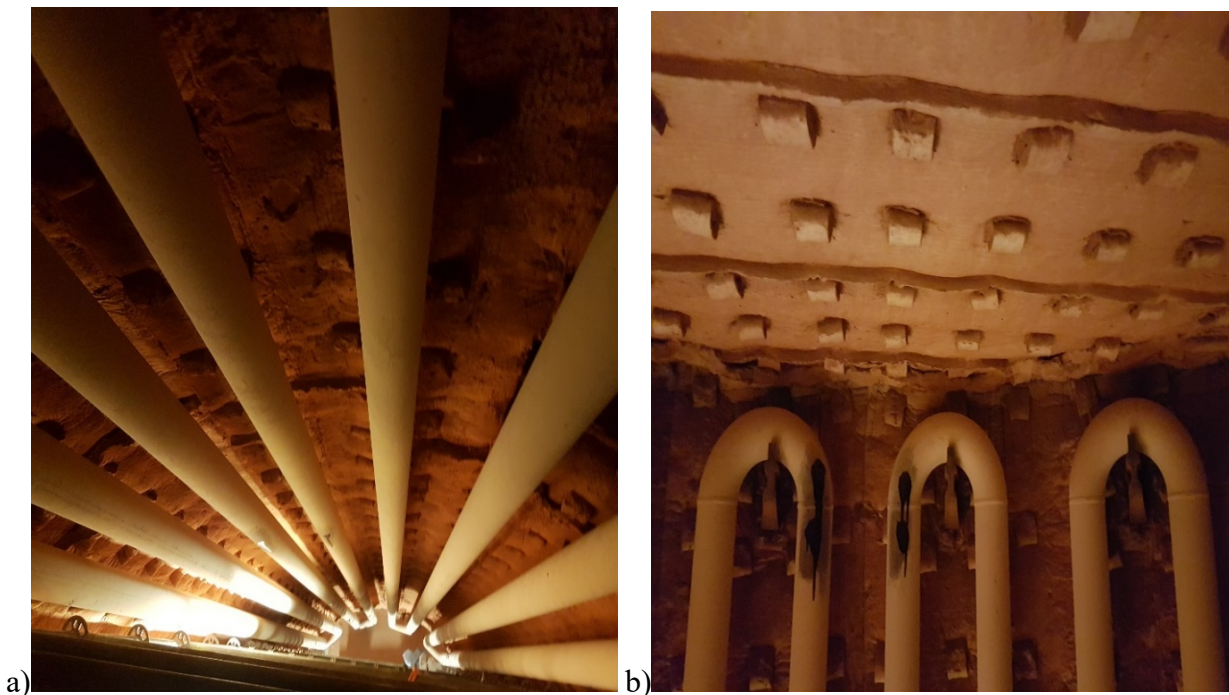
Figure 2 presents results of visual testing. according to results of VT, the pipes are in good condition.

Visual testing confirmed that the tubing inside the regeneration system seem to be in good condition. There are no visible cracks or deterioration on the shell and the heads. There are no evidence of corrosion, leaks and painting defects.

Fig. 2. Visual inspection showed that pipes are in good condition

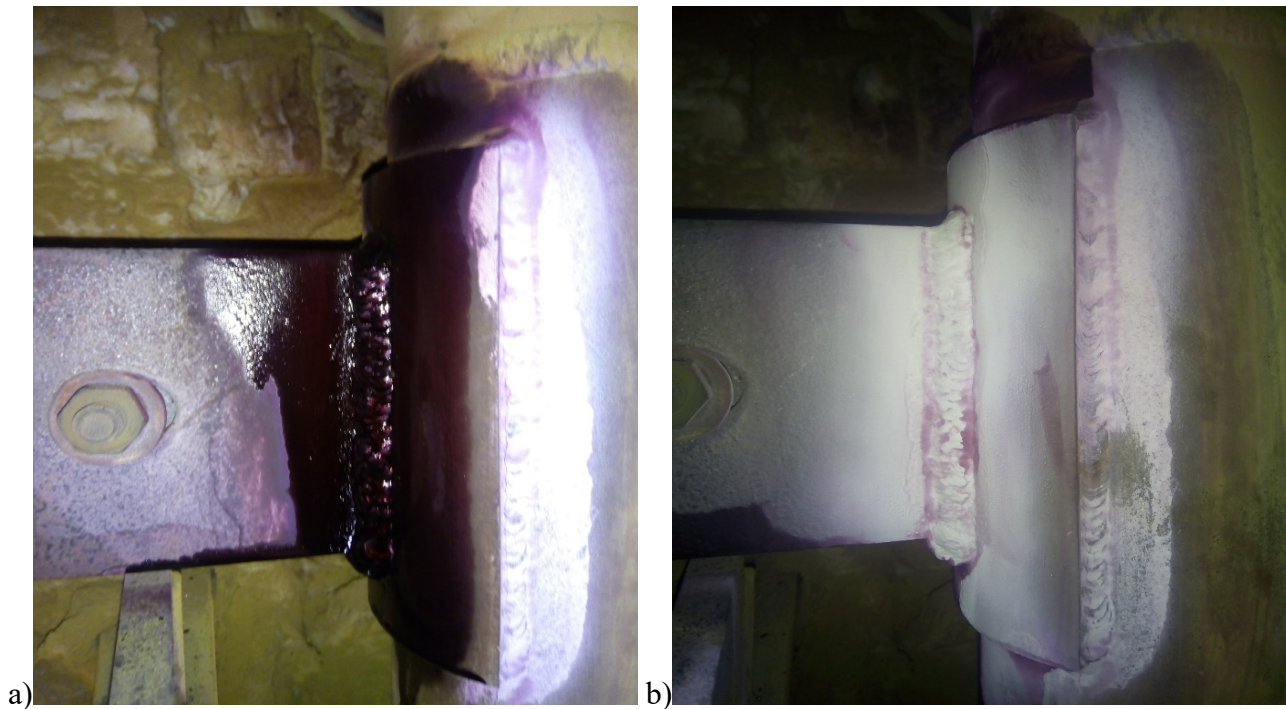
Liquid penetrant testing has been performed at several welding joints. One defect (crack) has been found at the internal support of pipes and two cracks have been found on external side of Regeneration Gas Heater at the pipe of thermocouple gage.

Fig. 3. Crack on support of pipe removed by grinding and repaired by welding, penetrant test was conducted after repair welding and cracks was not found at time of inspection

Plan to repair support of tubes on interior side of Regeneration Gas Heater in Train 2 includes removing of cracks or any other defects using appropriate tools. This should be followed by Liquid Penetrant Test to ensure that no any defect exist prior to repair welding activities. Further, the surface should be cleaned by well utilizing chemical solvents to remove any dirt, contaminants, etc. Welding for the repairing of the cracks was performed according to WPS list: WPS-SM-805, supported with the appropriate PQR. The welding process was GTAW + SMAW, manually; joint design groove and fillet with no backing according to ASME Sec. IX. Specification type and grade of base material was A312GrTP304, and filler metal ST 3011/S309L-16 (Hyindai Weld Co.). Preheating temperature was 10°C and interpass temperature was max. 150°C, shielding gas was argon (99,99%) with flow rate 12-20 l/min. Welding was performed in four layers, first two by GTAW welding process and last two with SMAW process. Finally Liquid Penetrant Test should be done after completion of welding activities. Figure 3. presents the repaired support of tubes.

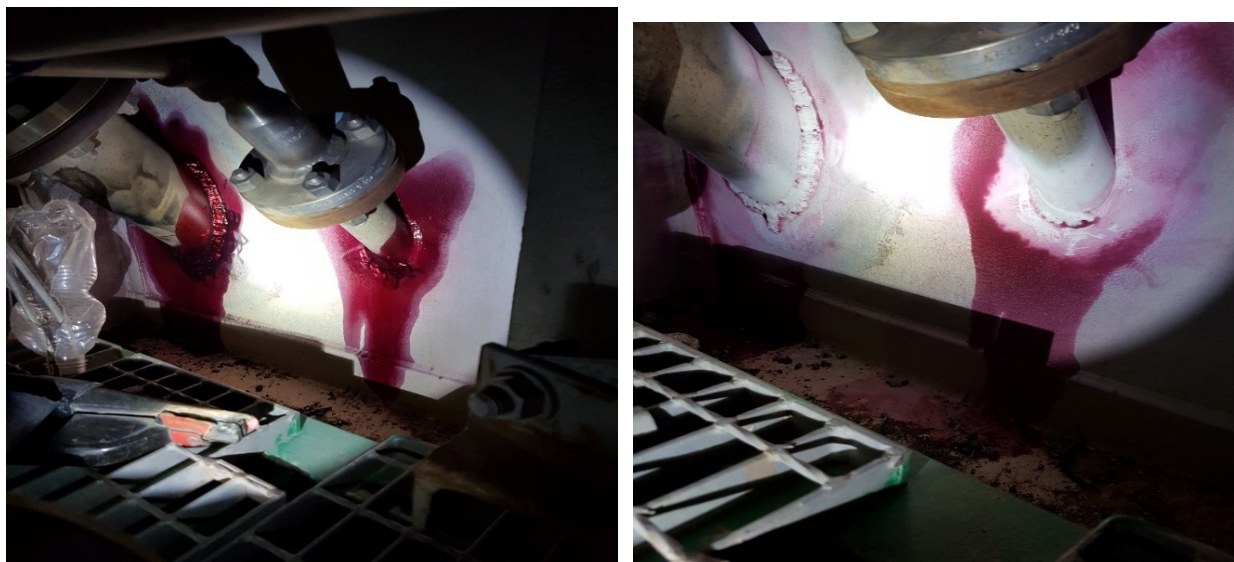
Fig. 4. Cracks on thermocouples removed by grinding and repaired by welding, penetrant test was conducted after repair welding and cracks was not found at time of inspection

Plan to repair connection at thermocouple nozzles-housing of Regeneration Gas Heater in Train 2 includes removing the cracks carefully (or any other defect) using appropriate tools.

Liquid Penetrant Test carried out to ensure that no any defect existed prior repair welding activities. After that it is important to clean the surface with well utilizing chemical solvents to remove any dirt, contaminants, etc. Welding should be performed to repair cracks following WPS list, supported with PQR. Finally Liquid Penetrant Test should be done after completion of welding activities. Figure 4. presents the repaired thermocouples.

As per Plant Inspection Philosophy, Next External Inspection, Internal Inspection, Hardness testing, Ultrasonic Thickness measurements and Penetrant Testing at the same positions, shall be performed within next 5 years. Visual inspection shall be performed within 6 months at the pipe of thermocouple gauge in the case of checks for cold cracks.
