Damage Occurrence in Welded Structures of the Bucket-Wheel Boom

Keywords: bucket-wheel excavator boom, damage, NDT, tensometry

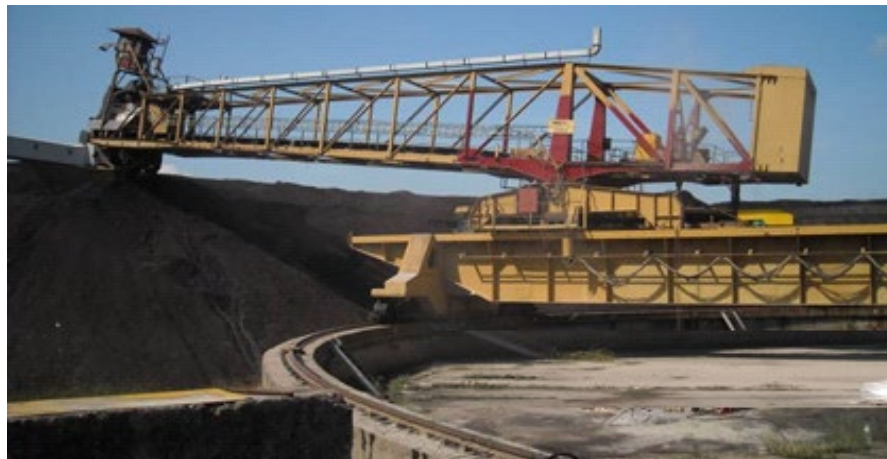
Figure 1. Bucket-wheel excavator DU1 at the coal landfill of the thermal power plant 'Nikola Tesla A'

Bucket-wheel excavator with designation DU1 is presented in figure 1. Considering the fact that there was no technical documentation, all tests and researches presented in this paper were carried out under the assumption that welded structures were made of structural steels S355 and S235 [13].

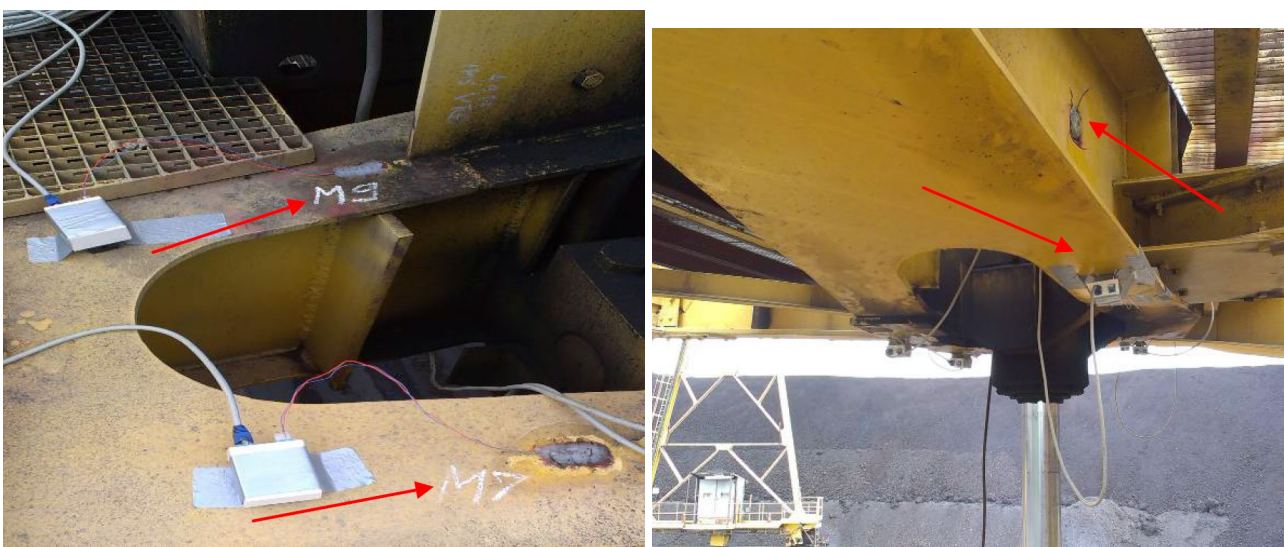
Figure 6. Measurement locations at the vital structure in the area of the cylinder which enables the movement of the bucket-wheel boom

Stresses were calculated on the basis of tensometric measurements of local strains in different positions of the bucket-wheel boom during the operation of the bucket-wheel excavator DU1 (figure 1), in order to check if there is a possibility of appearance of initial cracks due to fatigue that occurs at vital structures of the cylinder, which enables the movement of the bucket-wheel boom. Measurements were carried out through the use of a large number of measurement gauges TML PL-20. Certain number of measurement locations at damaged vital structure in the area of the cylinder and at the support structure of the cylinder itself are presented in figures 6 and 7. On the basis of results of measured local strains and calculated stresses it was determined that the above-mentioned structures are subjected to the highest variable stresses, when bucket-wheel excavator DU1 is in the lowest position of exploitation. Allowable tensile stresses for structural steels S235 and S355 for safety level $S=1.5$ are $TS_{all} = 157$ [MPa] and $TS_{all} = 237$ [MPa] respectively, with note that compressive stresses do not have the same effect on the propagation of the initial crack and structural integrity.

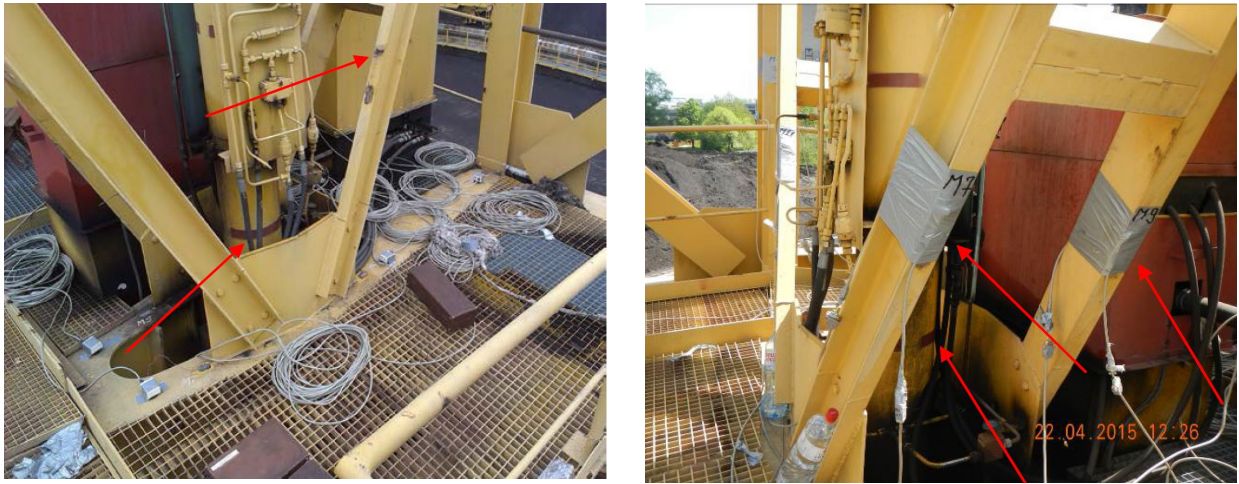
a) Measurement locations right of the support structure

b) Measurement locations left of support structure

Figure 7. Measurement locations at the support structure of the cylinder

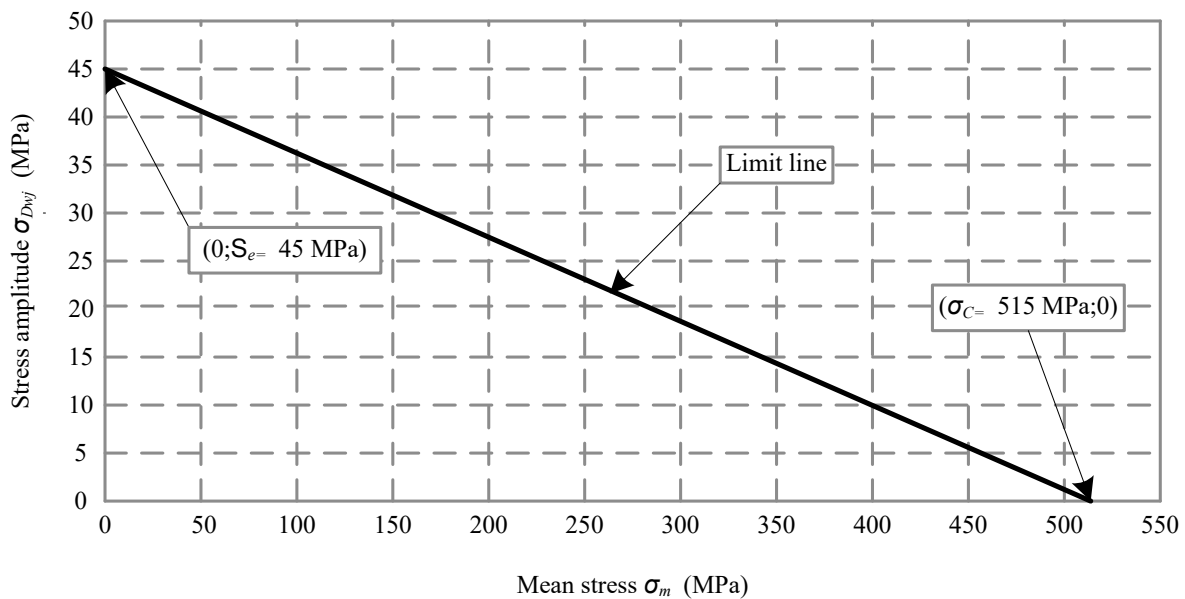
Fig. 12. Modified Goodman diagram

In accordance with recommendations [14], it was adopted that critical value of fatigue safety is $\sigma_{Dwj} = 45$ MPa. Tensile strength of the weld metal is determined by the following expressions [15]:

It is obvious that in both representative combinations of static stresses (figure 12), measured stresses in critical areas of vital components of the bucket-wheel (tables 1-3) lie beneath the limit line which connects fatigue strength σ_{Dwj} and tensile strength σ_{UTSmin} of weld metal, which proves that damages at vital components of welded lattice structure of the bucket-wheel boom occurred due to the application of inadequate welding technologies during the manufacture of the bucket-wheel excavator and/or during the previous repairs.
