## SOME DAMAGES OF RC BRIDGES AFTER STRONG EARTHQUAKES

**Abstract:** Highway bridges in seismically active regions are often subjected to multiple earthquakes, including multiple main shocks during their service. Repeated seismic events result in reduced structural capacity and may lead to bridge collapse, causing disruption in the normal service. Serious earthquake events cause damage of the elements, with different damage level, even causing them to collapse. It is very important to save the damaged or weakened structures by emergency supporting or/and later strengthening, and to perform rehabilitation of their seismic resistance. The methods of evaluation of seismic resistance of damaged elements and structures are discussed in this paper. After evaluation of the damage degree and determination of the required demands and available seismic resistance of structures, redesign must be performed. Also, the method of rehabilitation of the elements and entire damaged bridge structures are analysed, including both traditional and advanced techniques. The focus of this paper is on reinforced concrete (RC) bridges. Post-earthquake assessment and analysis of the seismic performance of th

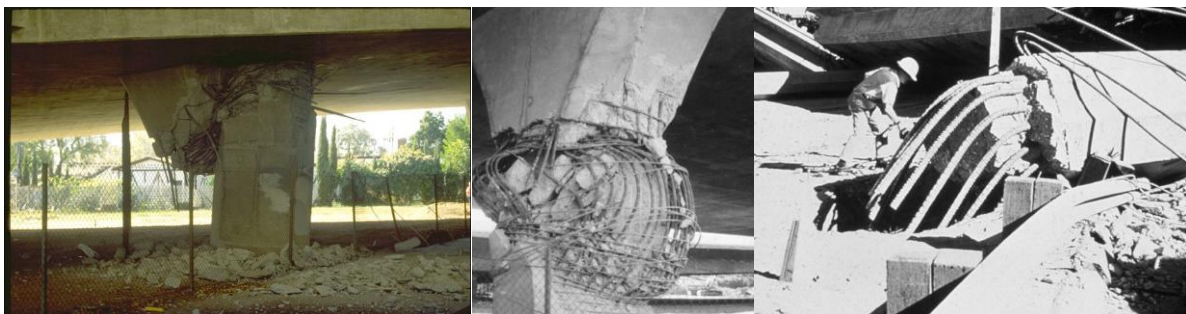
**Figure 1.** Shear failure, 1971 San Fernando earthquake; RC column failure modes; Compression failure of confined concrete; RC column failure modes Lap-splice failure [19]

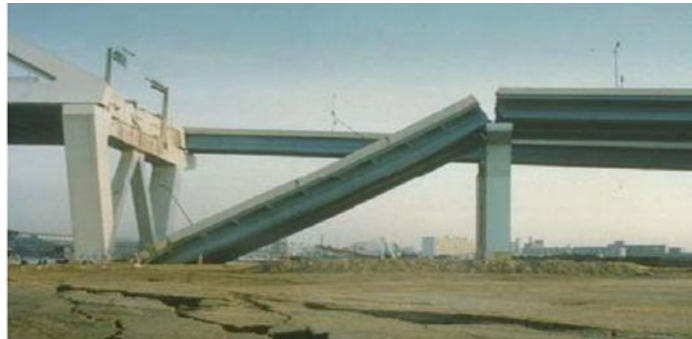
**Figure 5.** Unseating damage (Kobe, 1995), after [16]

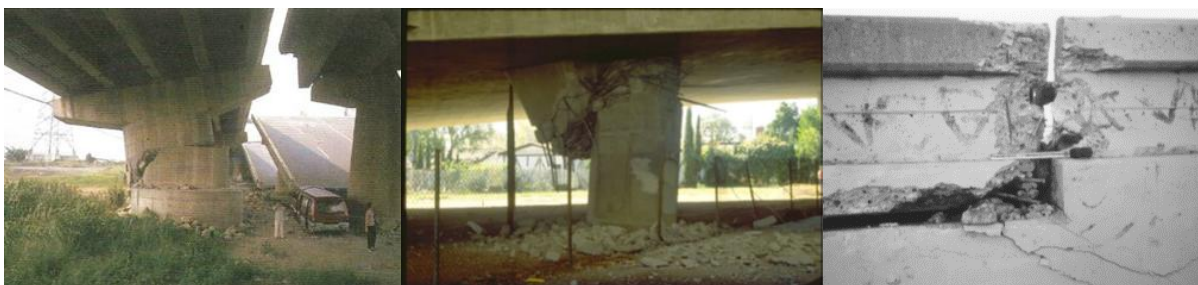
**Figure 6.** Collapsed spans and damaged piers bridge at the third span, Taiwan 1999, after (Sung et al., 2012), cited in [1], Severe Damage: Shear failure 1971 San Fernando Earthquake, after [16], Santa Clara River Bridge pounding damage in 1994 North-bridge EQ, after [21]

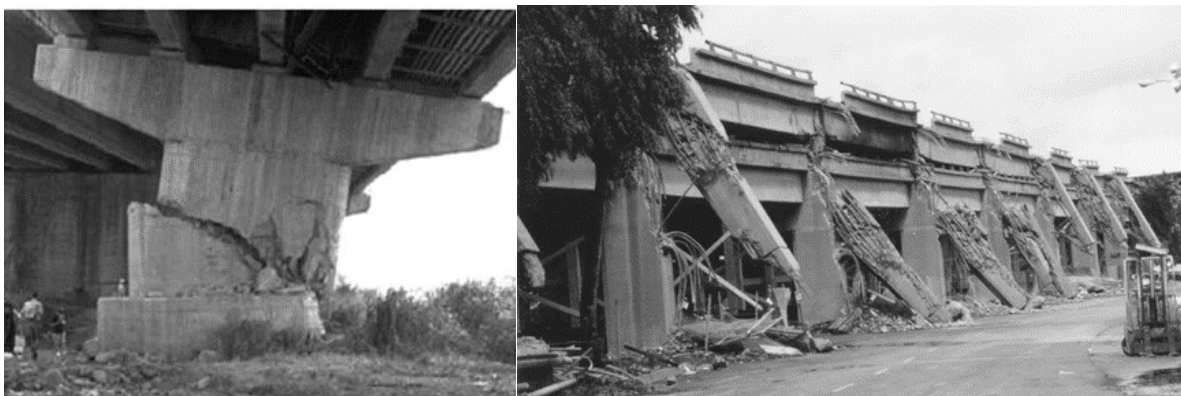
**Figure 7.** Column shear damage (left), Cypress Street Viaduct collapse in the 1989 Loma Prieta earthquake (right), after [12]

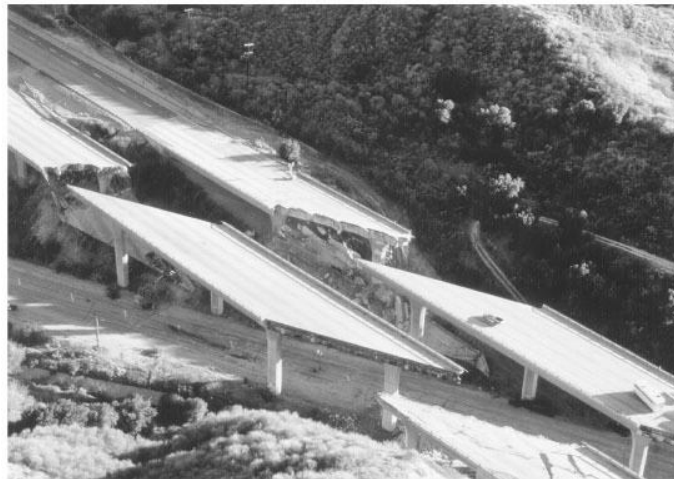
**Figure 9.** Gavin Canyon Undercrossing collapse in the 1994 Northridge earthquake, after [8]

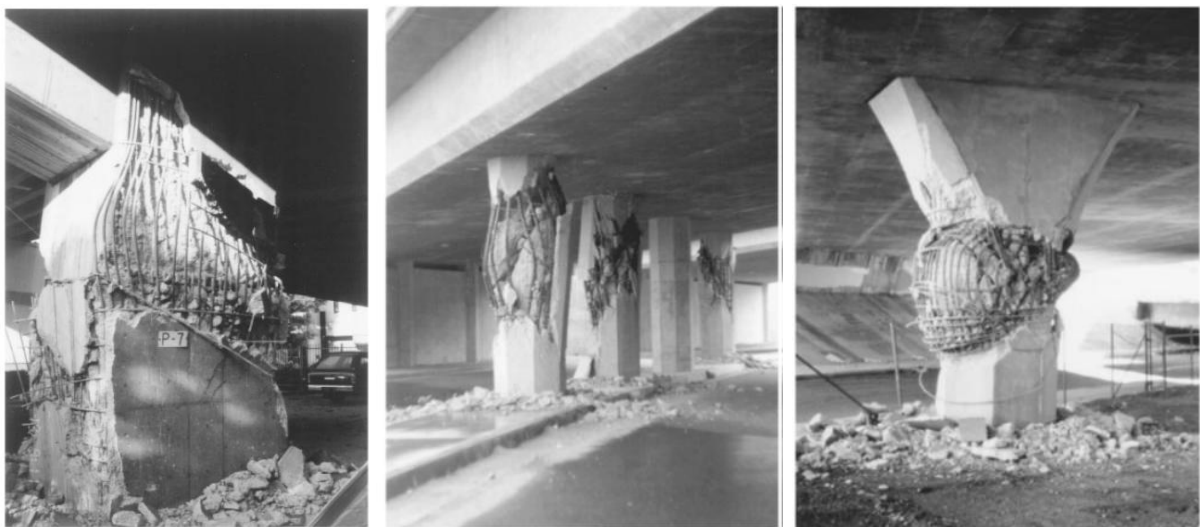
**Figure 11.** Failure of columns with longitudinal reinforcement cutoffs near midheight in the 1995 Hyogo-Ken Nanbu earthquake after [8]; of the Route 5/210 interchange during the 1971 San Fernando earthquake after [8]; Failure of flared column in the Route 118, Mission-Gothic Undercrossing, in the 1994 Northridge earthquake[11]

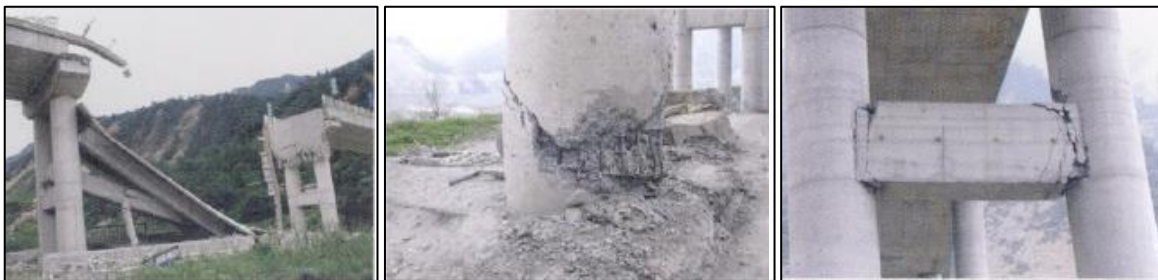
The Gaoyuan Bridge also has the girder falling, as showed in Figure 12. In the Tangshan earthquake, many simple-supported girder bridges were damaged by girder falling. Piers earthquake damage of the Baihua Bridge in the Wenchuan earthquake. [4].

**Figure 12.** Girders falling of the Gaoyuan Bridge; Piers seismic damage of the Baihua Bridge [22]

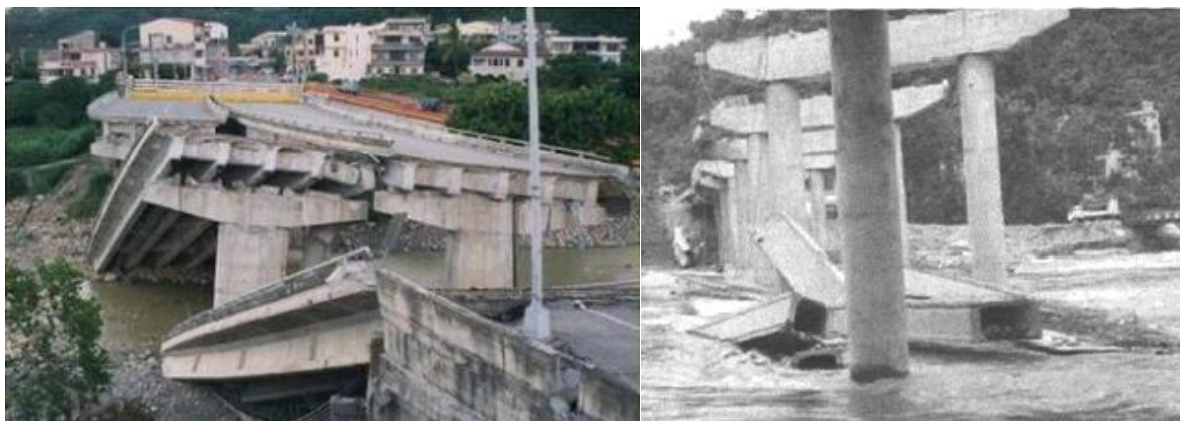
**Figure 13.** Seismic damage of foundation displacement, after [22]
