# Filler Material Choice for Stop Valve Repair Welding

**FILLER MATERIAL CHOICE FOR STOP VALVE REPAIR WELDING**

Filler material choice for repair welding of stop valve spindle of thermal power plant by-pass pipeline was presented in this paper. Repair welding of the stop valve spindle was necessary because of plant operating problems due to very frequent localized damage appearance in the form of erosive wear on it. For this purpose it was necessary to choice appropriate filler material with high wear resistance characteristic. Experimental investigation and testing (hardness measurement, chemical composition analysis and microstructural investigation) of prepared specimens after welding simulation with different kind of filler material was performed. On the basis of obtained results it was recommended procedure for application of the filler material with generally preferable characteristic.

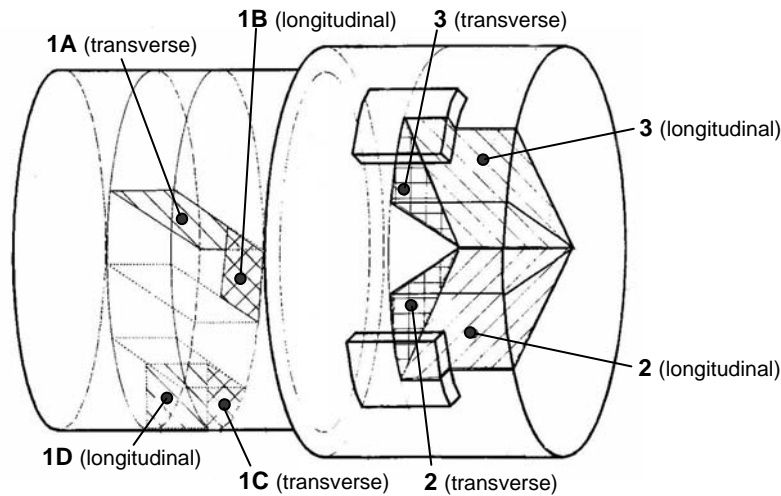
**Figure 3 – Schematic view of sampling positions**

The view of valve spindle with repair weld positions and the scheme of sampling are shown on Fig. 3. Samples were taken in a two mutual normal direction. All samples were submitted to hardness measurement and microstructural investigations.

For comparative purposes repair welding on the same valve spindle, in three different locations, were performed with different techniques and filler material, as follows:

- I approach - Repair welding was carried out in two steps. As a first, several layer of filler material (shielded electrode of commercial mark UTP 068HH) was deposited circumferentially on the base material by MMAW technique in the aim of damaged area elimination; in the second step, the powder UTP 6H was deposited as a final layer by the treatment of hot metallization.
- II approach - Repair welding was carried in two steps, too. Damaged area was filled with UTP 068HH shielded electrode, but over the last layer Stellite 6 was deposited by GTAW technique;
- III approach - On the damaged parent material, Stellite 6 was directly deposited.
