## UTICAJ OTKAZA ZUBACA NA BEZBEDNOST MAŠINA – ISPITIVANJE I ANALIZA THE EFFECT OF TEETH FAILURES ON MACHINE SAFETY – TESTING AND ANALYSIS

Stručni članak / Professional paper

*According to clauses of Machinery Directive 98/37/EC the basic requirements are defined which have to be met by gear power transmissions in regard to health and safety. Different types of gear teeth damage, fracture and affecting conditions of environment, service and maintenance are analysed in the paper. A detailed description of damage forms of teeth flank surfaces under high loads and insufficient lubrication which can cause failure of heavy machinery and also imposes danger for people and environment. Testing and analysis procedures for some types and levels of teeth damage are shown. Tests of gear teeth of an excavator front arm are presented.*

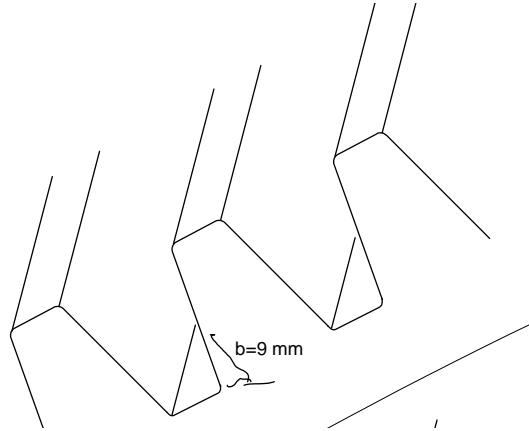
Slika 9. Oblik i dimenzije prslina na čelima zubaca (L—dužina prsline, b—dubina prsline).  
Figure 9. Shape and dimension of cracks on tooth faces (L—crack length, b—crack depth).

Ljuspasti piting koji se ne javlja samo u pojusu bokova zubaca oko podeonog kruga, već i na temenim delovima bokova zubaca, ukazuje na to da oštećenje nije prouzrokovano nedozvoljenim kontaktnim naprezanjima, već lošim podmazivanjem koje dovodi do odlepljivanja čestica sa površine bokova zubaca. Ovo oštećenje može biti i rezultat loše termičke obrade zupčanika, ali za ispitivane zupčanike nema raspoloživih podataka o termičkoj obradi.

- cracks on tooth faces (Fig. 9),
- cracks on flanks of previously repaired regions on the wheel of the right and left gear pairs.

Flake pitting that occurred on teeth flanks, not only around pitch circle zones, but also on zones below teeth tips, indicates that damage was not caused by non-allowed contact stresses, but due to poor lubrication which produced spalling of particles from teeth flank surfaces. This type of damage can also be associated with poor heat treatment, but for gears considered here there are no available data about heat treatment.
