Procedia Engineering 10 (2011) 2244-2249

# ICM11

# Failure Analysis of the Stacker Crawler Chain Link

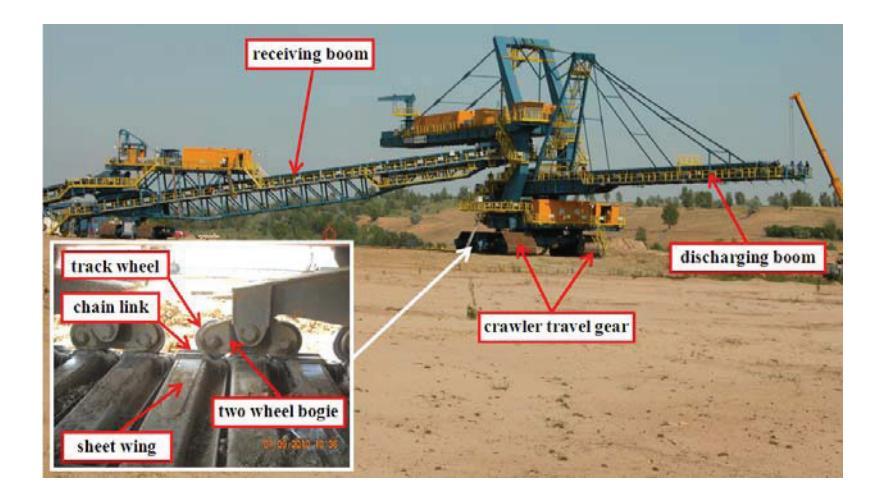
Fig. 1. Stacker ARs 2000

width and height. During the stacker's journey from the erection site to the open pit mine, three crawler chain links fractured, presenting an indication of the problems that were to occur during exploitation. In fact, after only 1000 working hours (about three months), 30 chain links sustained fractures, Fig. 2.

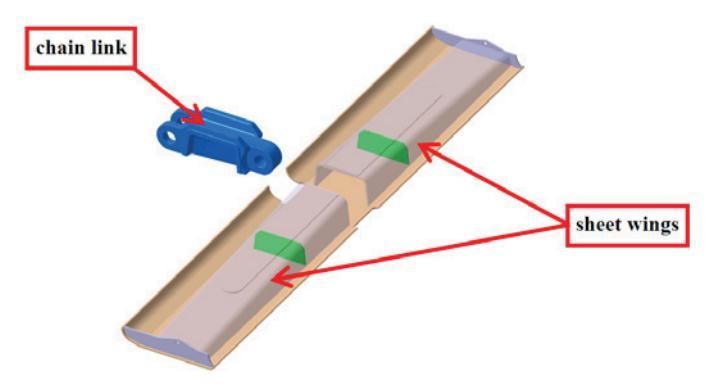
Fig. 3. Basic substructures of the crawler pad

Basically, the crawler pad structure consists of a chain link and sheet wings which are welded to it, Fig. 3. The chain links are interconnected by cylindrical joints, thus forming a close crawler contour. The driving force is transmitted during the coupling of the chain links with the drive tumbler. The track wheels roll over the chain links Fig. 1. Thus, chain links achieve key functions of the crawler travel gear: the transfer of propulsive forces and all loads on the ground. Due to the highly complex conditions in which they operate, it is of primary importance to make a proper selection of materials, as well as to follow a strict chain links fabrication technology. In the considered case and according to the design documentation, the chain links were supposed to be made from cast steel quality grade G30CrMoV6-4 + QT2 according to the code [10].
