Radomir Jovičić¹, Aleksandar Sedmak¹, Stojan Sedmak², Ljubica Milović², Katarina Jovičić²

LEAKAGE OF AN AUSTENITIC STEEL CO₂ STORAGE TANK CURENJE POSUDE ZA SKLADIŠTENJE CO₂ OD AUSTENITNOG ČELIKA

Originalni naučni rad / Original scientific paper
UDK /UDC: 621.642.34:669.15-194.56
Rad primljen / Paper received: 21.01.2012

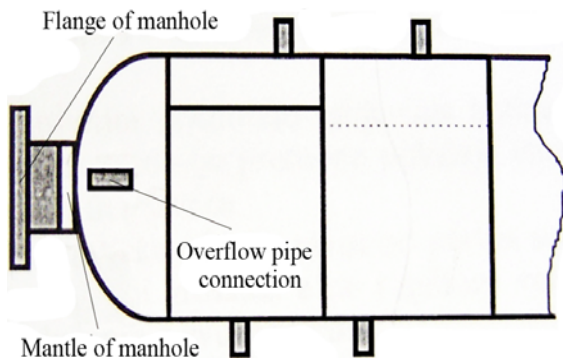
During the testing of storage tank for liquefied carbon dioxide by proof pressure droplets of water had been revealed on the outer wall of its manhole, /1/. The storage tank is of cylindrical form, thermally insulated, 12.5 m³ in volume. The mantle and tank lids are produced of micro alloyed steel P 460NL1, 14 mm in thickness. The lowest operating temperature of the tank is -55°C, the highest operating pressure 30 bar, the proof pressure test 39 bar. The storage tank is classified as II class of pressure vessels. A general view of tank and position of a manhole is presented in Fig. 1.

Figure 1. General view of tank for liquefied CO₂ storage with the position of the manhole.
