Investigation into the causes of fracture in railway freight car axle

Zoran Odanovic, Mileta Ristivojevic, Vesna Milosevic-Mitic

To appear in: *Engineering Failure Analysis*

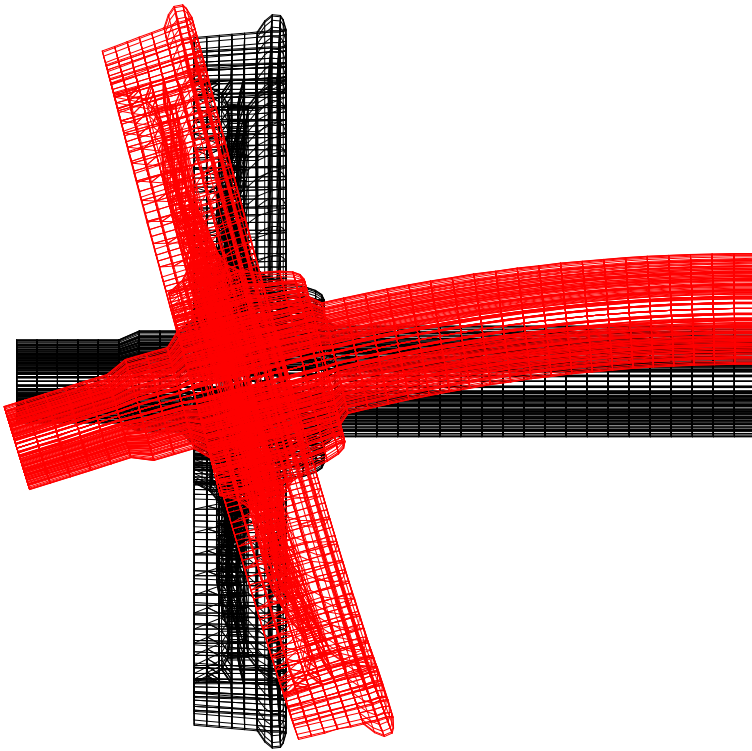
Fig. 12. Model, deformation

The first model for FEM calculations [12, 13] was created using volumetric finite elements. A quarter railway axle model with wheels was developed by means of 11 591 points and 9288 finite elements. The conditions of symmetry were specified, as well as a moving support at the wheel-rail contact. Resulting maximal displacement on the axle free end is 1.5 mm and 1.6 mm in the centre of axle. Wheel displacements on the ends range from 2.1 mm on the upper section to 2.5 mm on the lower section (Fig. 12).

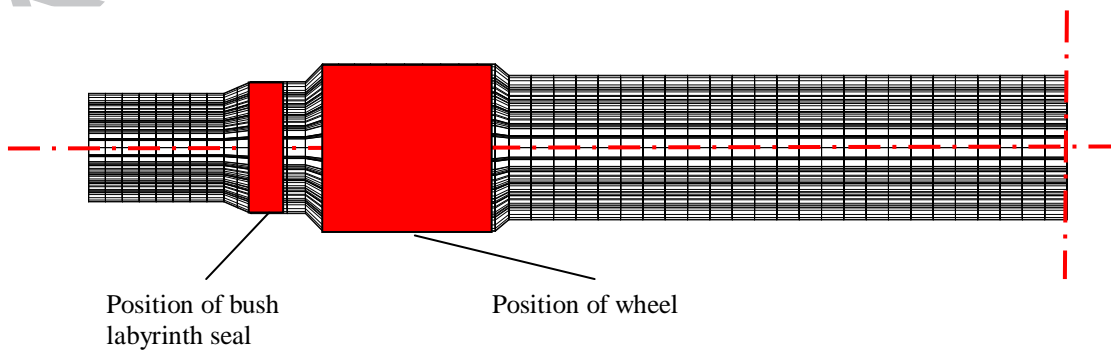
Fig. 14. Positions of bush labyrinth seal and wheel

The next stage involved the analysis of simultaneous effect of loading from the load mass and pressure at the press fit joints location on the axle stress state. This calculation was performed on a quarter railway axle model developed by applying 4641 points and 3600 volumetric finite elements. Also, 288 surface finite elements were fictionally added to the model so that the pressure at the press fit joints locations is more easily specified. The horizontal force was reduced to the axle axis, and then a corresponding moment of the force was added. Figure 14 shows the positions of bush labyrinth seal and wheel.

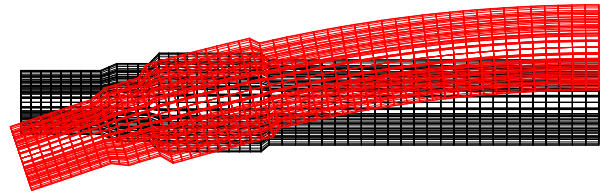
Fig. 16. Axle deformation

First, the comparison with the previous calculations was carried out. The stress state picture of the concentrated stresses is presented in Fig. 15 and obtained values coincide with the values of previously presented calculations. Figure 16 represents the corresponding deformation. Maximal displacement of the axle ends amounts to 1.53 mm coinciding with the previous calculations.
